**BANK FAILURE ASSESSMENT
16 Sea Watch Court, Florence, OR**

March 18, 2011

Prepared for:
Patricia and Richard Lukens
16 Sea Watch Court
Florence OR 97439

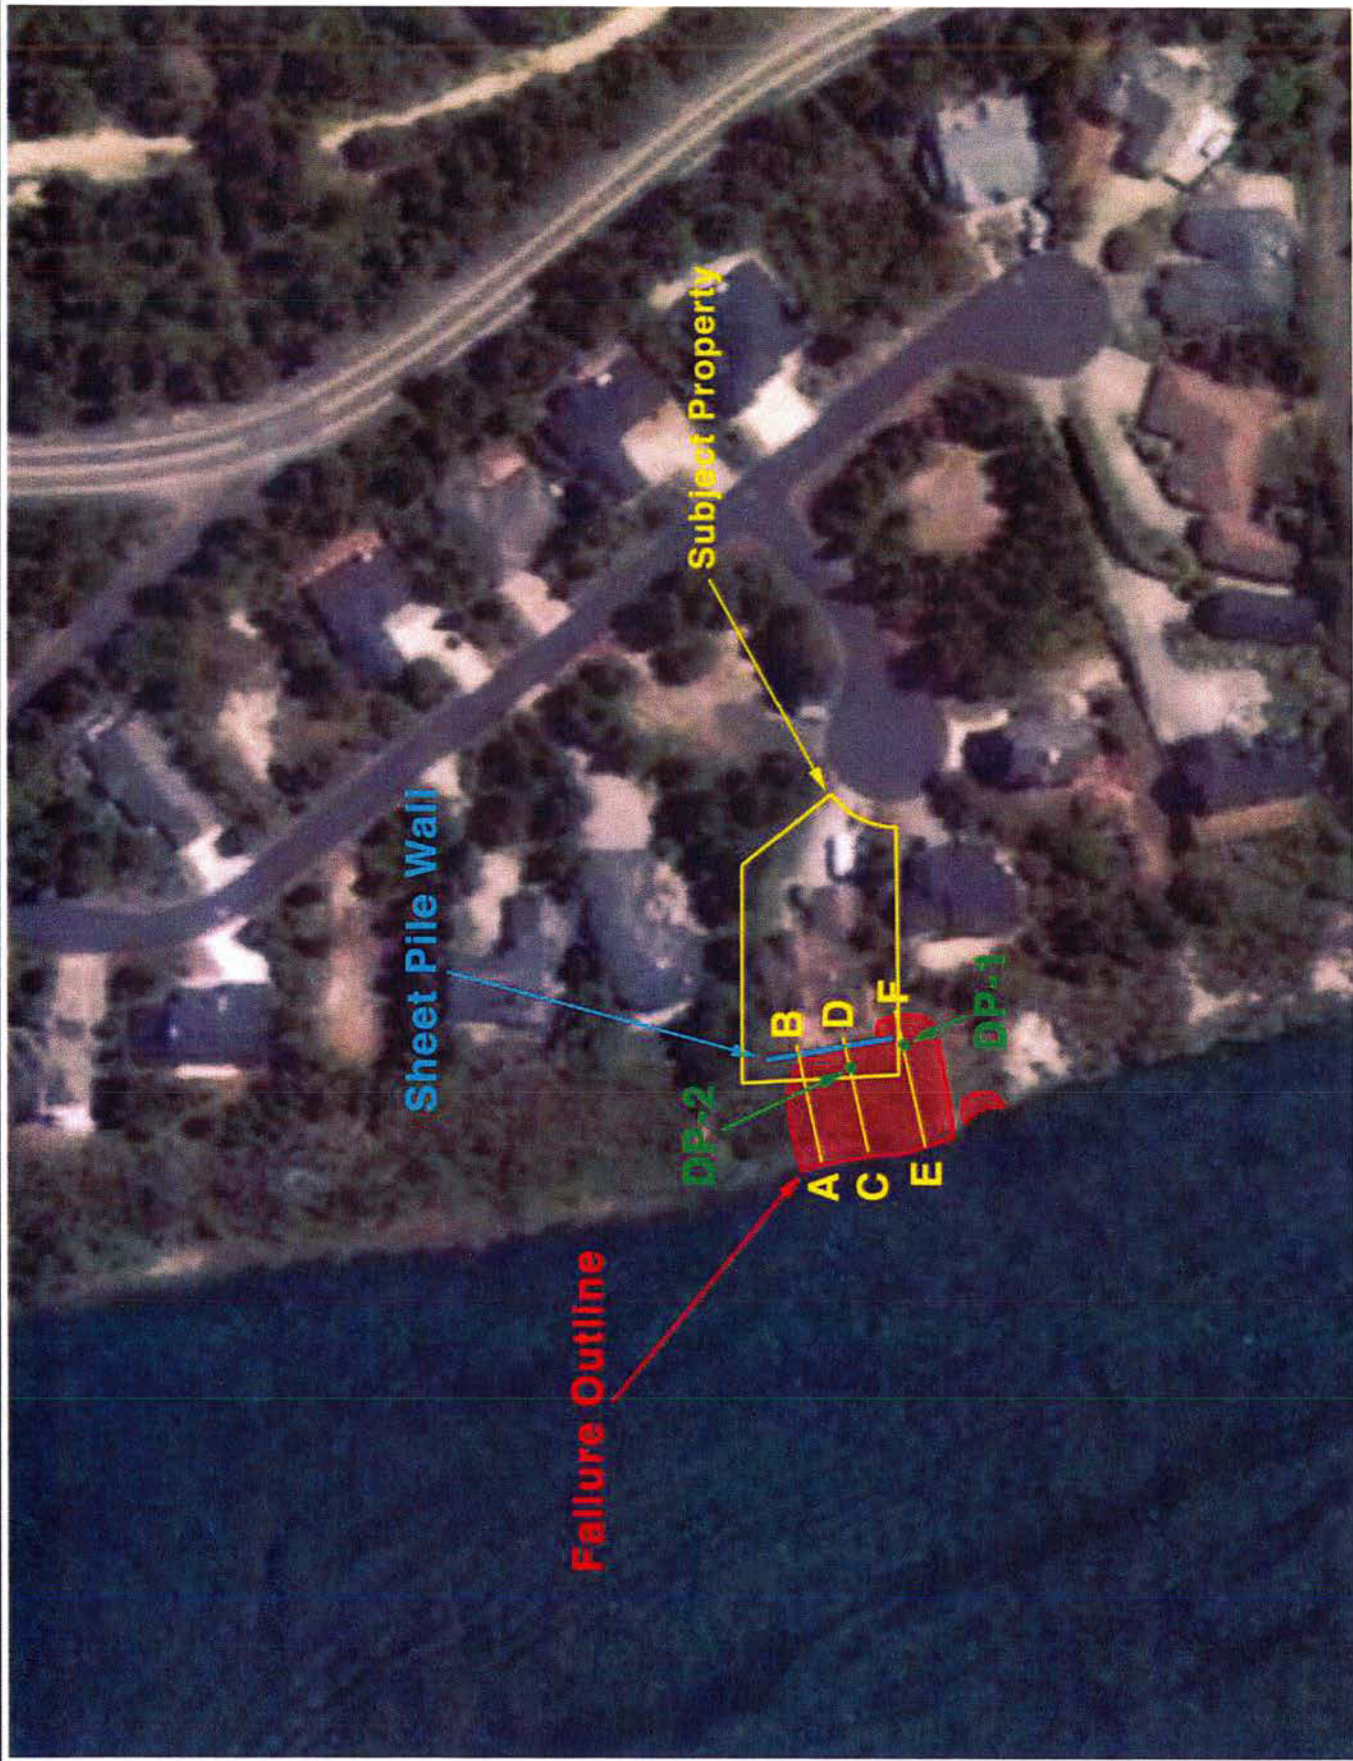
Figure 3: Failure, Field-developed Cross Section and WRDP Locations

The currently active failure is approximately 80 feet wide (Figure 3) and, for the most part, extends from the steel sheetpile sea wall beyond the low water mark of the bank of the Siuslaw River. At the southern end, the failure extends eastward beyond the edge of the sheetpile wall and is encroaching north toward the house behind the seawall (see site photos, Appendix A). Figures 4, 5, and 6 show the three field-developed geologic cross sections measured at the site. The failure area is underlain by imported organic-rich sand ("root mat") overlying native clean, cross-bedded dune sand, which in turn overlies several older dune forms with variably well-developed paleosol horizons. The lowermost two (exposed) paleo-sol appear to be horizontal to very gently sloping. Another, higher paleosol has significant relief, rising towards the east at angles ranging from approximately 10 degrees to 36 degrees. The lower two paleo-sol form both a "ledge" (lowermost paleosol, designated SU-1, and exposed only at low tide) and a "cliff band" (second-lowest exposed paleosol, designated SU-3, mostly exposed even at ordinary high tide) which ranges in height from approximately 4 feet to as much as 8 feet or more south of the immediate failure area. All paleo-sol consist of former dune sand which is cemented by clay, derived from weathering of feldspar sand grains and, in places, by iron hydroxides (rust), derived from weathering of ferro-magnesian sand grains. Even the better-cemented portions of the material can be easily cut and craved with a pocket knife.

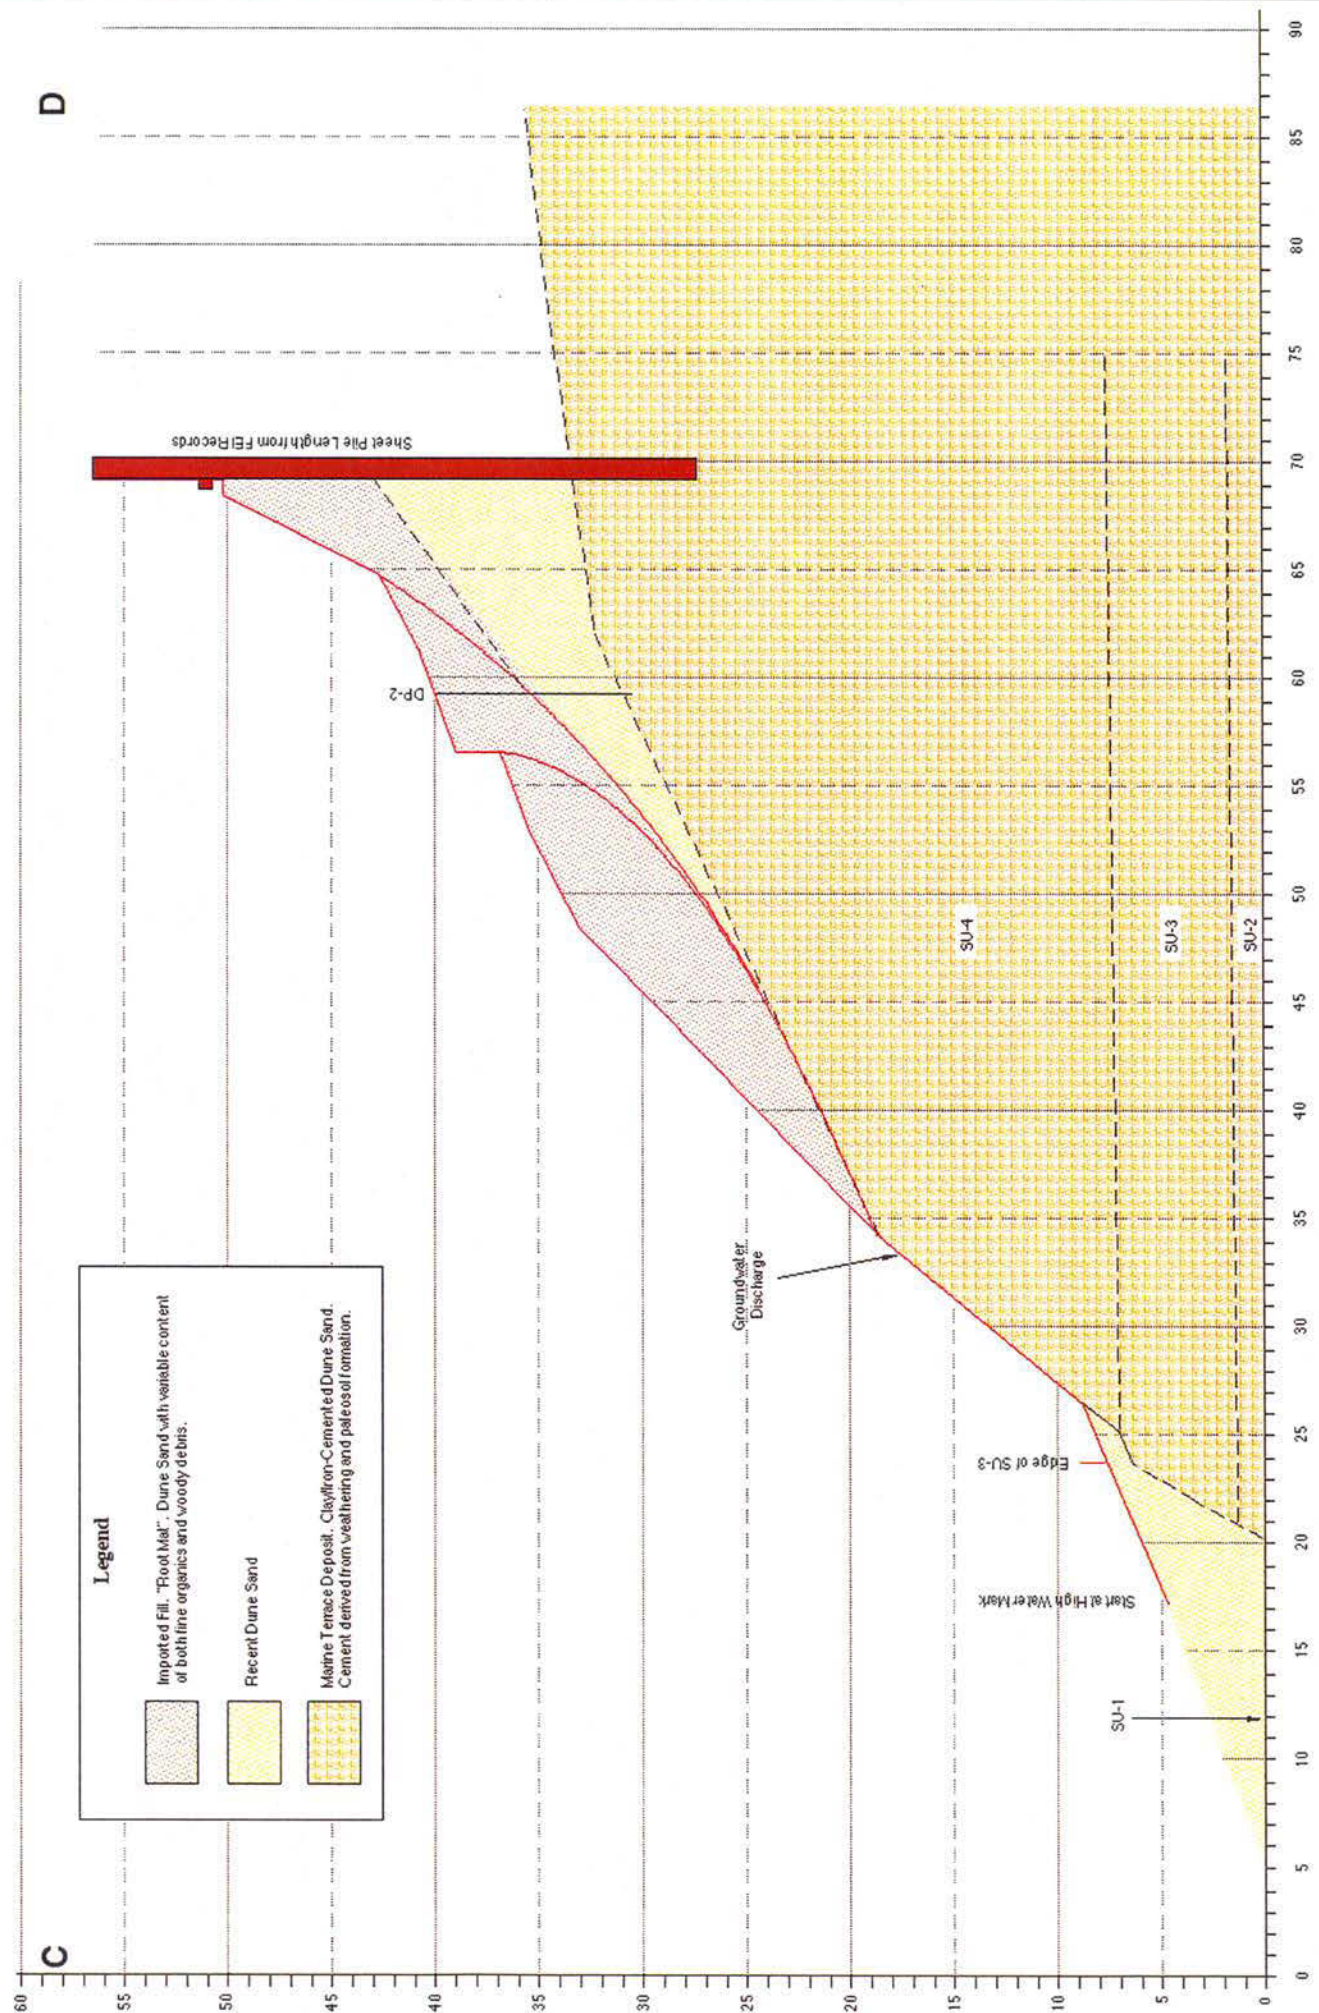
Figure 5: Field-Developed Cross Section C-D

Note: Section measured using clinometer and 300-ft fiberglass tape. This represents only one of numerous possible interpretations of the data. It is based on very limited subsurface information and is subject to change as additional data is developed.

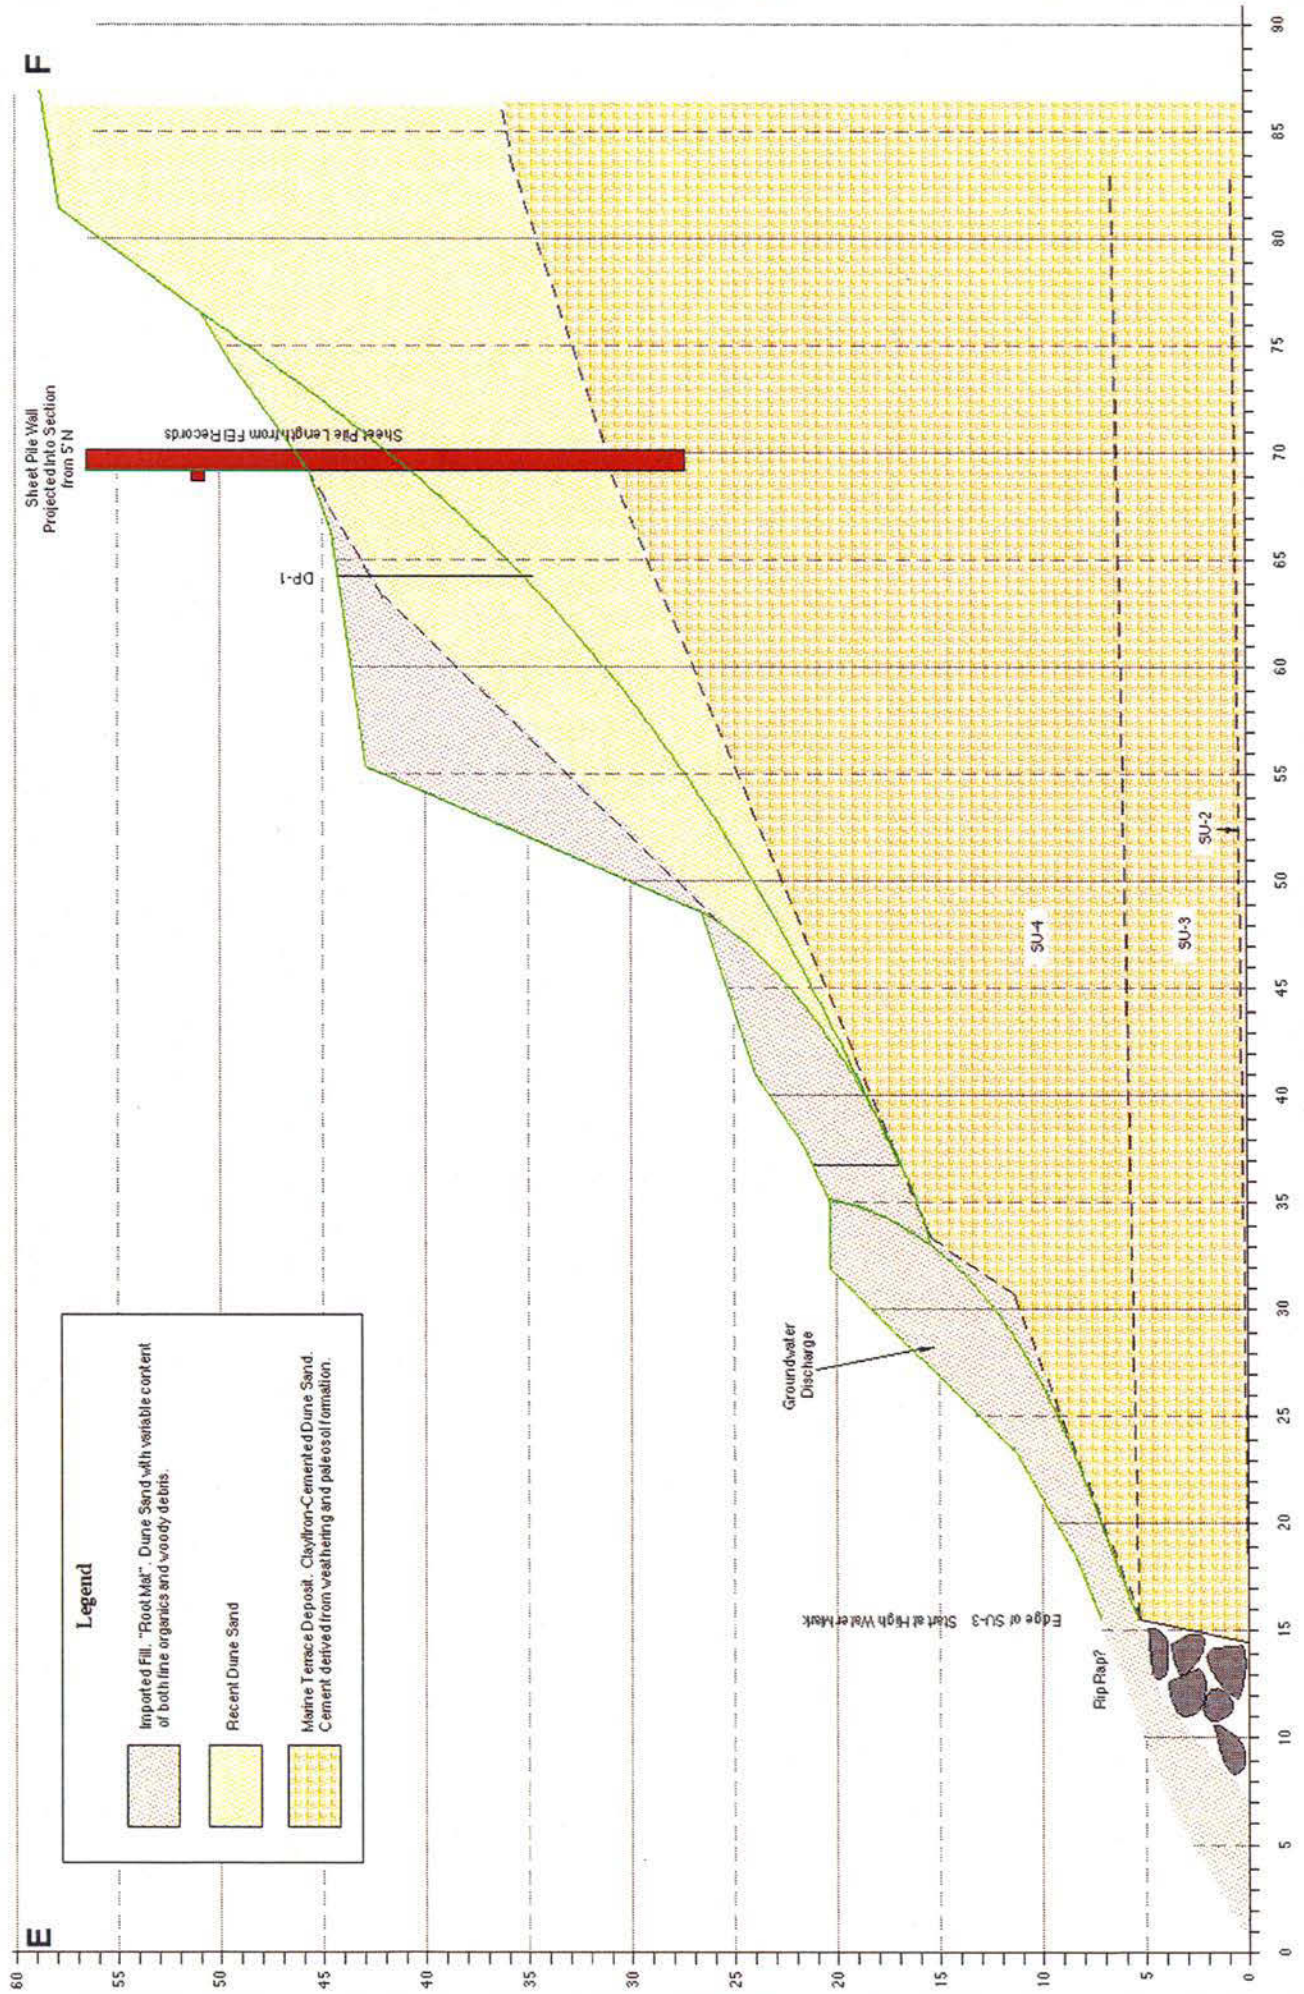
Figure 6: Field Developed Cross Section E-F

Note: Section measured using clinometer and 300-ft fiberglass tape. This represents only one of numerous possible interpretations of the data. It is based on very limited subsurface information and is subject to change as additional data is developed.

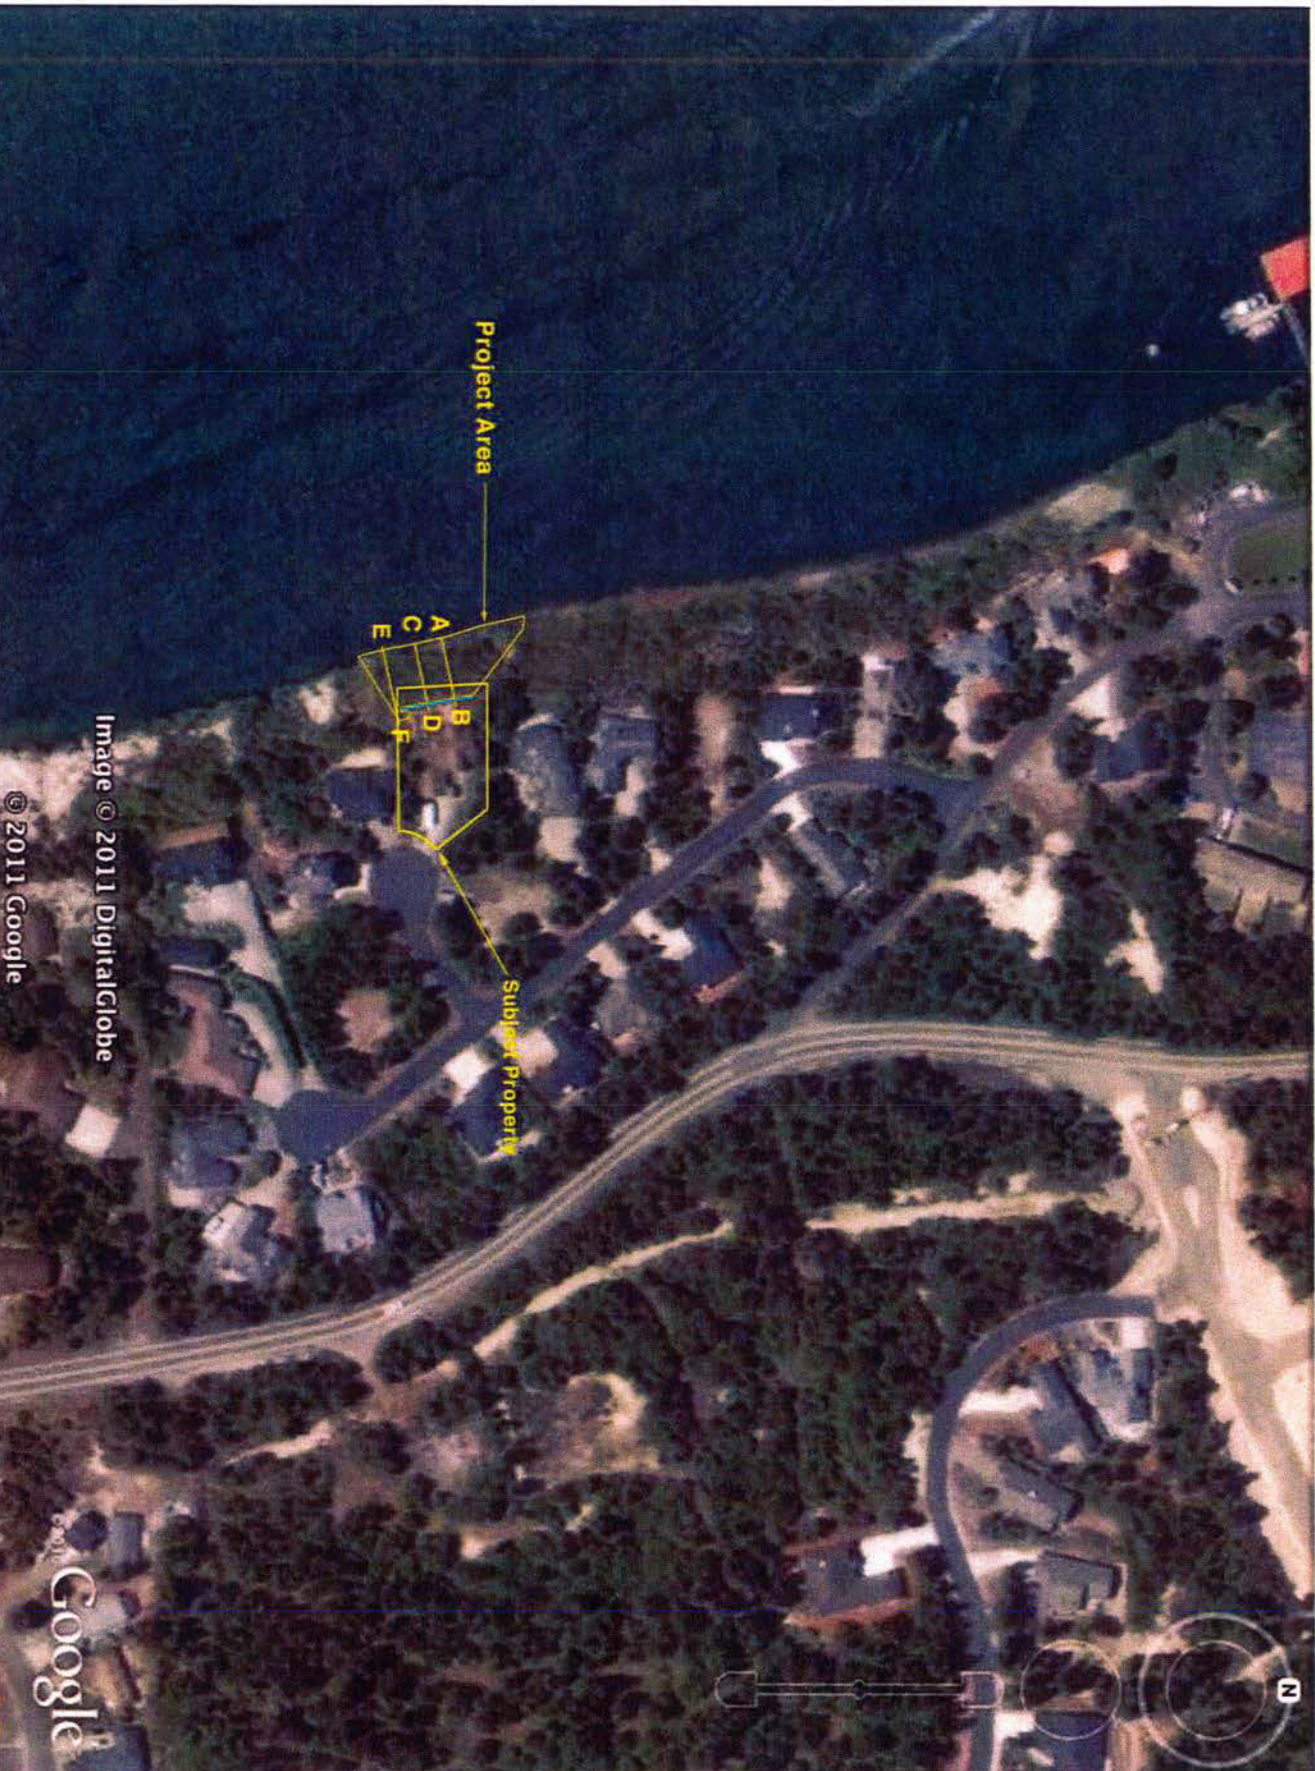
Figure 10: Approximate Extent of Mitigation Project

Whereas the current failure does not extend past the seawall on the north end, it does so on the south end. In addition, on the neighboring property past the north end of the failure, sand was observed in transport across SU-3 at several seeps of groundwater. As a result, the toe of the slope in that vicinity is being removed and the slope is expected to fail in a similar manner in the near future. The

gabion basket system in that vicinity is not expected to perform better than the system did in the failure area itself. In order to preclude the slope failure from encroaching the seawall from the north or south side, it is recommended to extend the mitigation beyond the ends of the seawall and current failure for at least a sufficient distance to allow for a 2H : 1V slope angle from the toe of the sand slope to the ends of the seawall. This results in the trapezoidal shape of the project area as shown on Figure 10. The property to the north already has a rip rap revetment in addition to some gabion baskets on SU-3. However, this rip rap was also placed without appropriate geotextile. Site observations indicate that "Road Fabric" was utilized and sand can be observed being flushed through the seams of the fabric, which is also in poor repair. Therefore, it is recommended to re-build at least the section of the revetment which is located within the 2H : 1V slope angle from the north end of the sheet pile wall.

As part of this project, it is proposed to remove the gabion baskets remaining above the shelf of SU-3 to the north of the current failure area, and retrieve as many of the gabion baskets as possible which were pushed into the river during the initial December 26, 2010 slope failure.

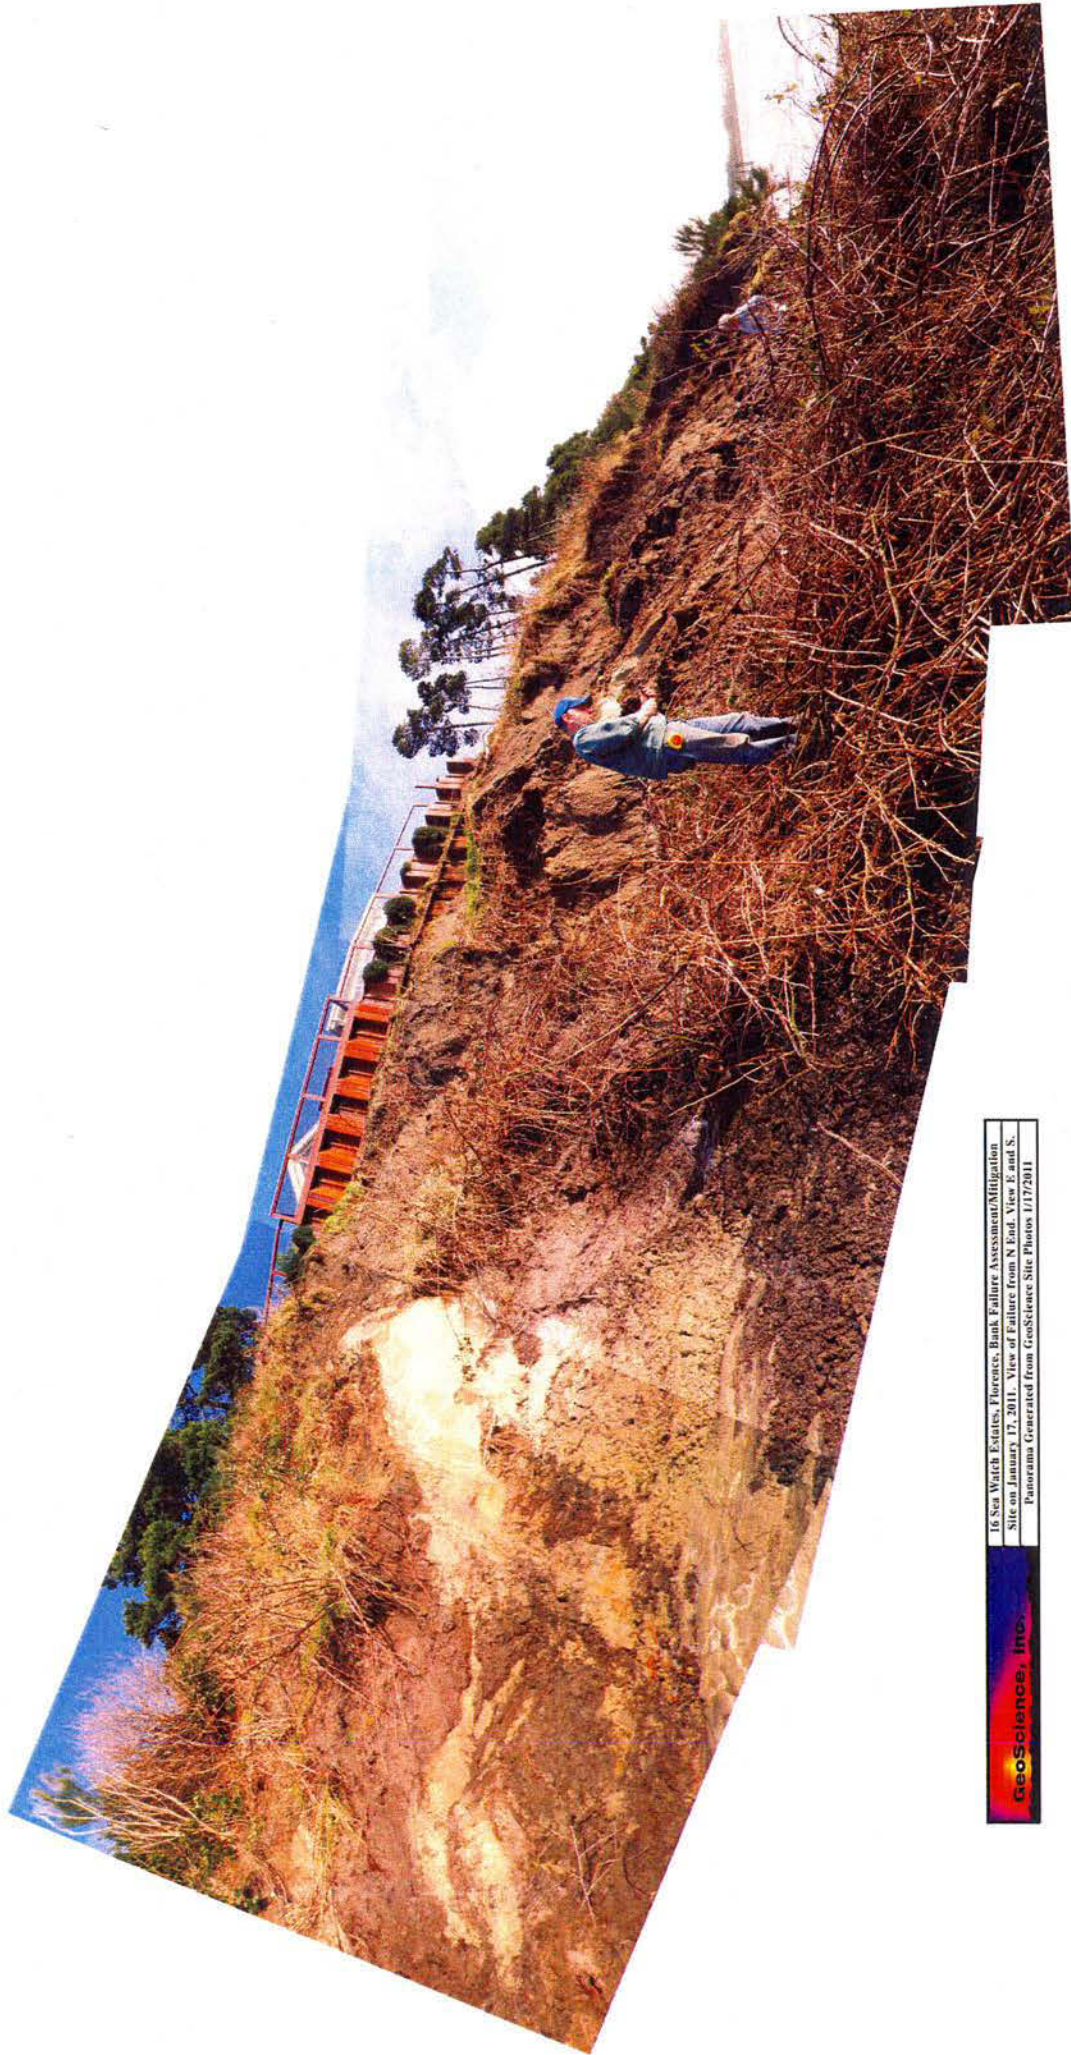
16 Sea Watch Estates, Florence, Bank Failure Assessment/Mitigation
Site on January 17, 2011. View of Failure from N End. View E and S.
Panorama generated from GeoScience Site Photos 1/17/2011

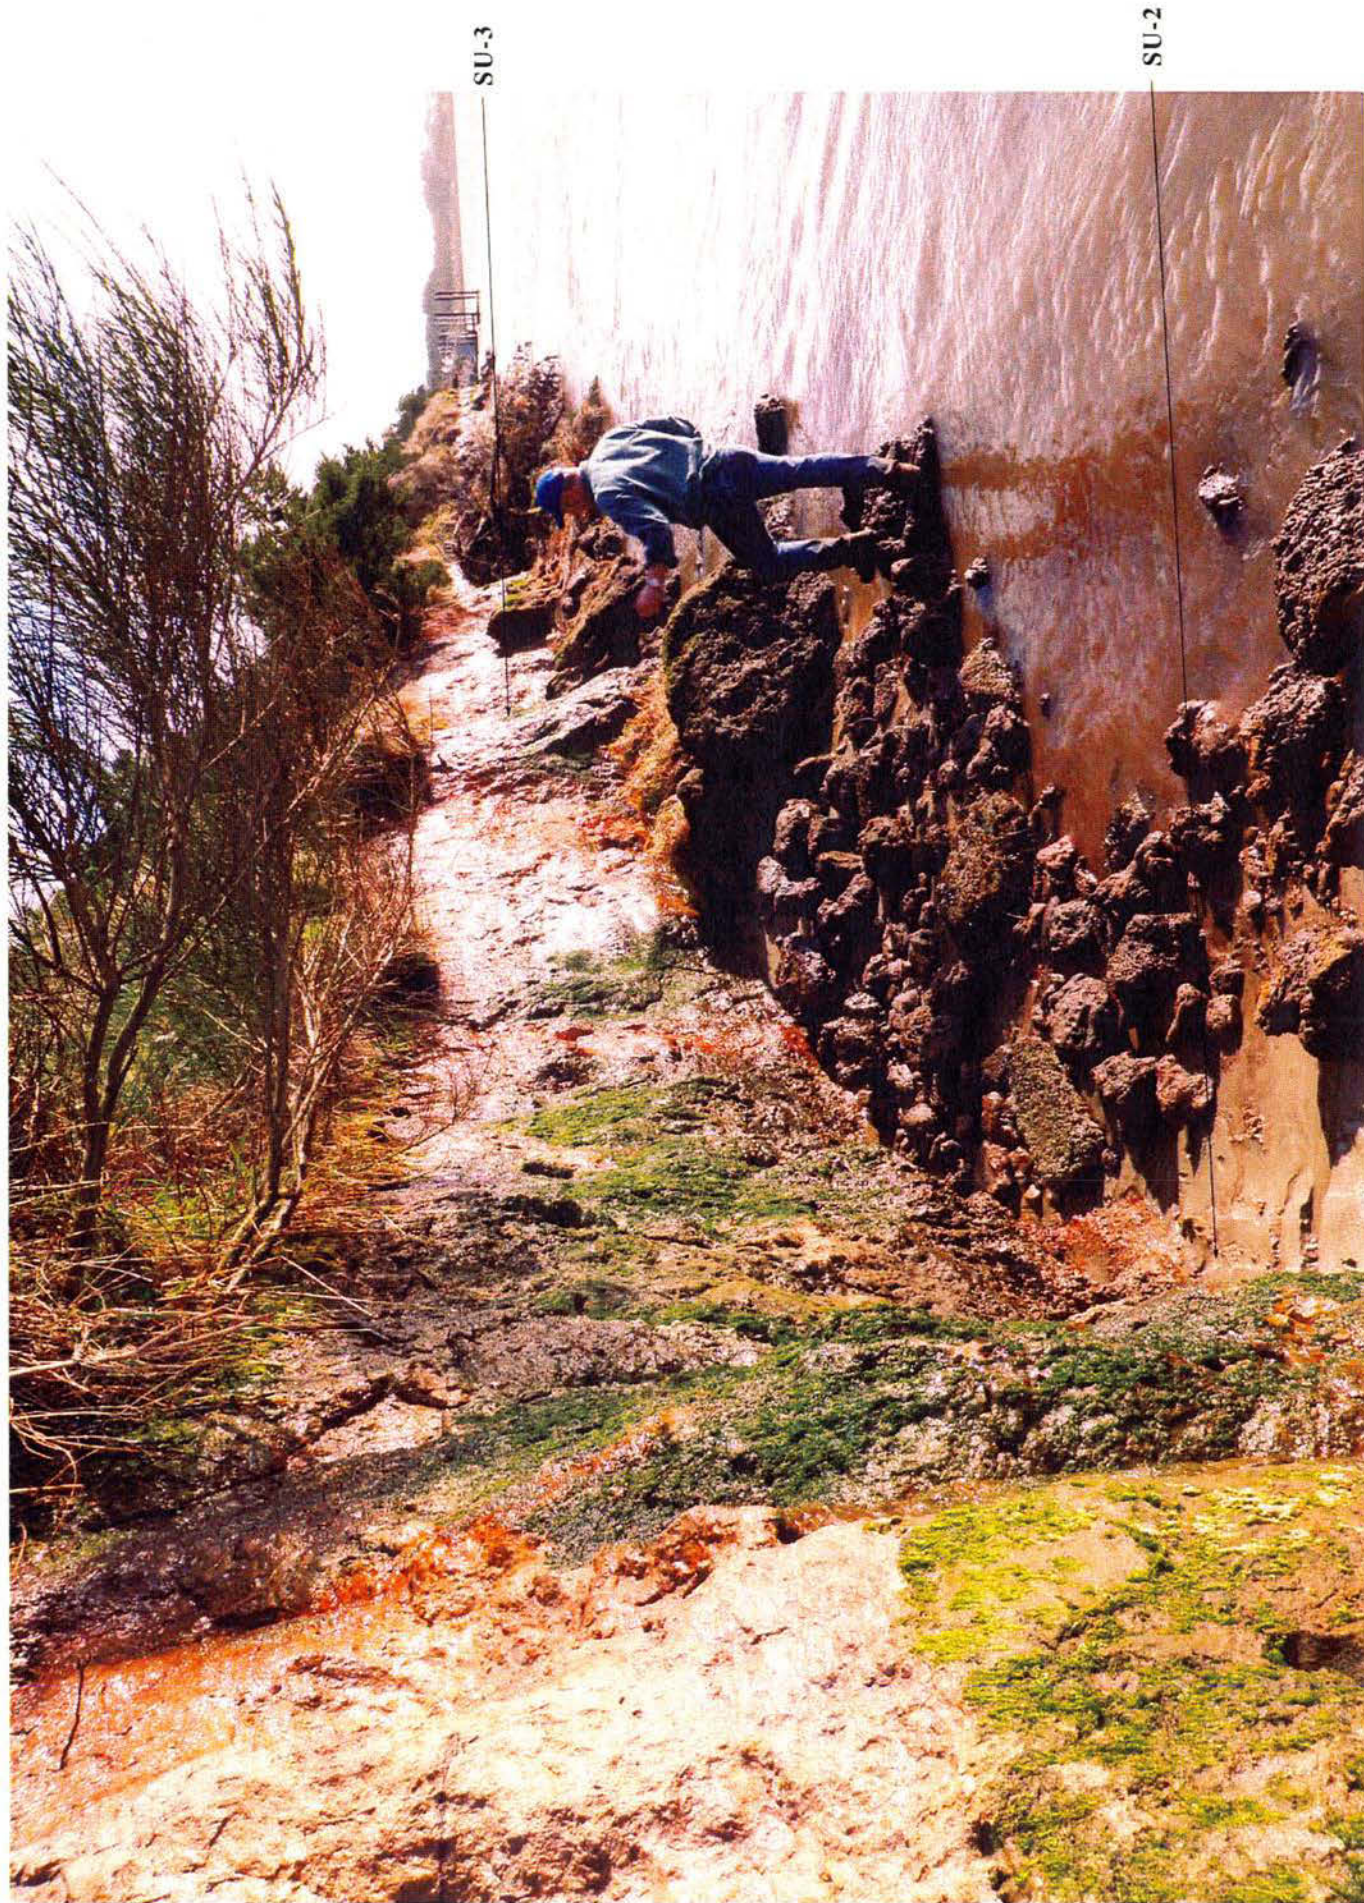
January 17, 2011. View S Along Cliff-forming SU-3

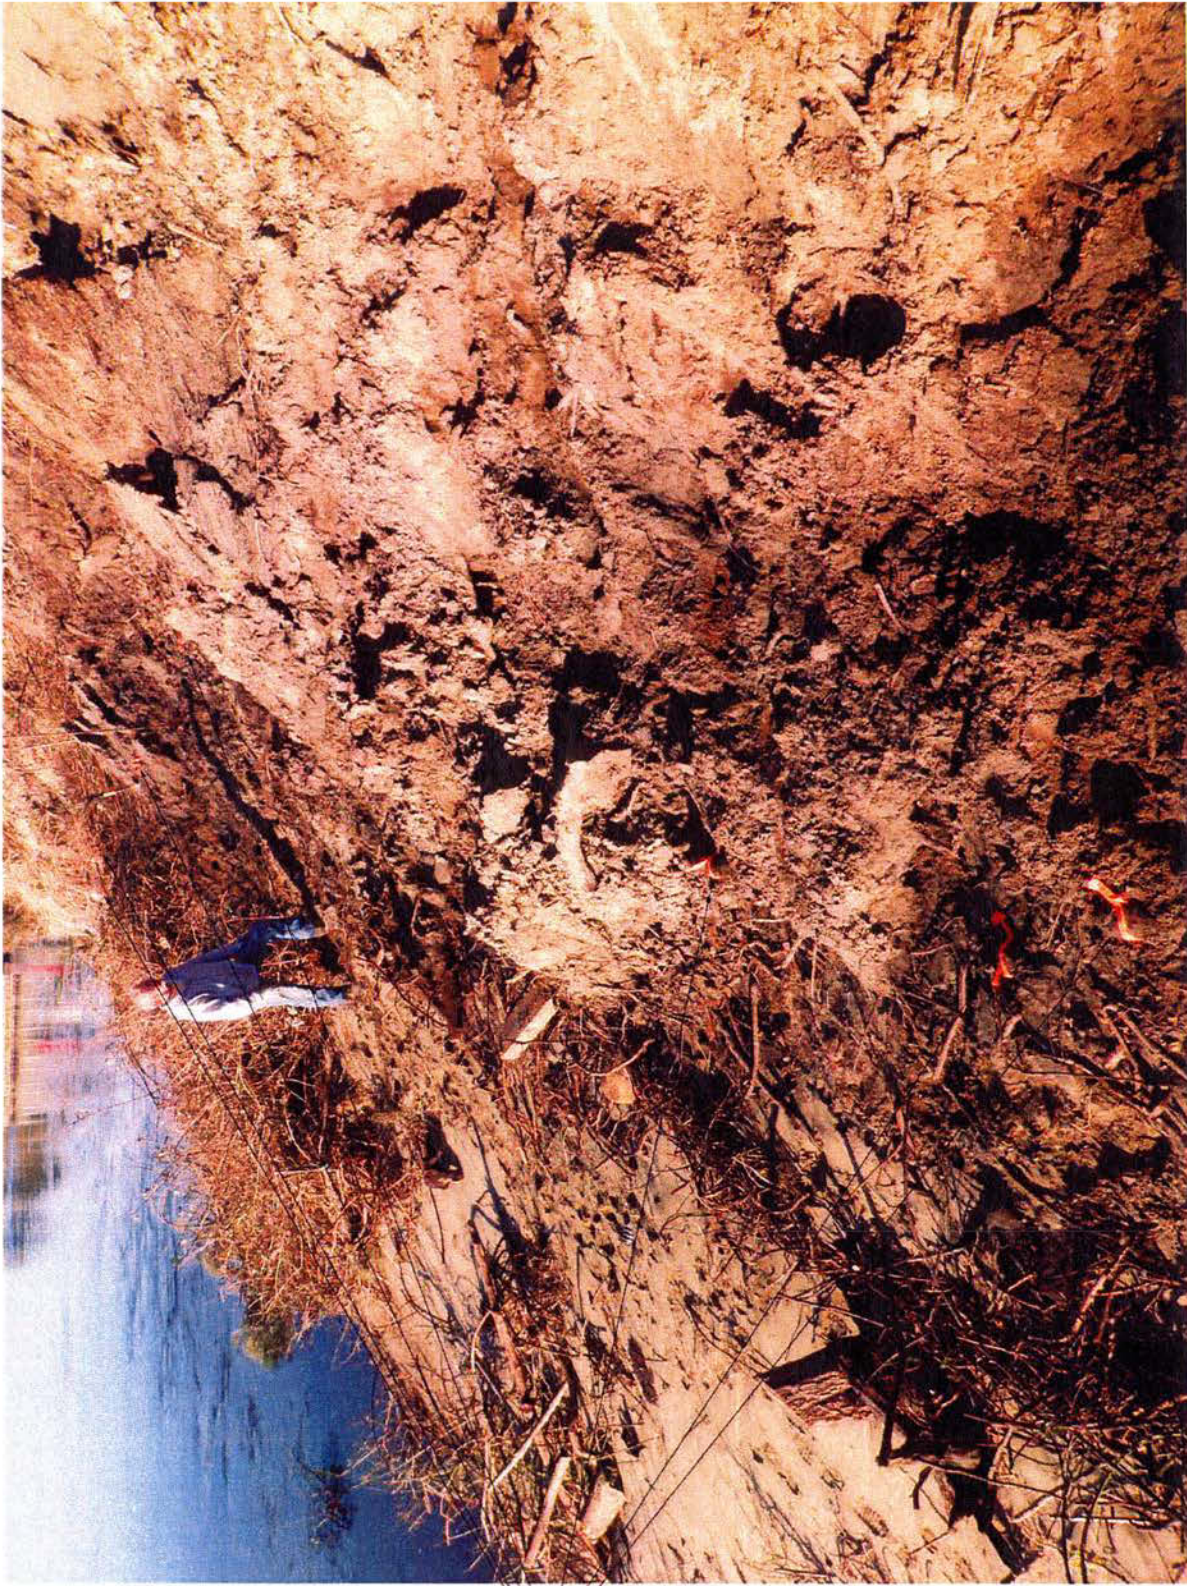
Buried Upper Edge of SU-3 Marked

16 Sea Watch Estates, Florence, Bank Failure Assessment/Mitigation
	View N ALong Buried Upper Edge of SU-3
	GeoScience Site Photos 1/19/2011

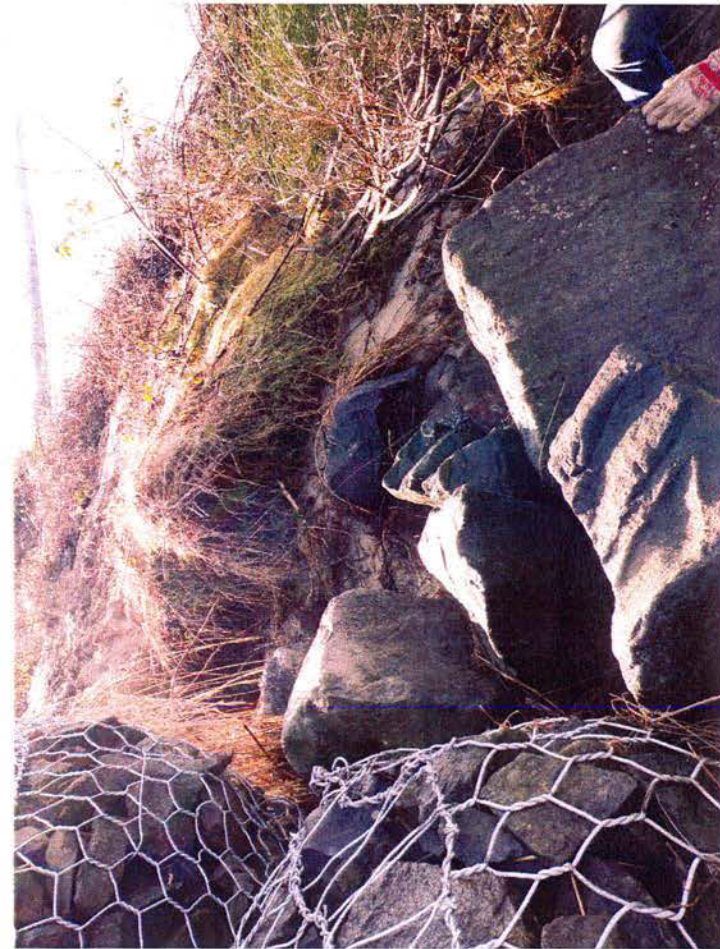
Gabions above SD-3 to the N of the current failure. View S toward failure.

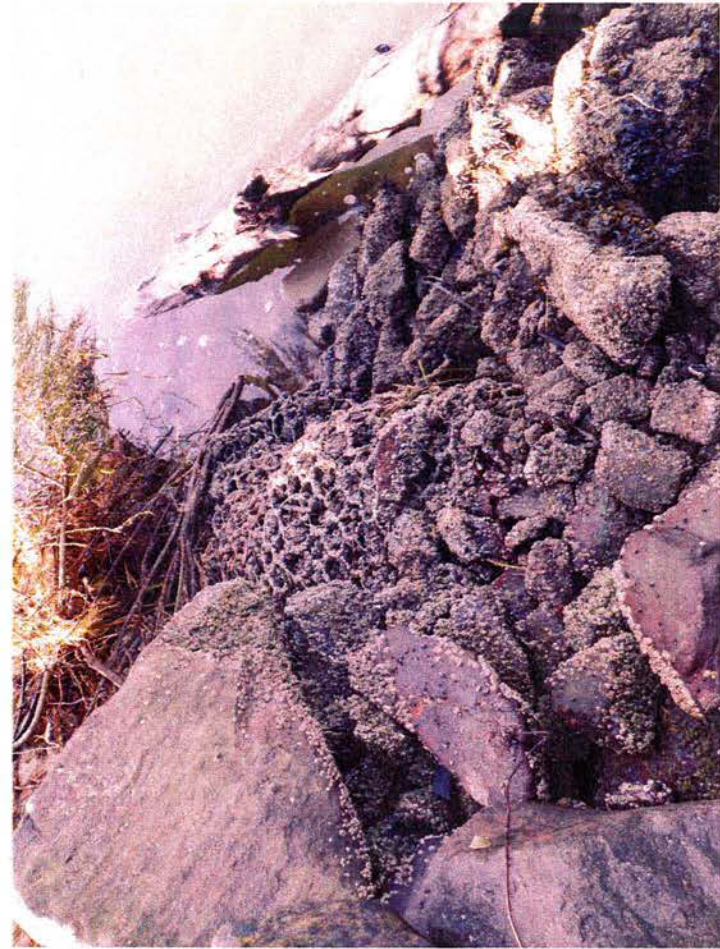
Portions of the gabion baskets were observed partially buried under the northern edge of the failure. These gabions appear to have been pushed westward and toppled off the cliff-forming SU-3. It is likely that the rest of the gabions have been pushed into deeper water below the low tide level near the center of the failure, where they have been buried by the slope failure deposit. Similarly, portions of the older rip rap revetment appear to remain in place both at the northern and southern edge of the failure, but in a portion of the center of the failure, estimated at 15 to 20 feet wide, the revetment appears to have been pushed into the river.

Gabions involved in failure at N end of slope movement deposit. Baskets have been deflected westward by the movement.

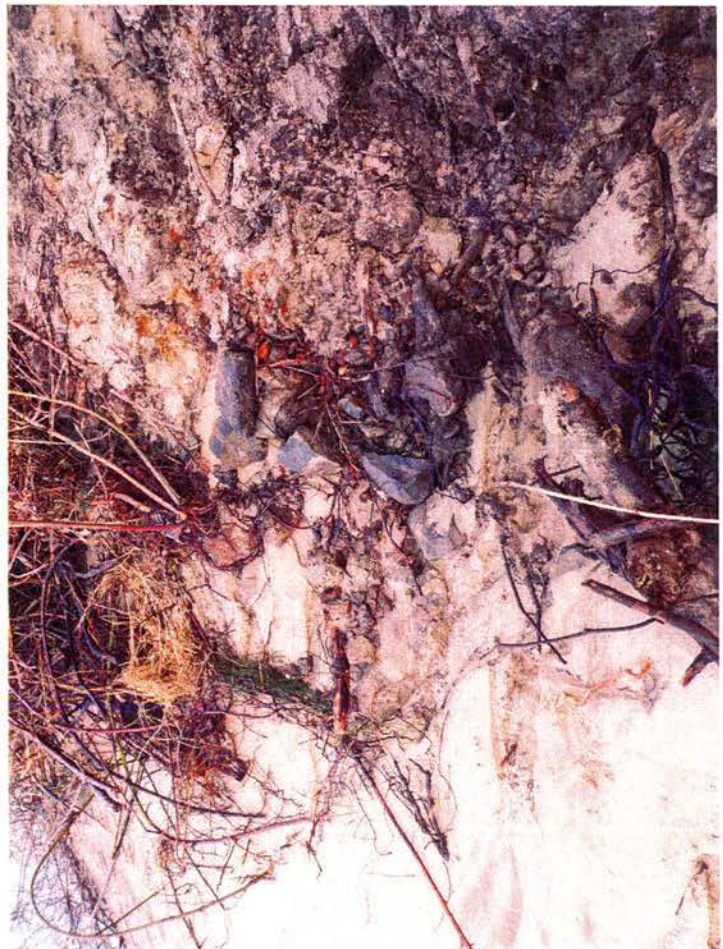
Rip rap exposed in S central portion of the toe of the slope movement. Sand to left is slope movement deposit in area under water at OHW.

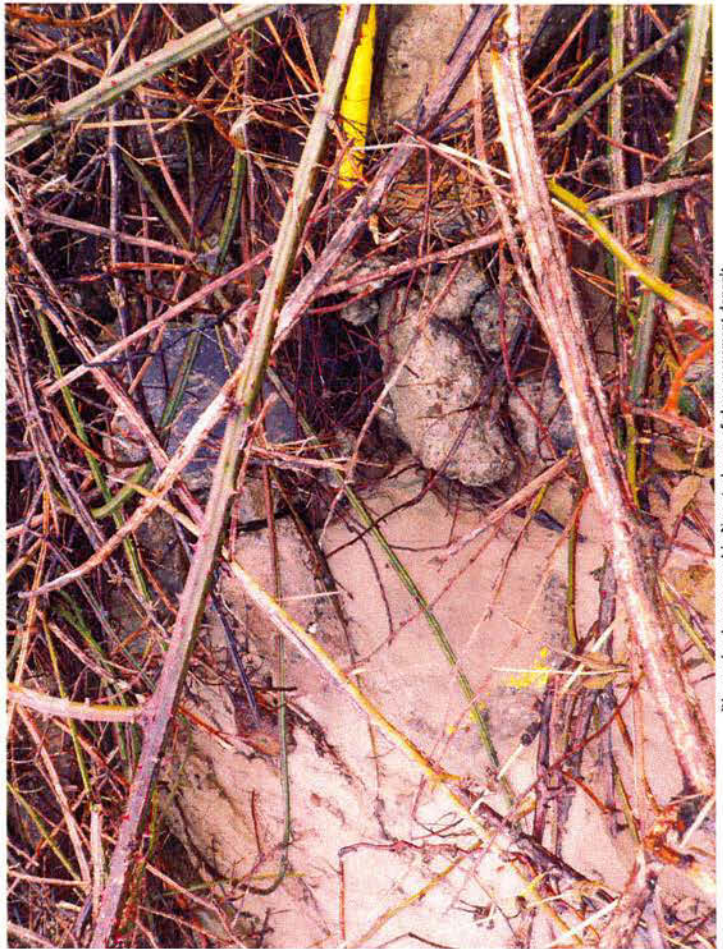
Rip rap in place exposed in N central area of slope movement deposit.

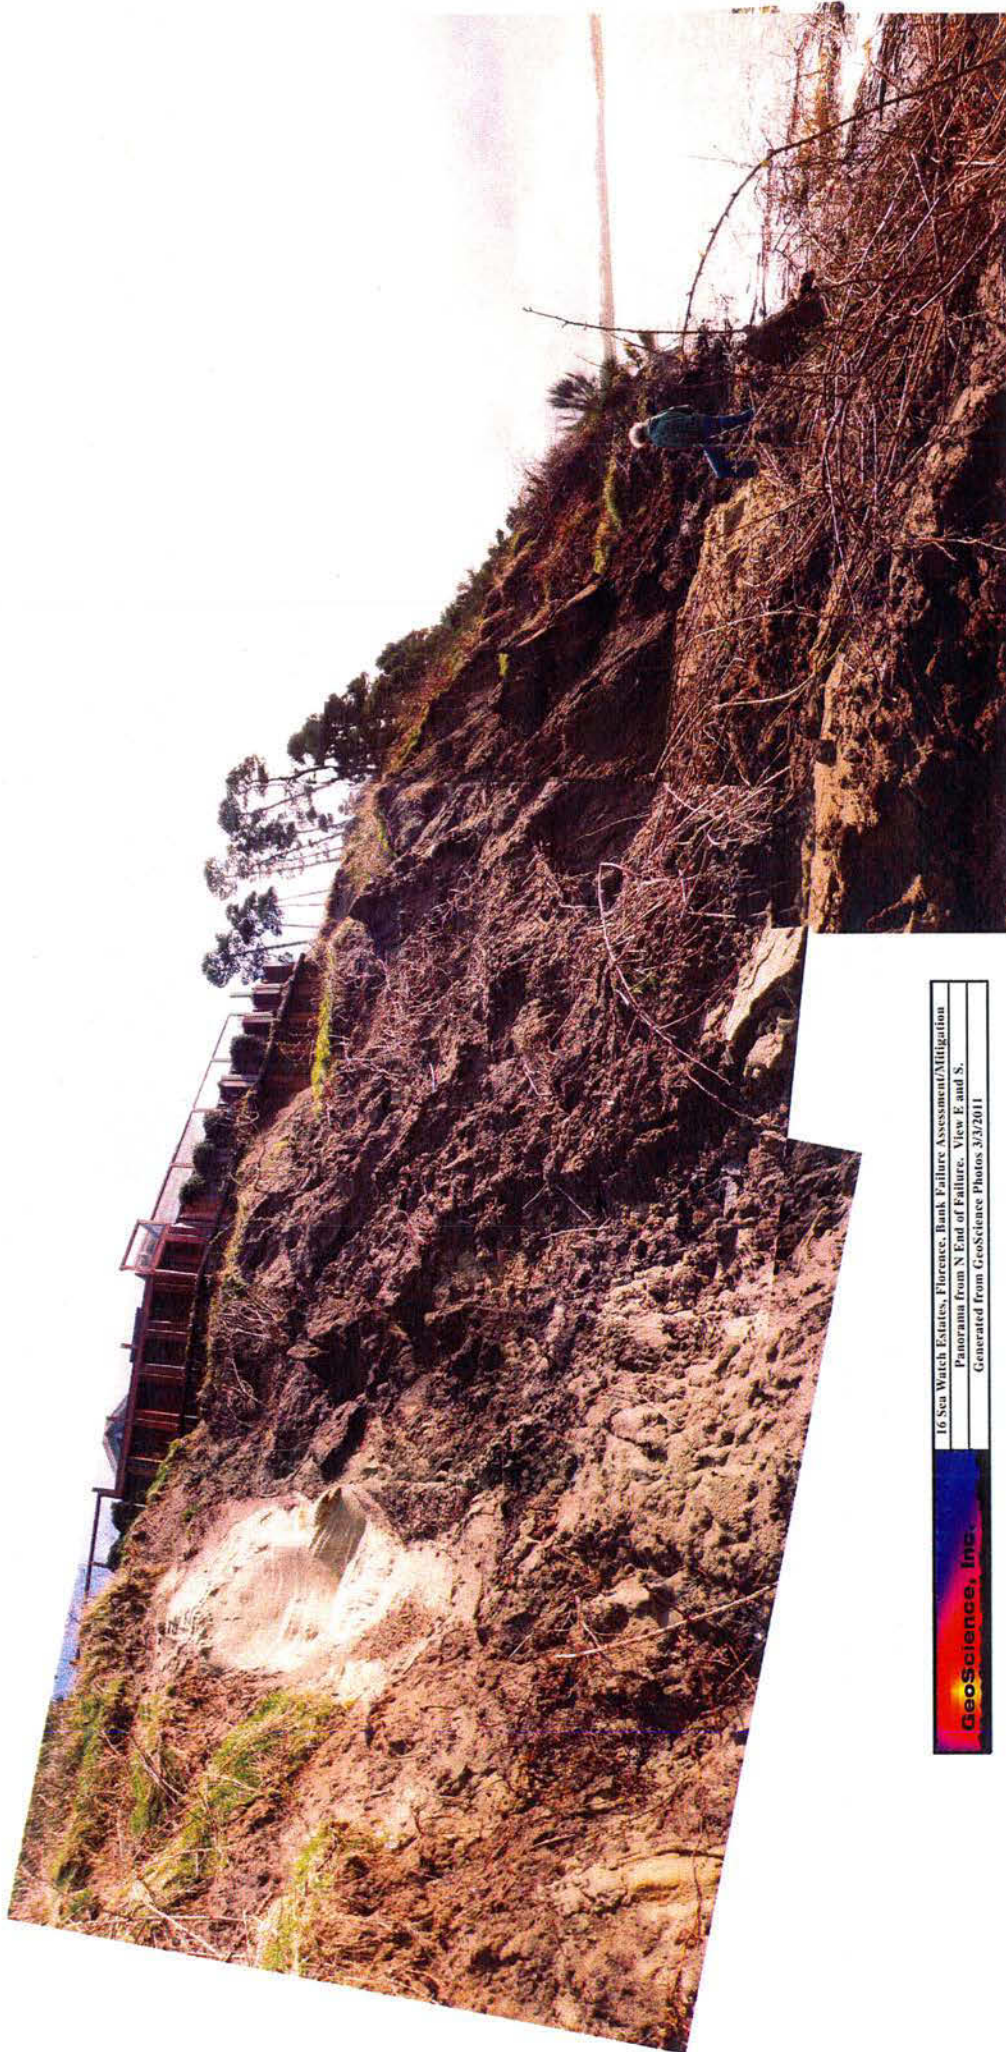
16 Sea Watch Estates, Florence, Bank Failure Assessment/Mitigation
Panorama from N End of Failure, View E and S.
Generated from GeoScience Photos, 3/3/2011

Remaining Older Gabion Baskets

MTD

Slope Movement Deposit
