**BANK FAILURE ASSESSMENT
16 Sea Watch Court, Florence, OR**

March 18, 2011

Prepared for:
Patricia and Richard Lukens
16 Sea Watch Court
Florence OR 97439

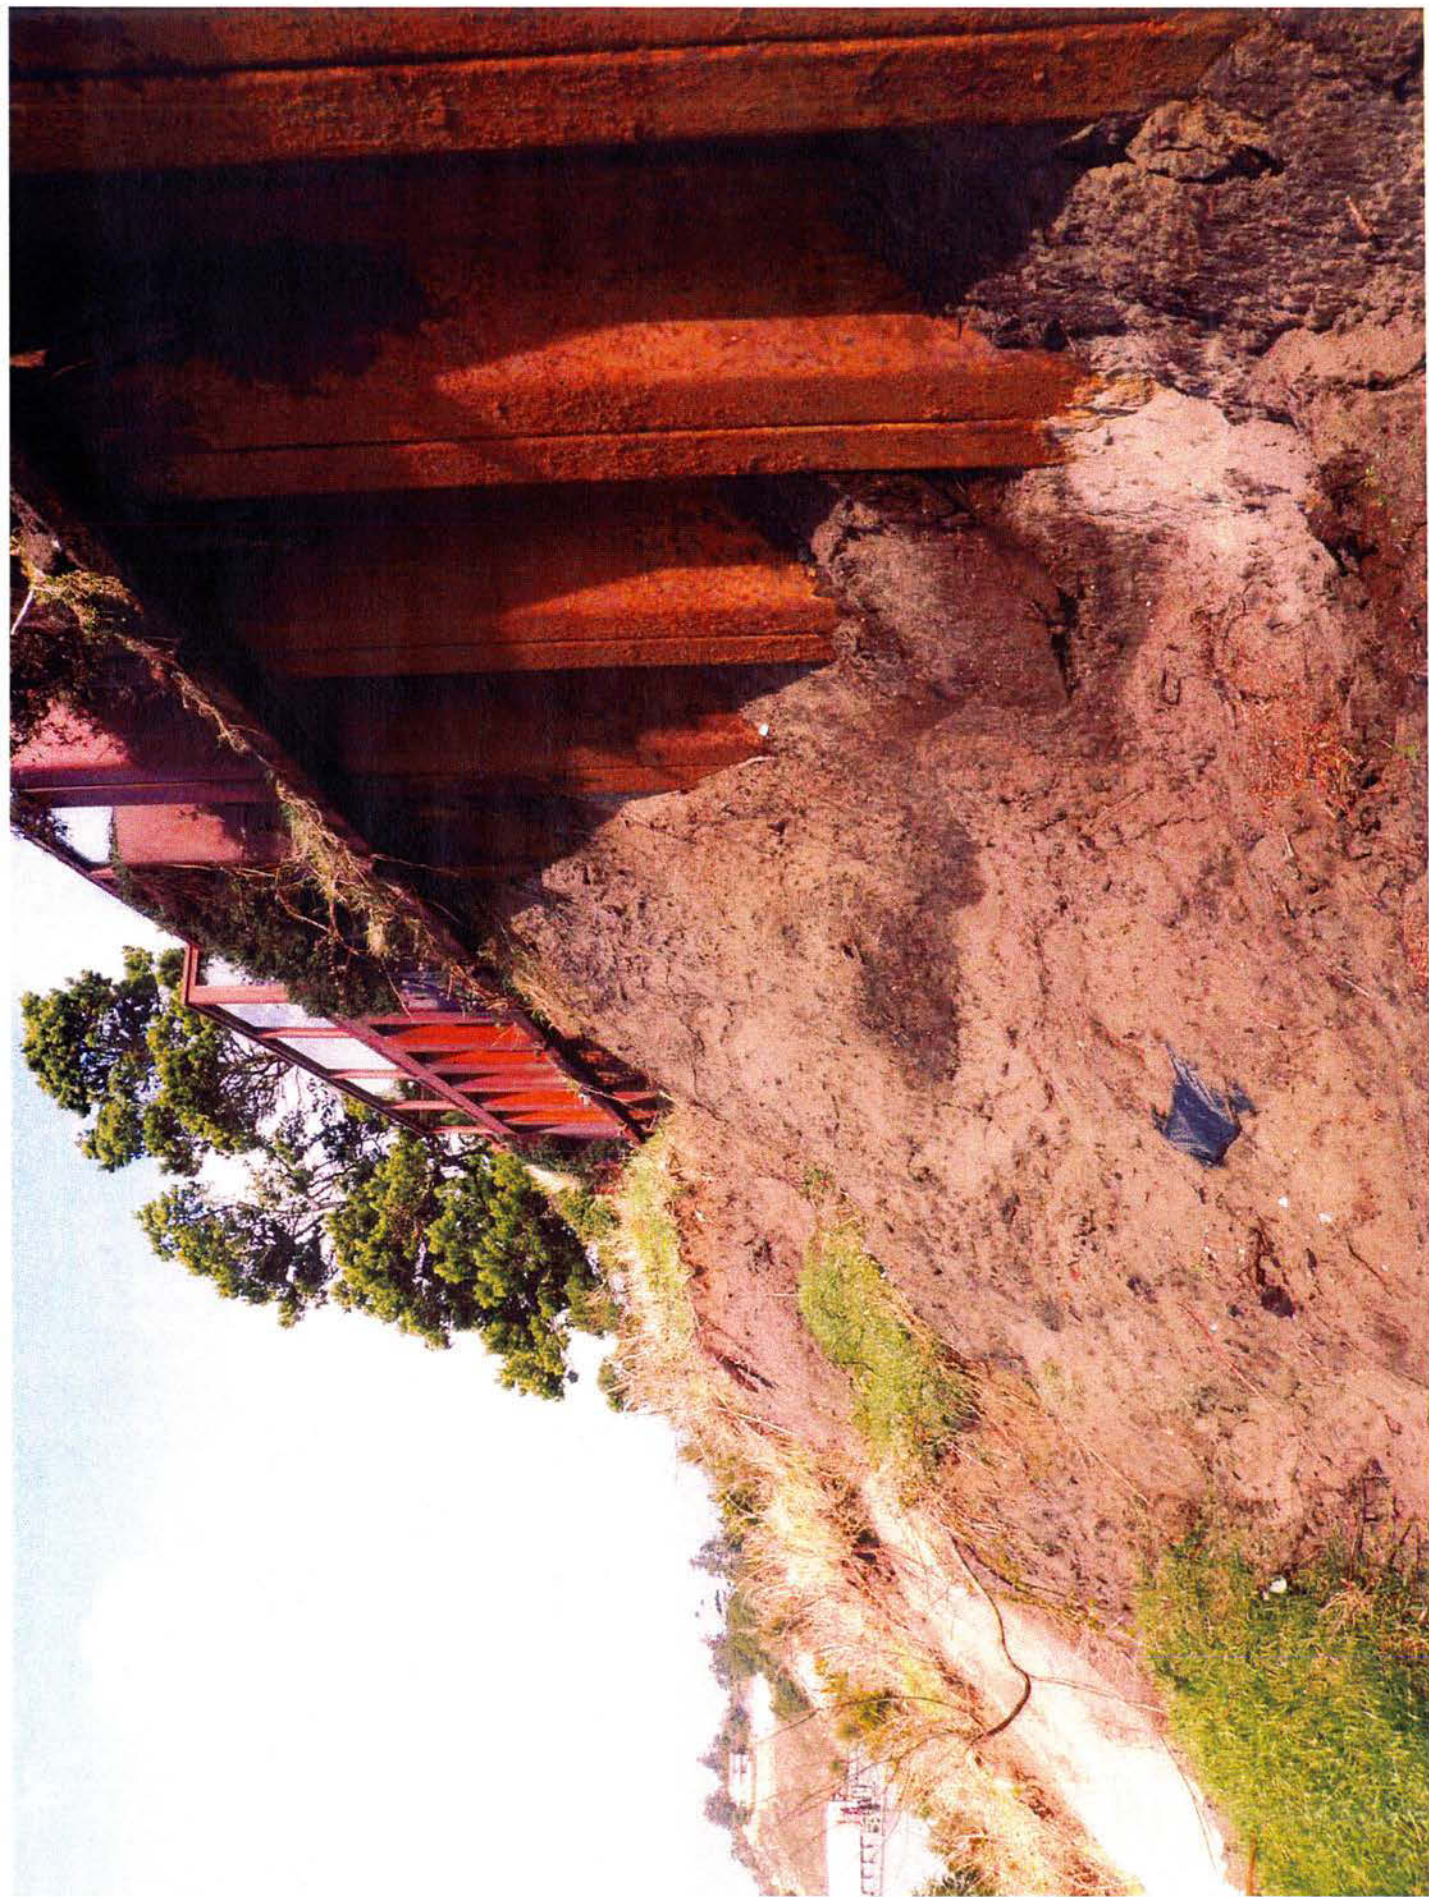
Although the bottom of the sheet pile wall is presumed to be anchored into the top of SU-4 and the sheet pile wall is tied back 5 feet from the top with anchors, the wall is designed for an exposure at the top of only 15 feet. At the time of the initial field work, the maximum exposure of the sea wall was 13.5 feet. Since that time, significant additional material has been eroded at the toe of the failure in the three areas where groundwater is discharging from the dune sand and the exposure is currently 15 feet in the worst area near the south end of the sheet pile wall. Additional failure of the slope above these eroding areas carries significant risk of failure of the seawall and portions of the house. As a result, mitigation is required as soon as practicable.

Sea Wall Exposed by Failure. View N. Wall is 5' from Top.

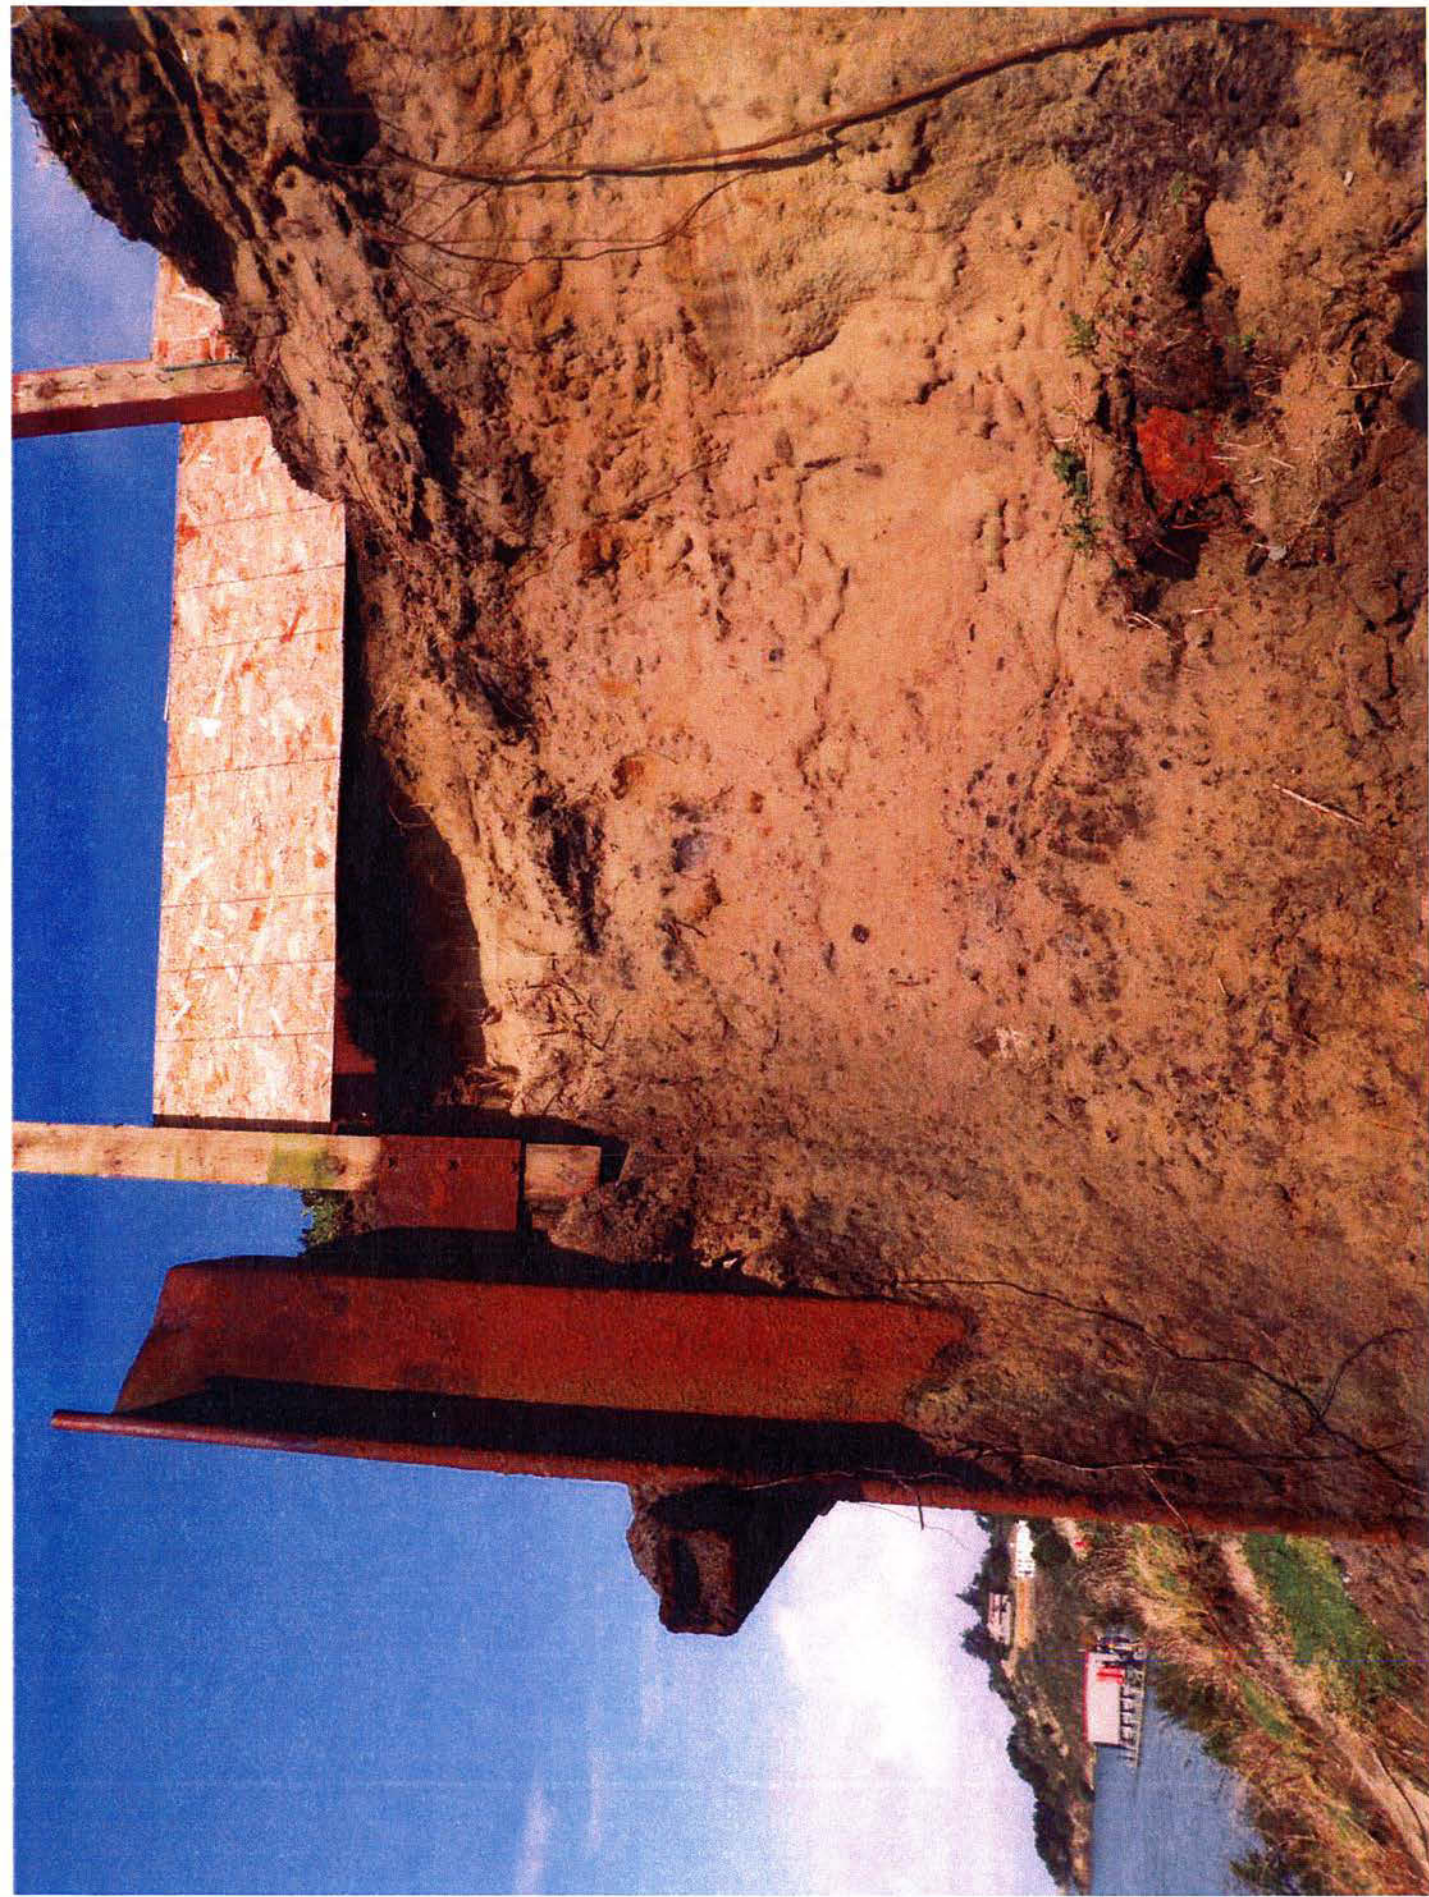
Failure Encroaching Behind S End Sea Wall. View N

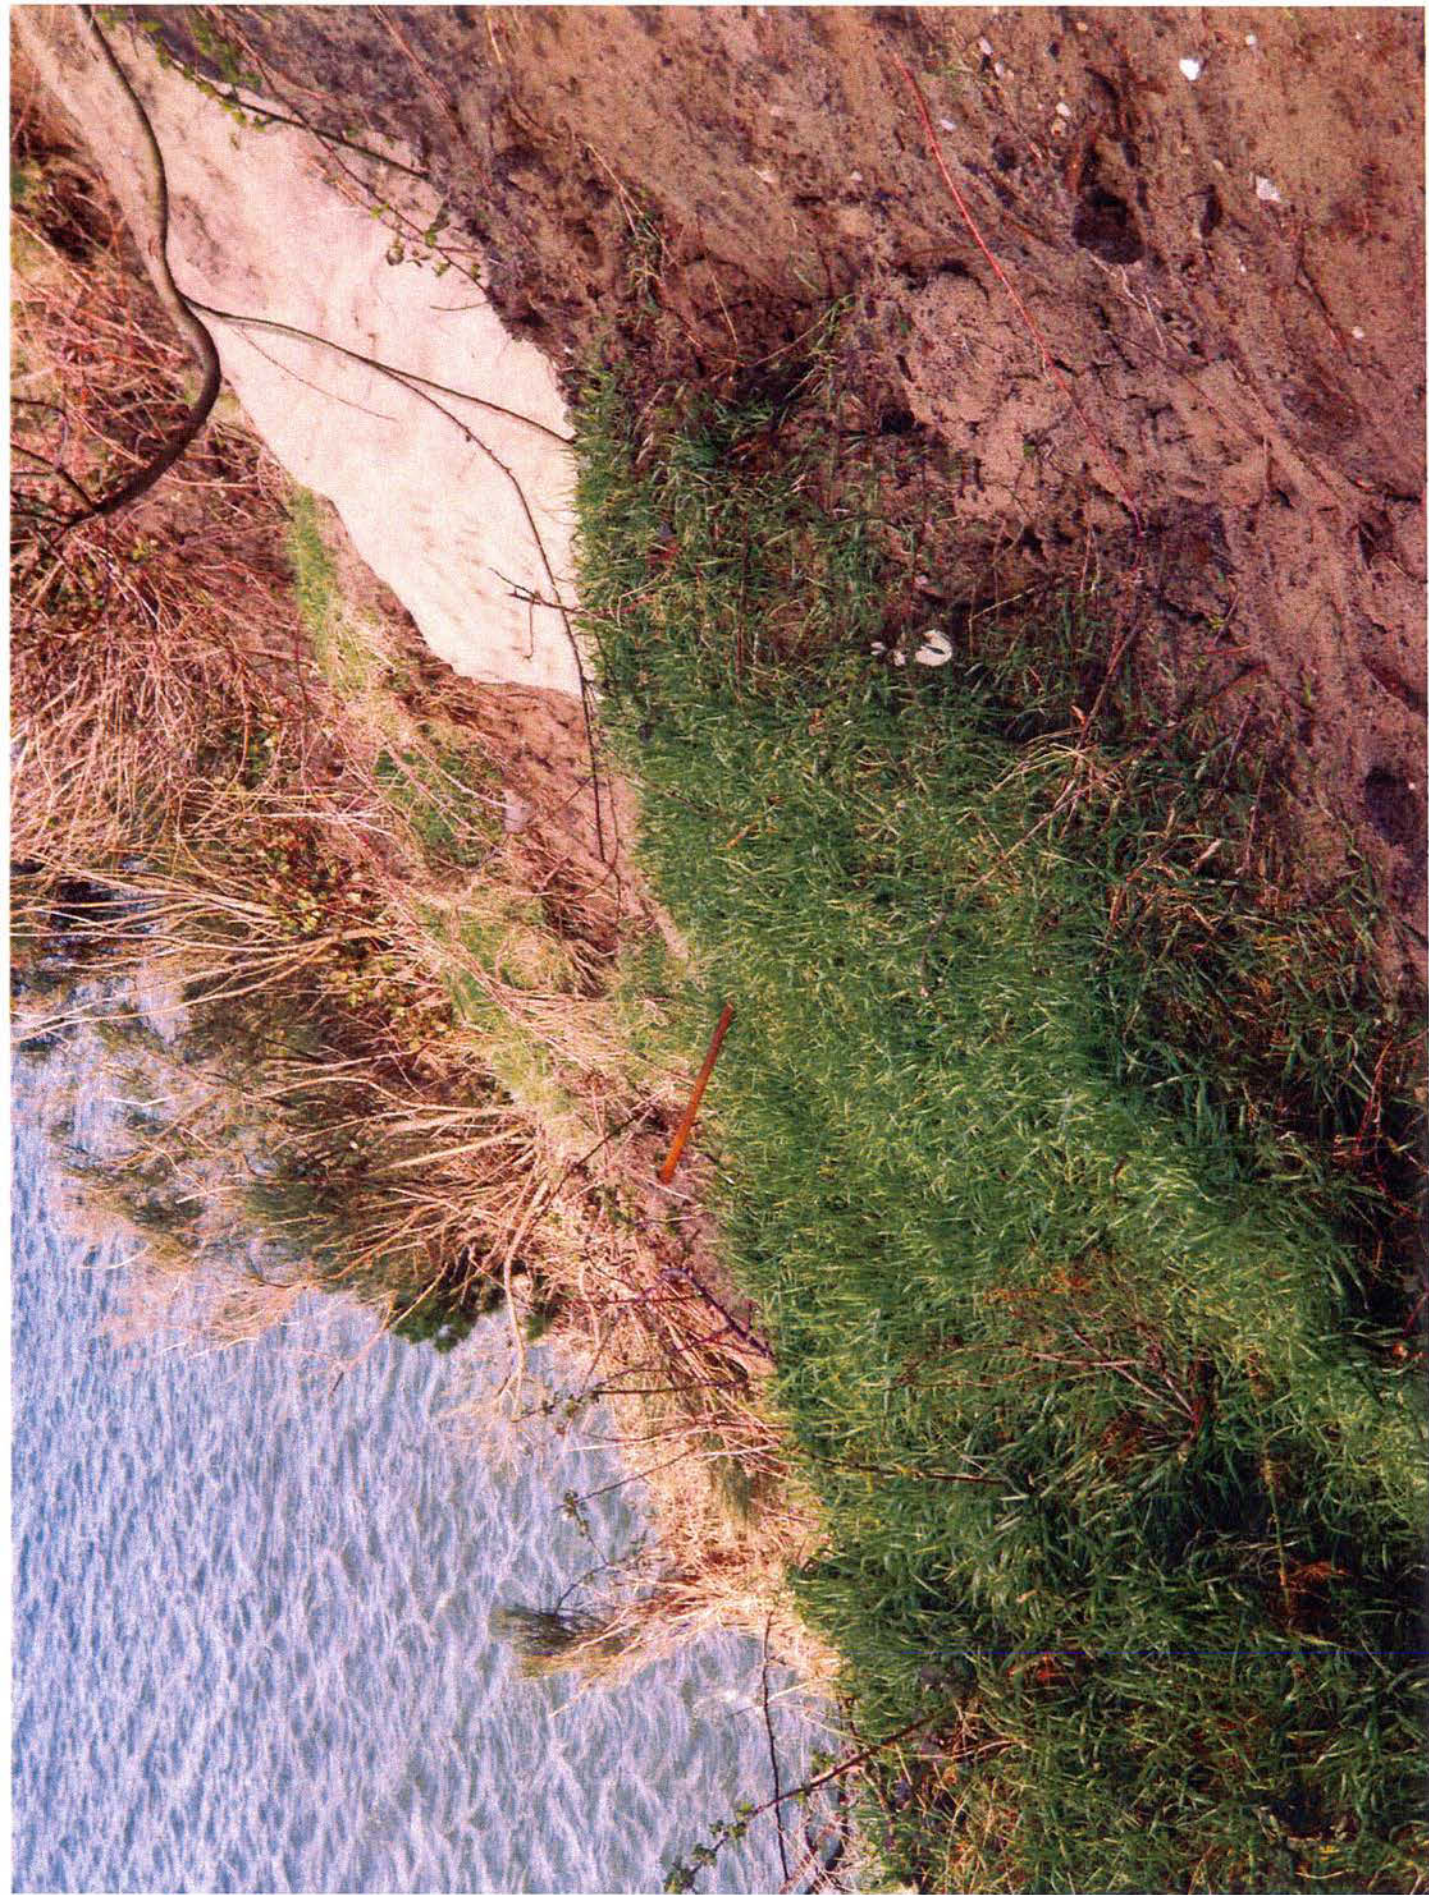
16 Sea Watch Estates, Florence, Bank Failure Assessment/Mitigation
Drive Probe Pipe Rotated from Vertical to Nearly Horizontal by Movement
GeoScience Photo 3/3/2011
