APPENDIX A:

SITE PHOTOS

16 Sea Watch Estates, Florence, Bank Failure Assessment/Mitigation
Site on January 17, 2011. View of Failure from N End. View E and S.
Panorama Generated from GeoScience Site Photos 1/17/2011

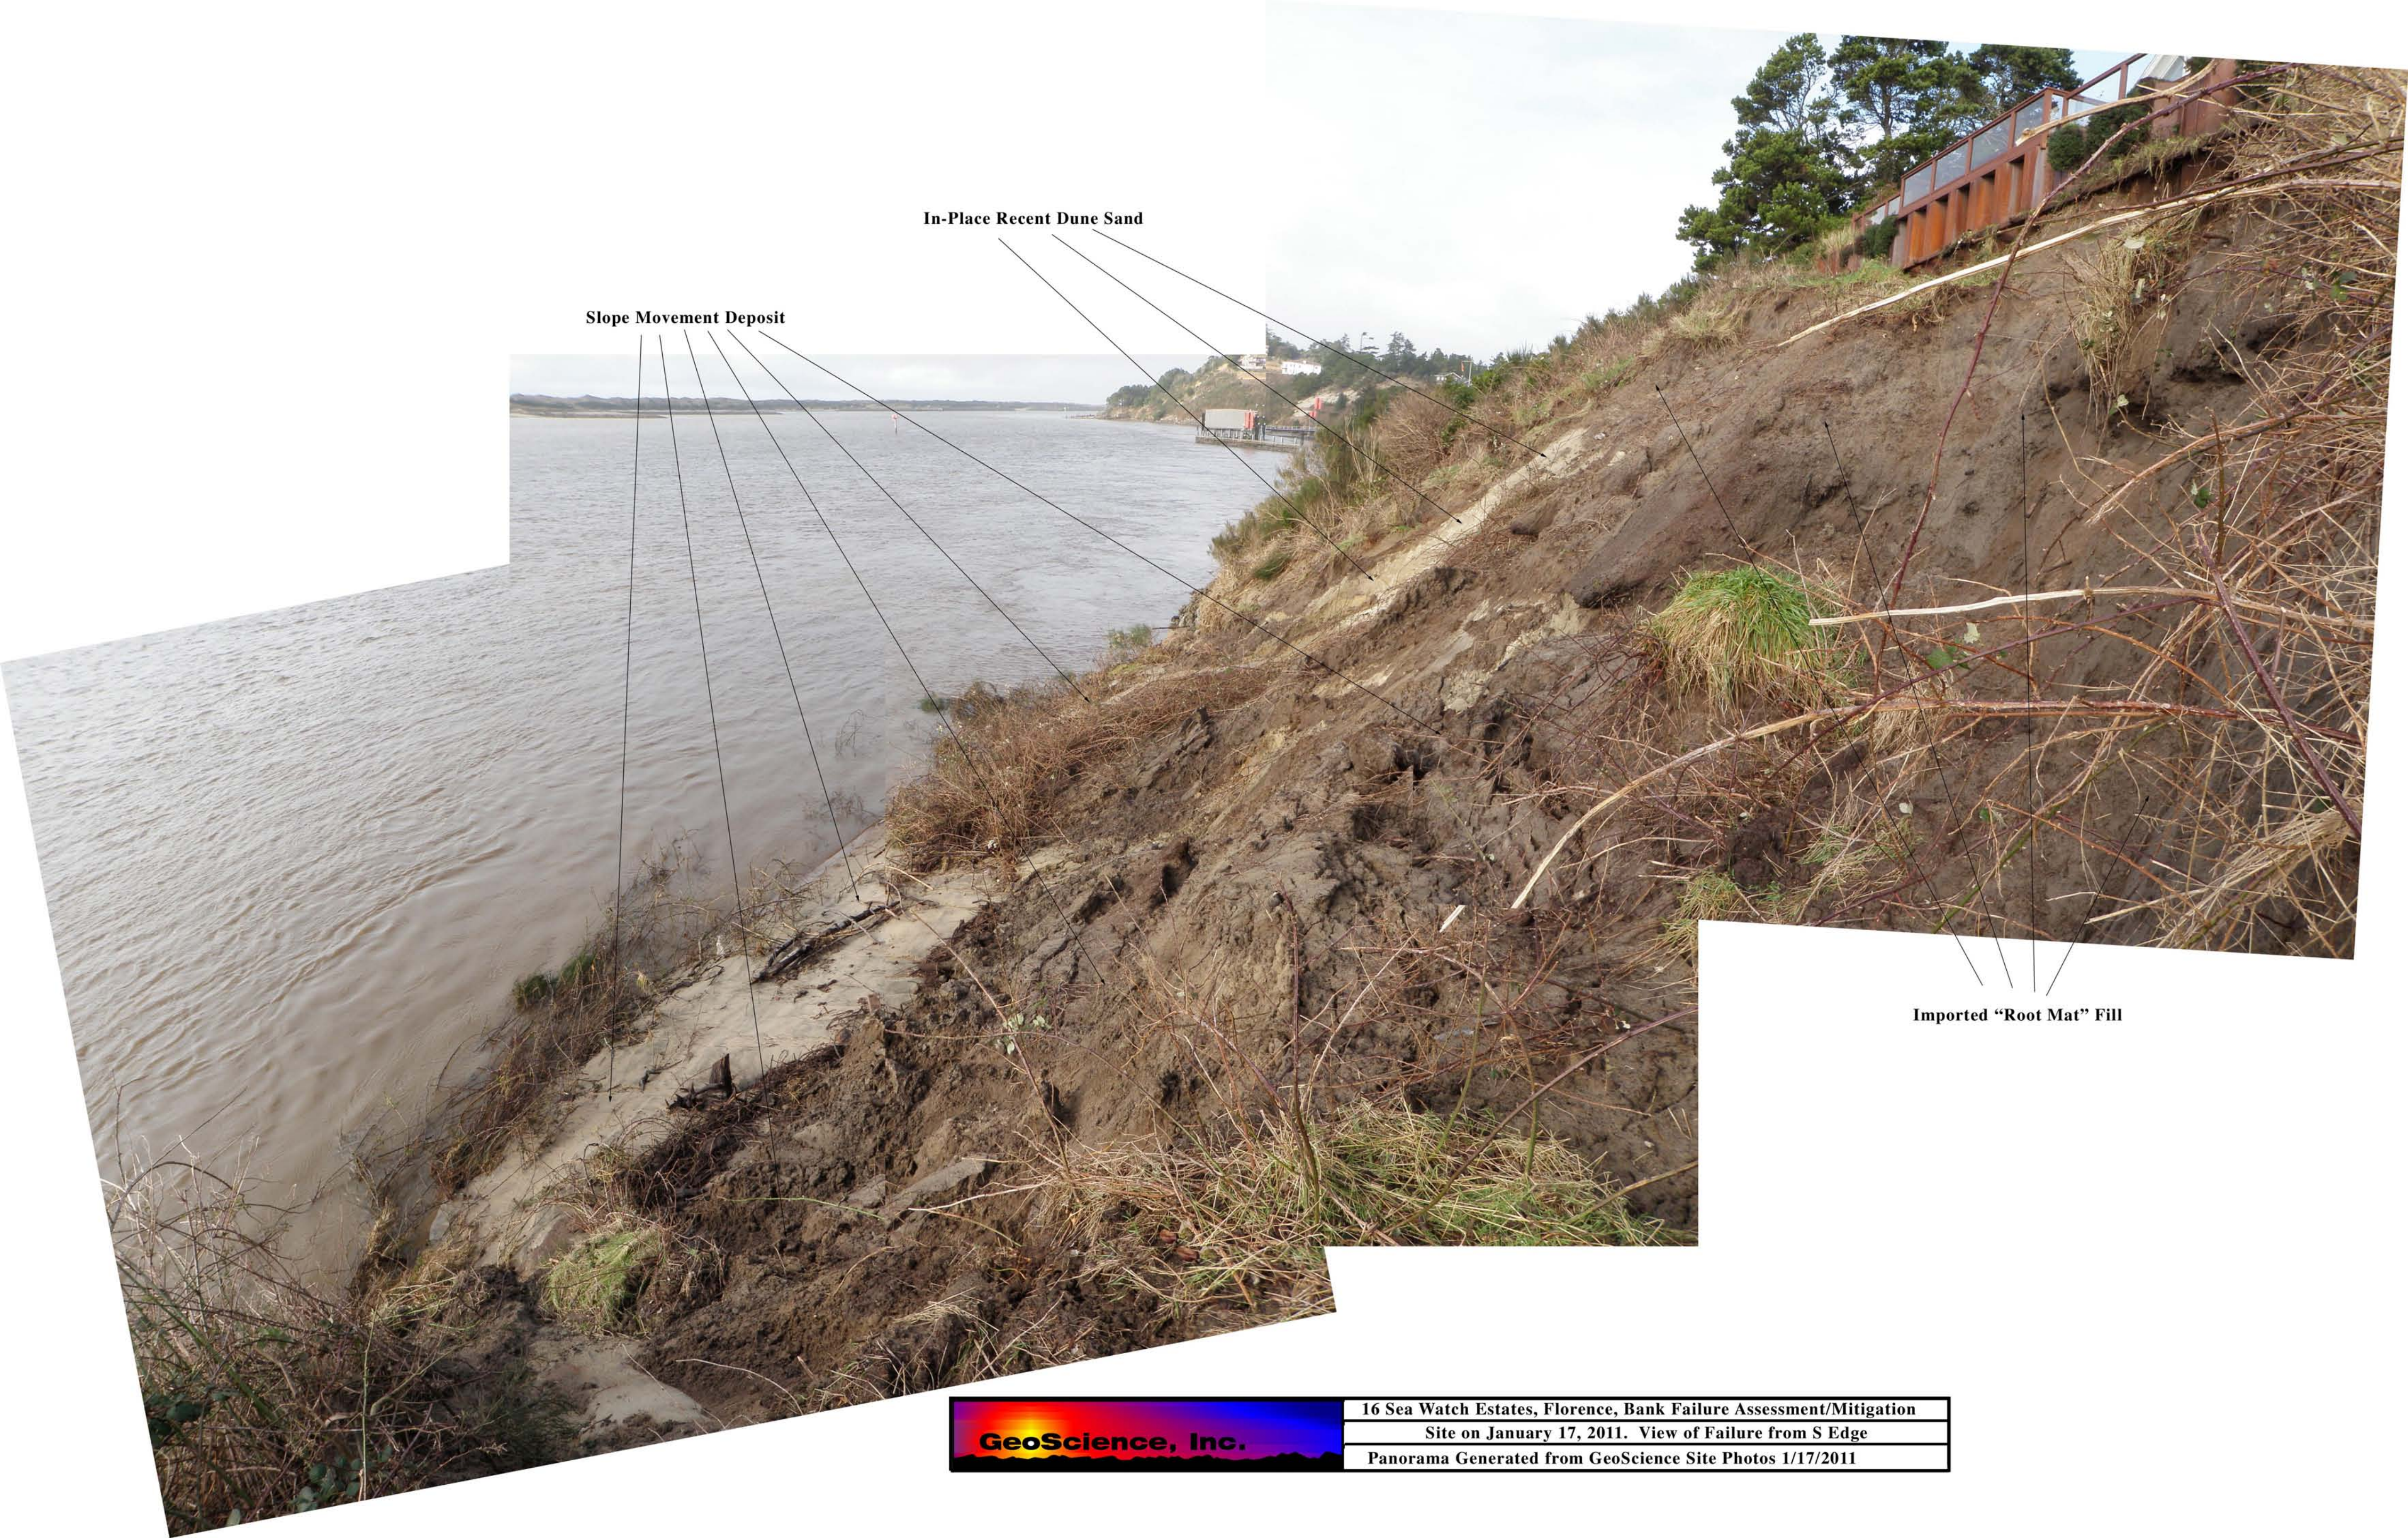
In-Place Recent Dune Sand

Slope Movement Deposit

Imported "Root Mat" Fill

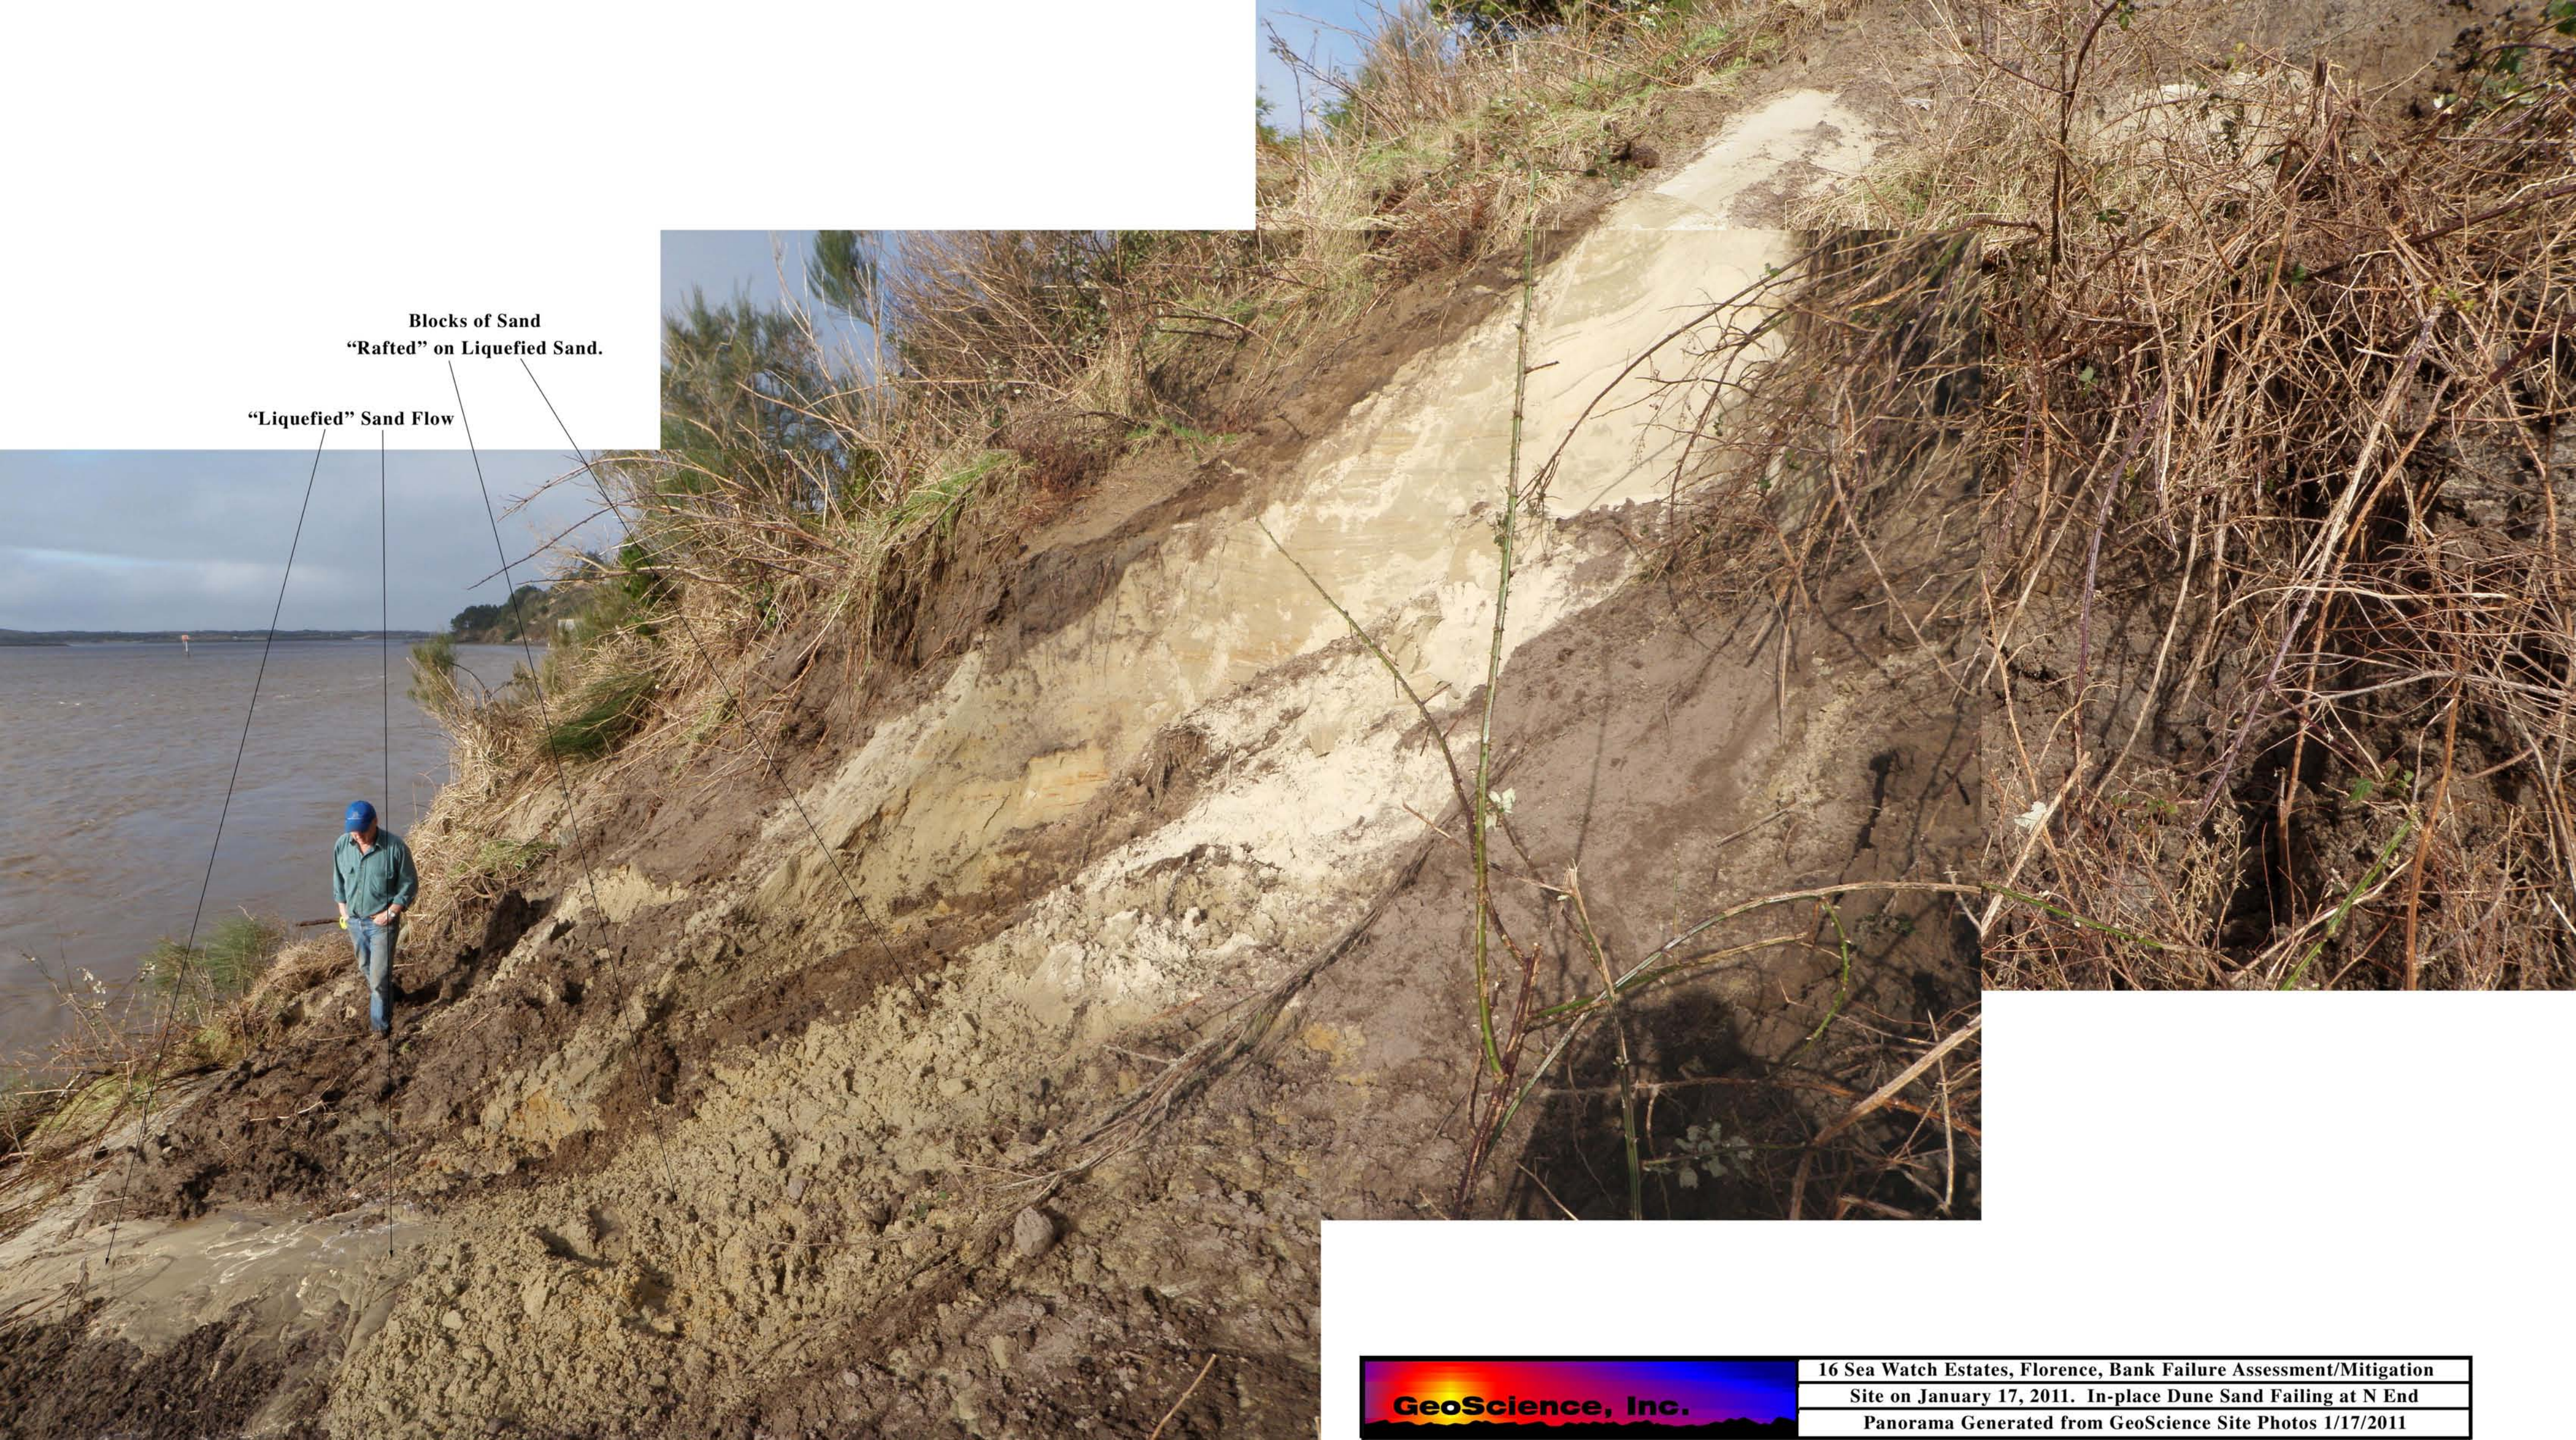
Blocks of Sand
"Rafted" on Liquefied Sand.

"Liquefied" Sand Flow

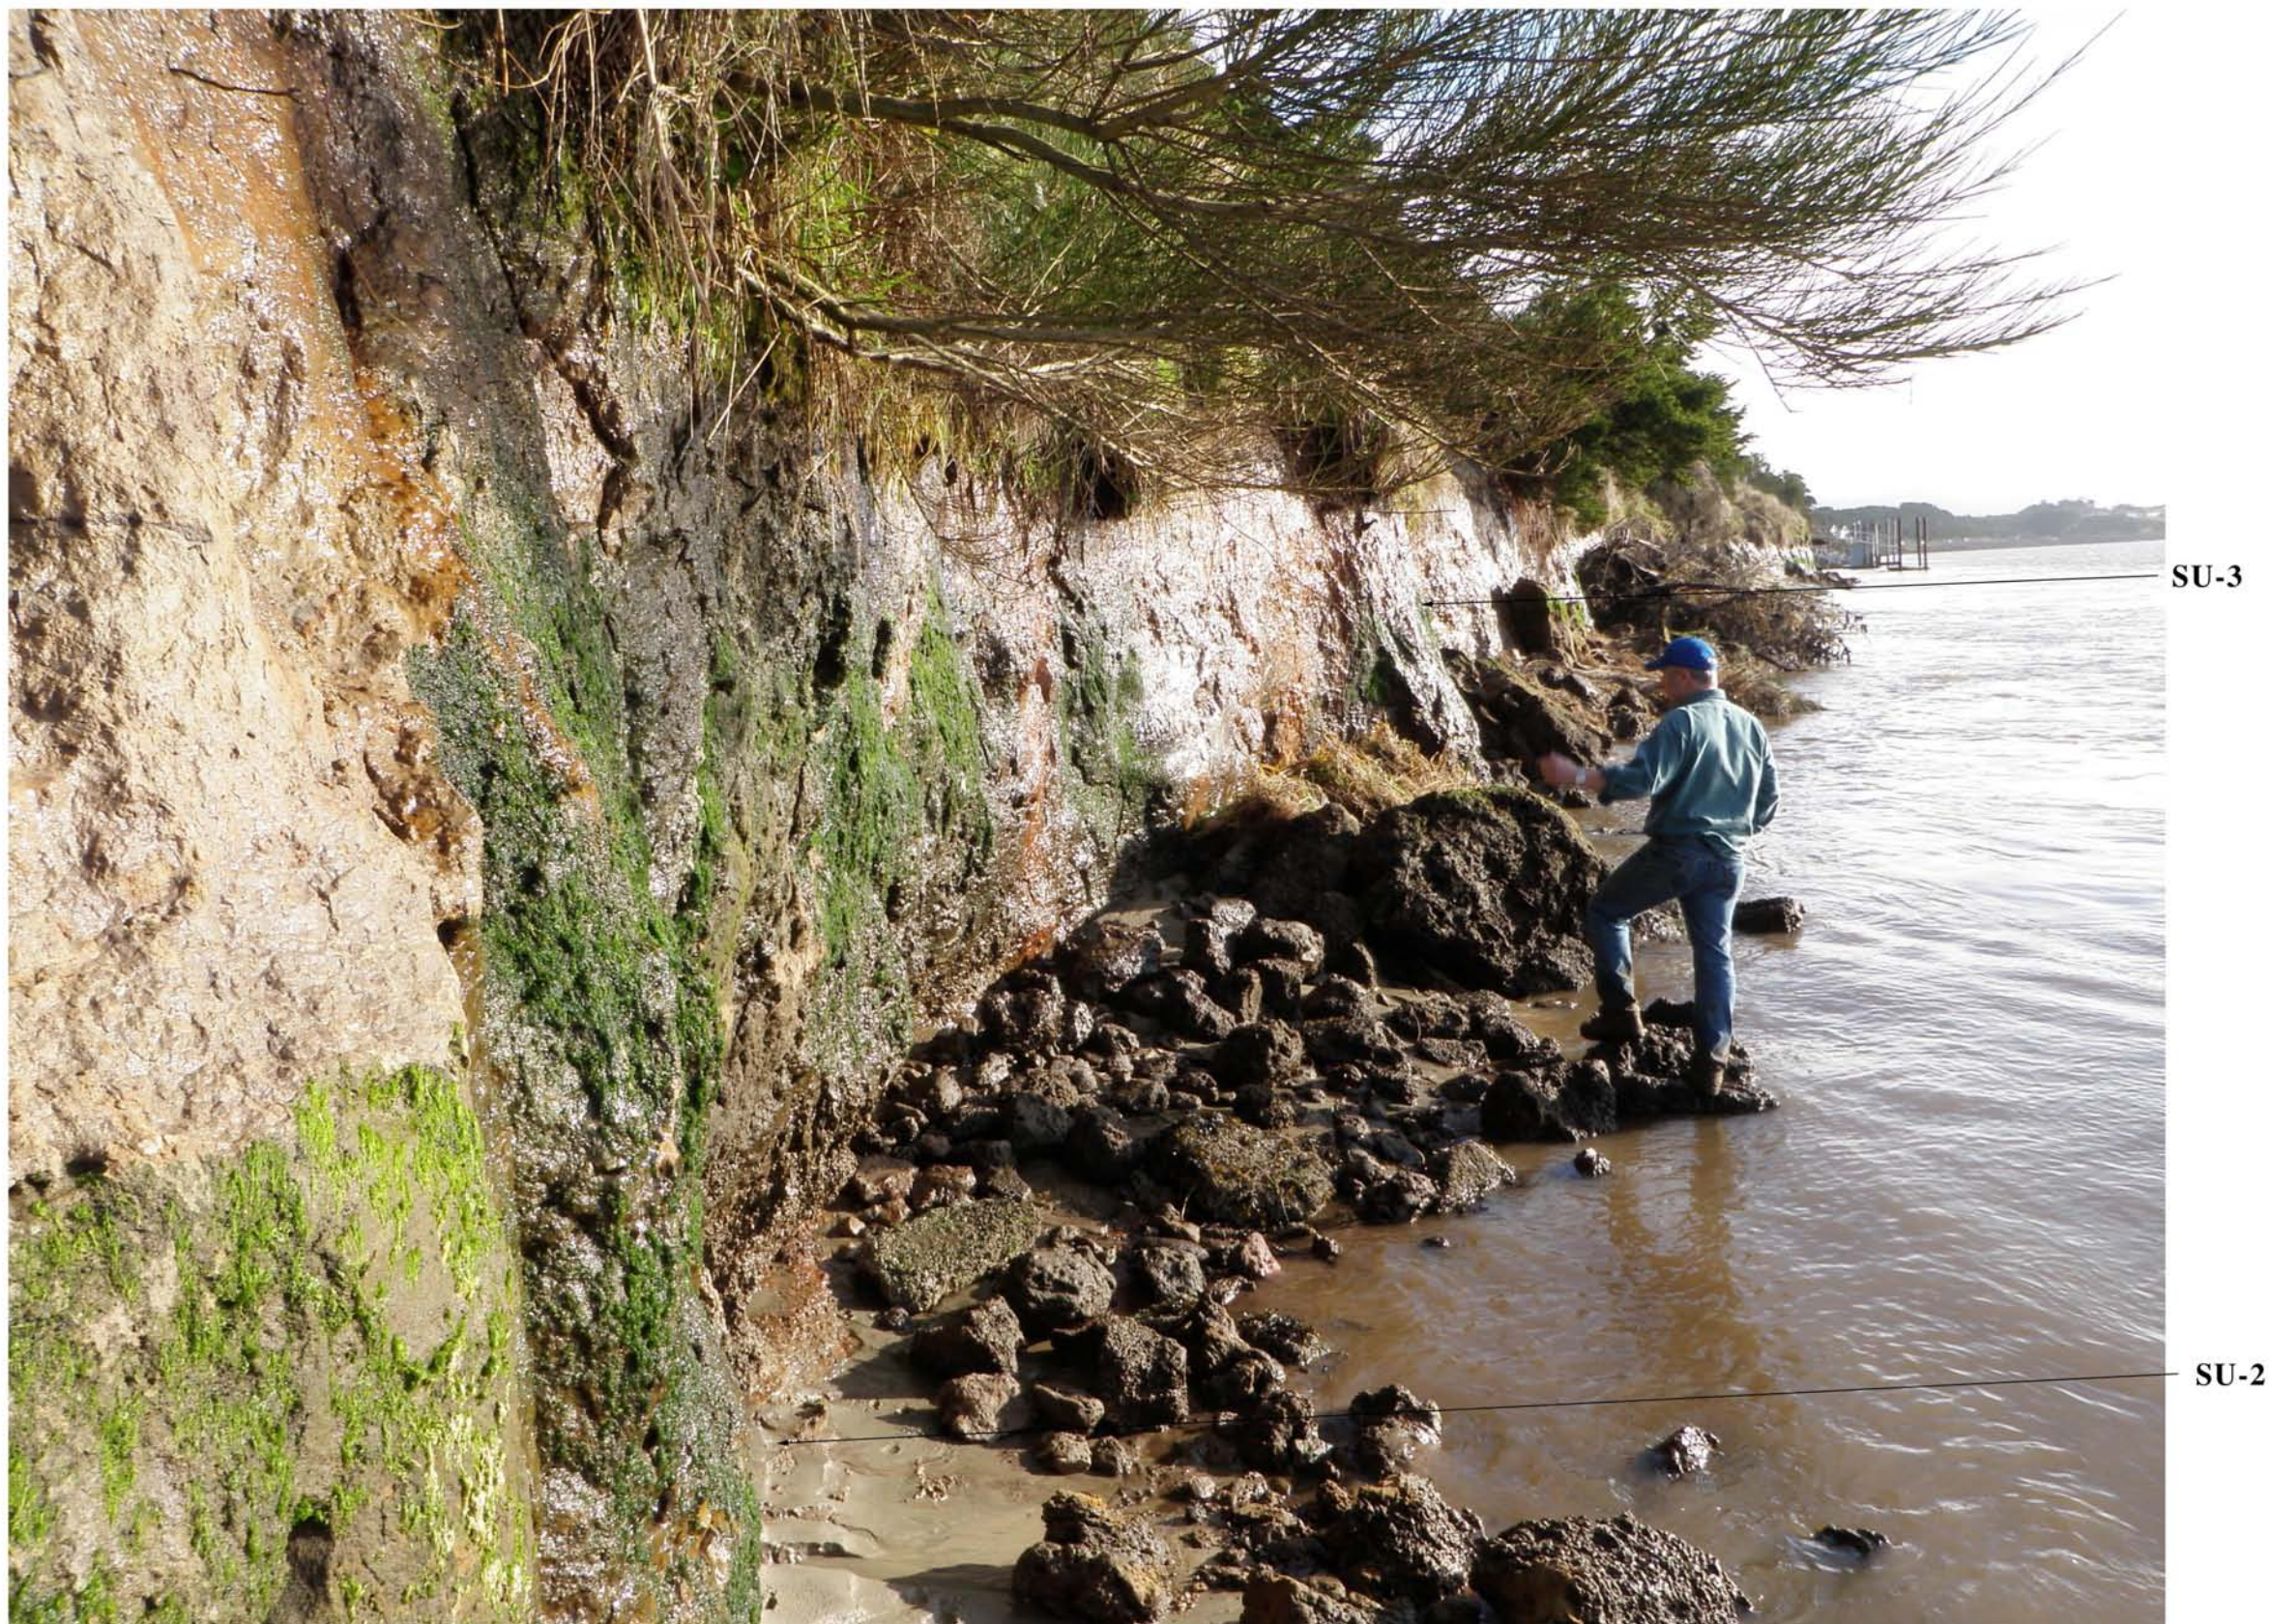
16 Sea Watch Estates, Florence, Bank Failure Assessment/Mitigation
January 17, 2011. View S Along Cliff-forming SU-3
GeoScience Site Photos 1/17/2011

Buried Upper Edge of SU-3 Marked

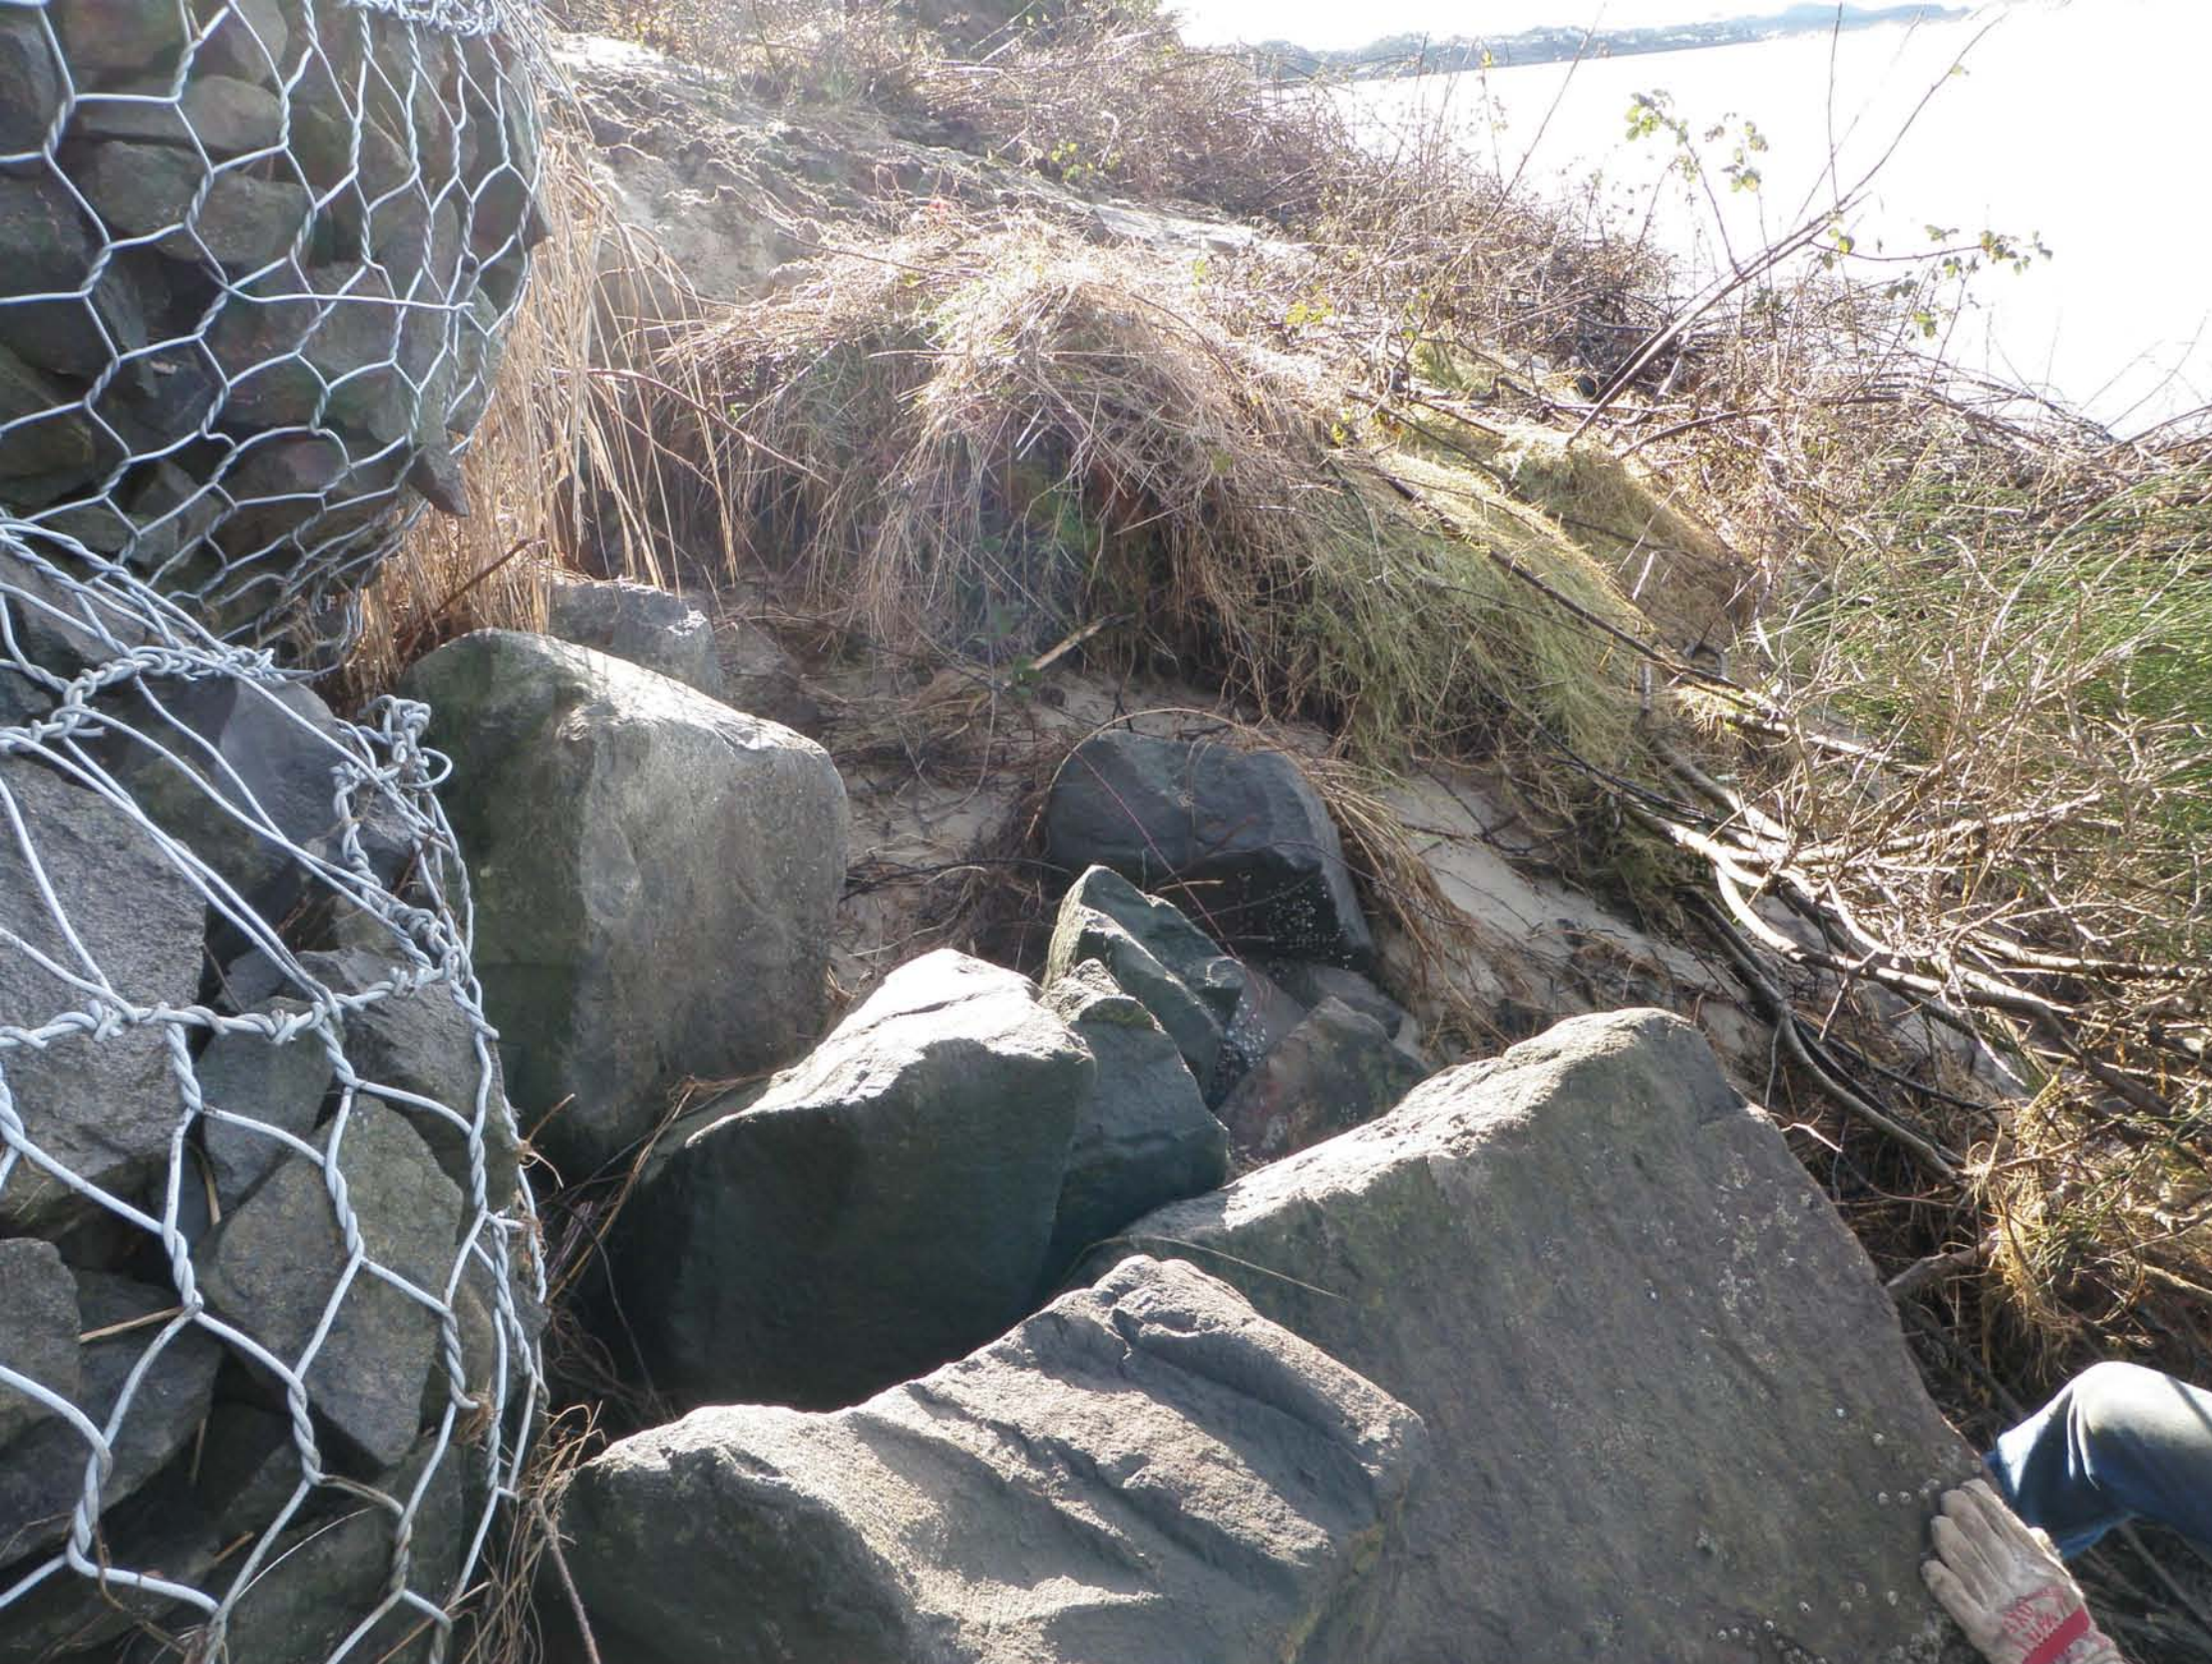
Gabions above SU-3 to the N of the current failure. View S toward failure.

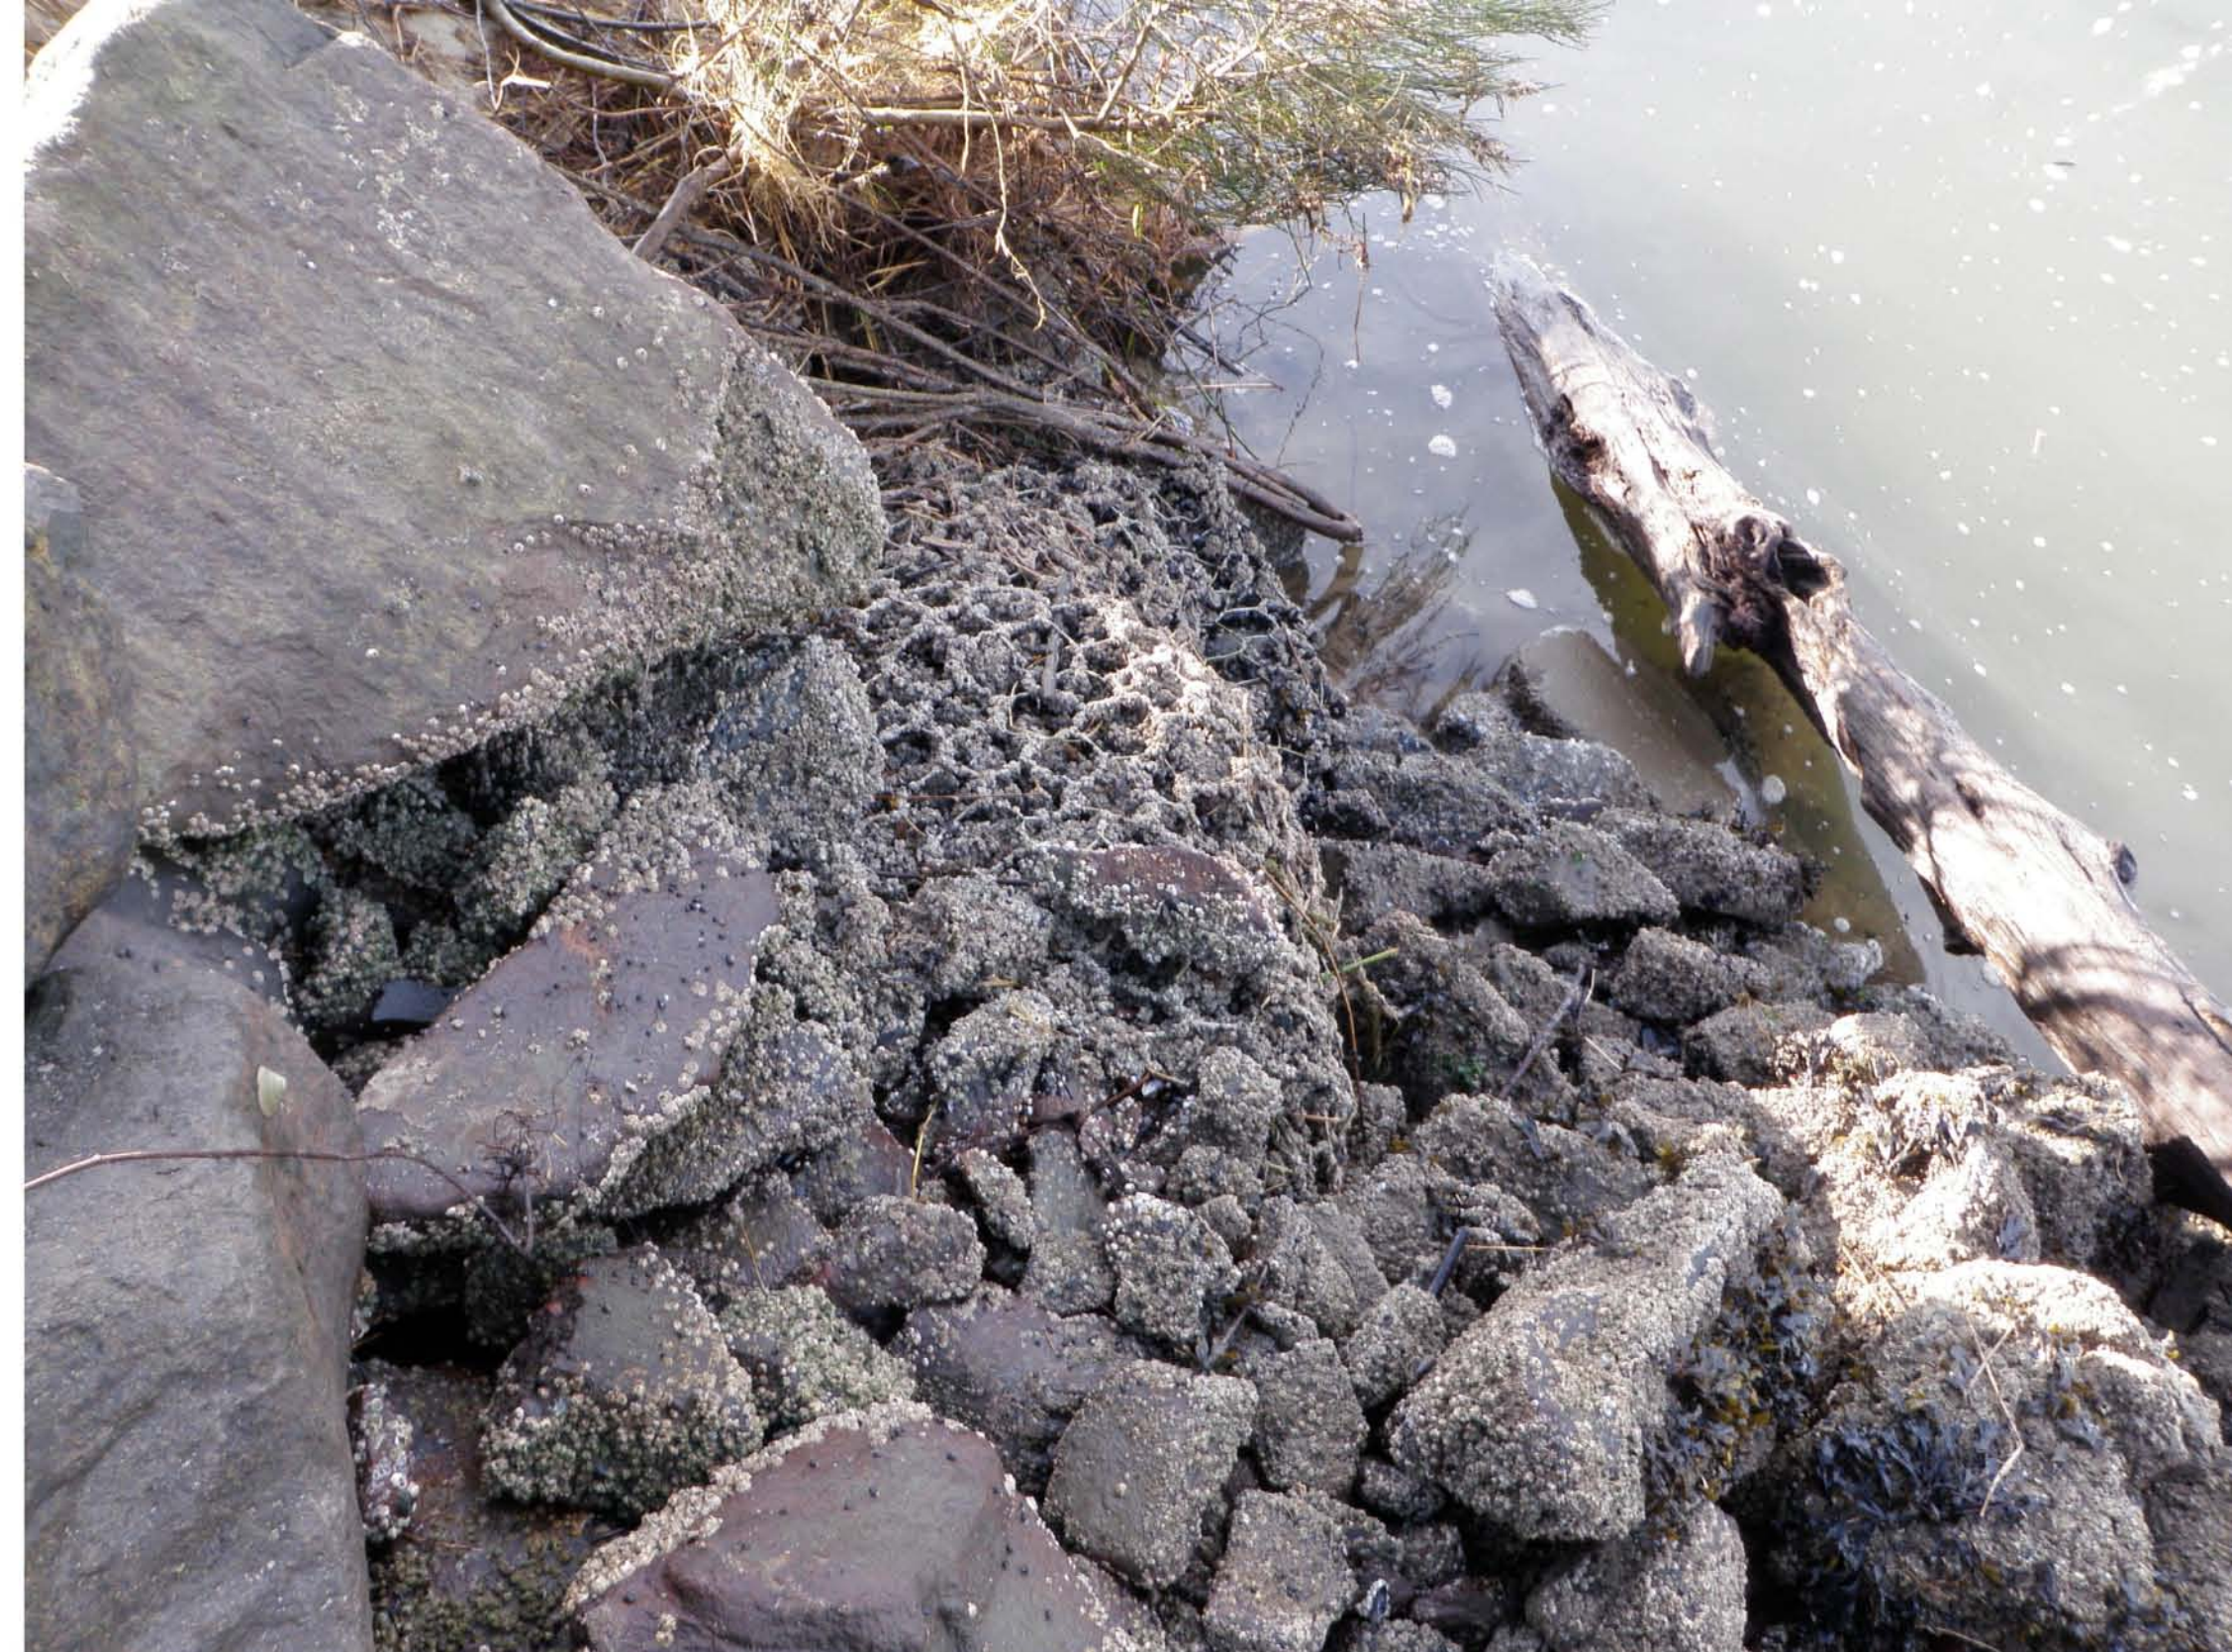
Gabions involved in failure at N end of slope movement deposit. Baskets have been deflected westward by the movement.

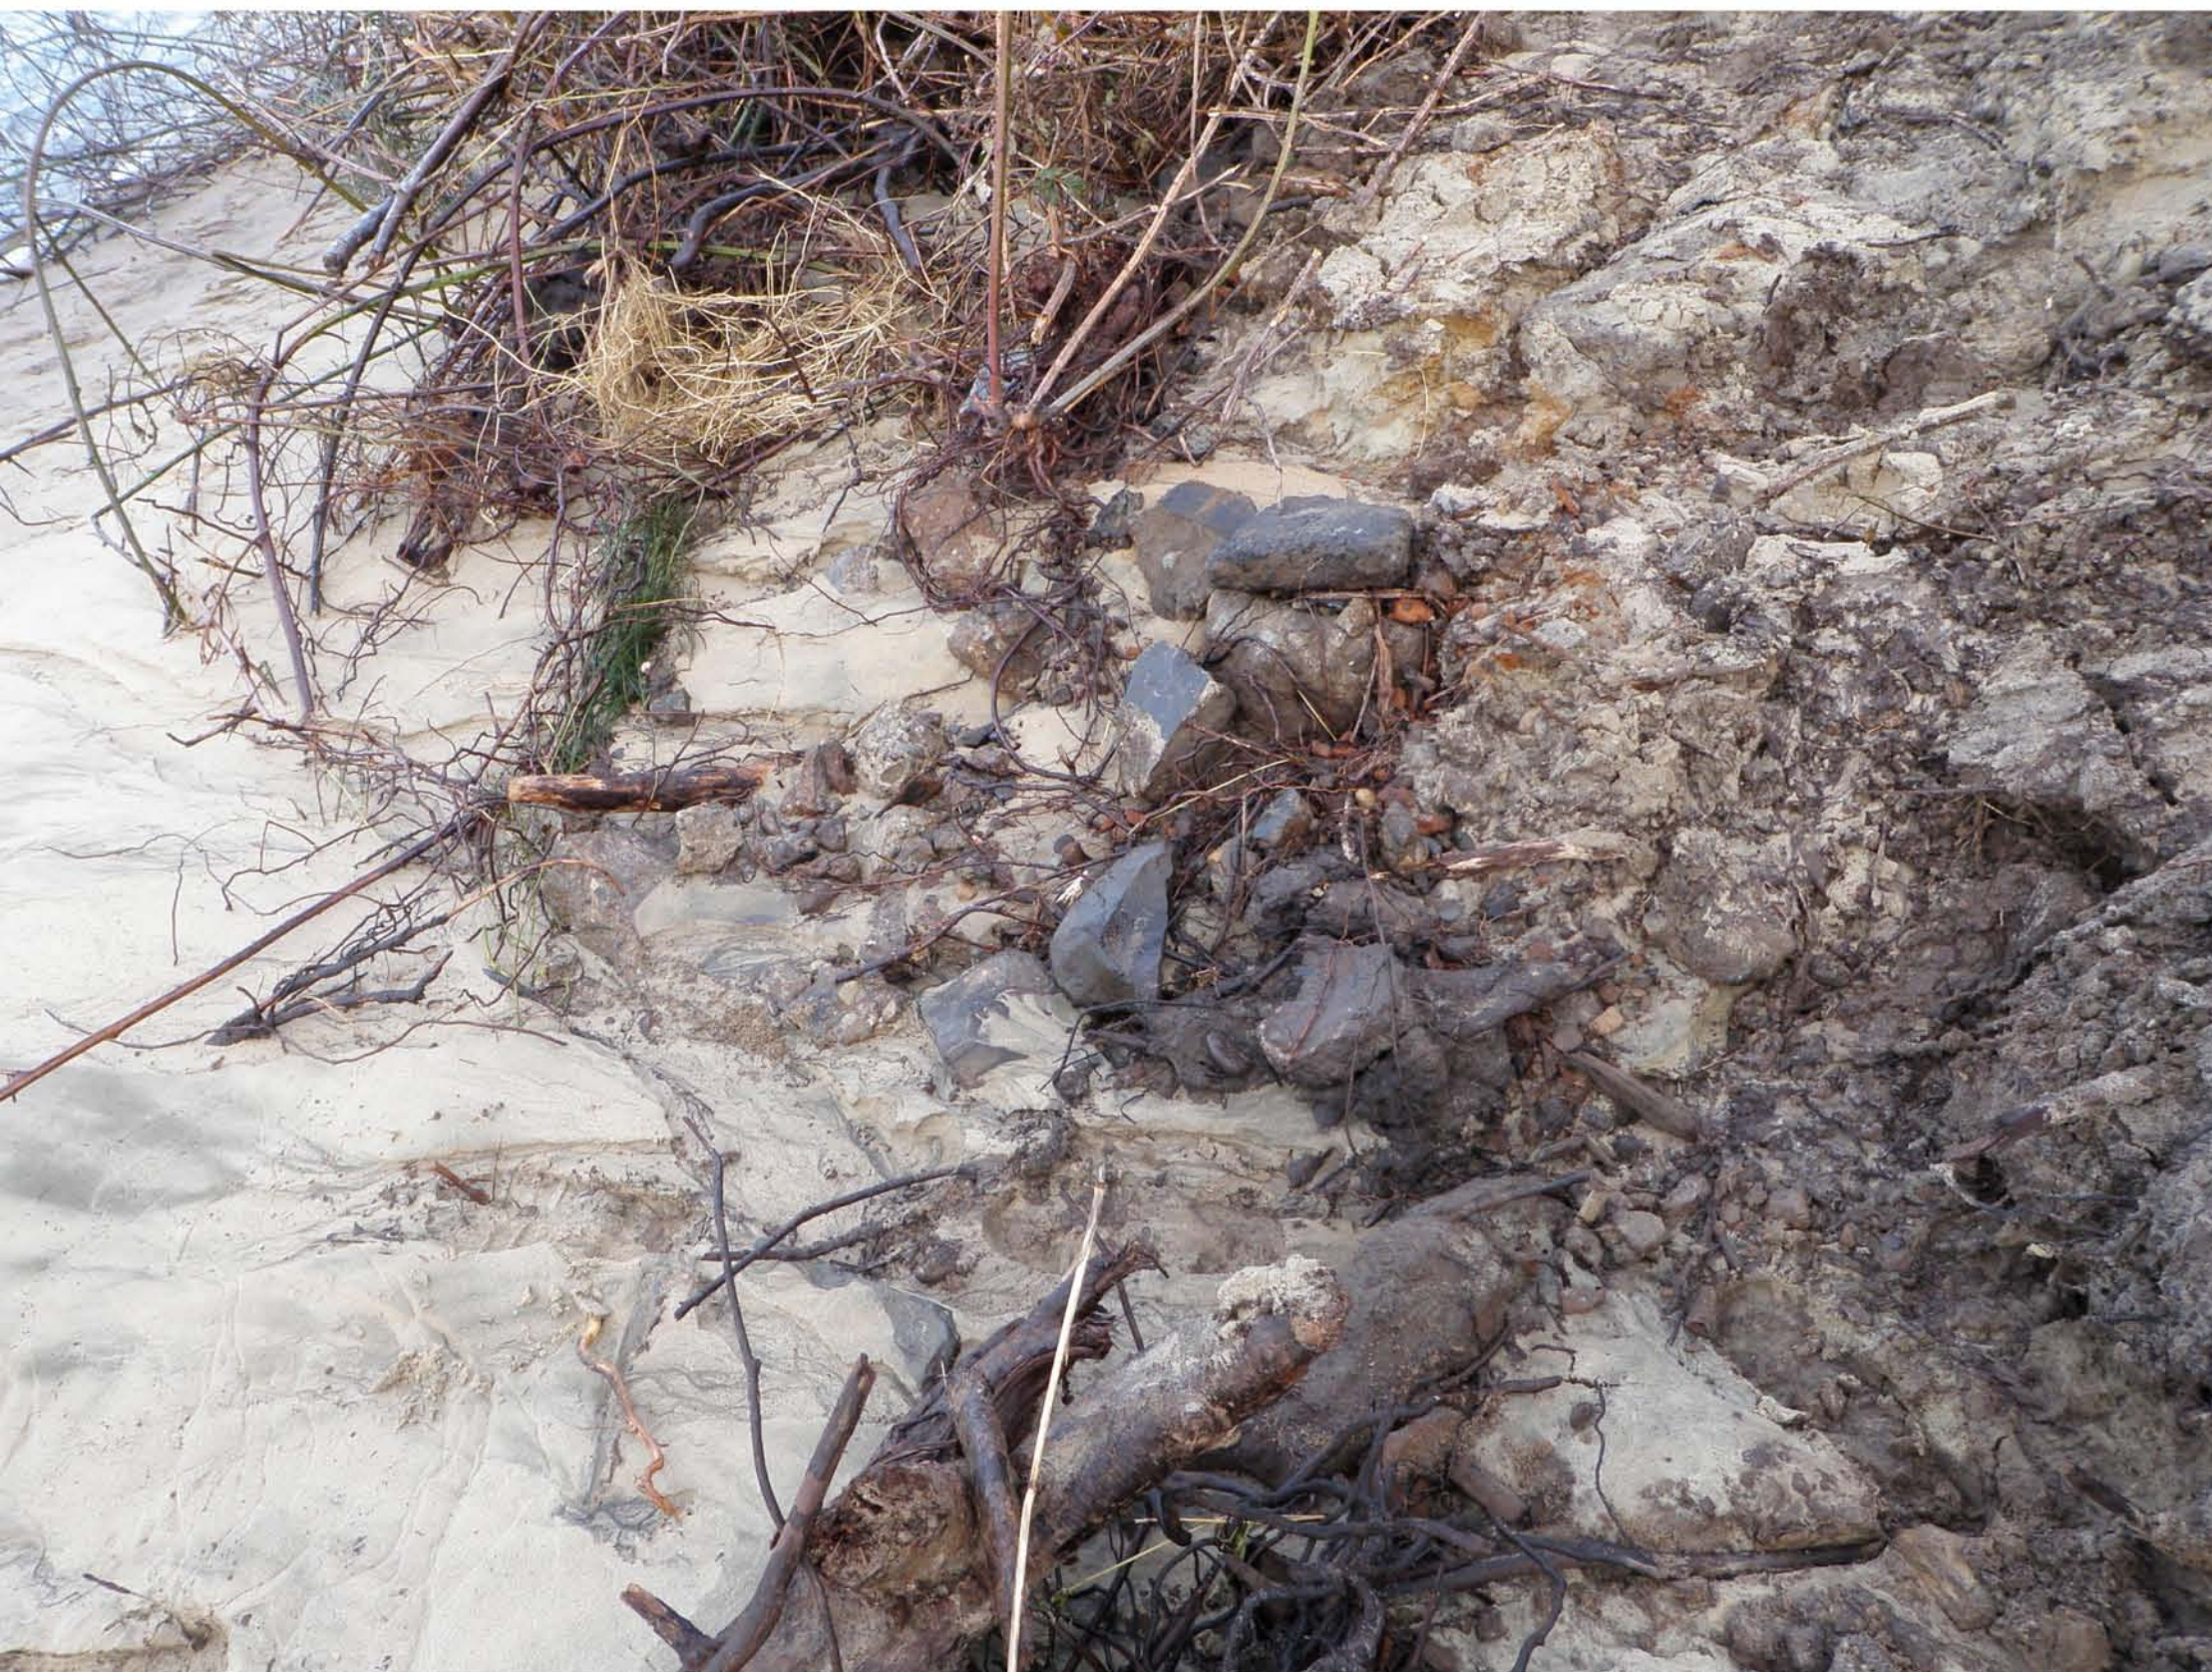
Rip rap exposed in S central portion of the toe of the slope movement. Sand to left is slope movement deposit in area under water at OHW.
