APPENDIX A:

SITE PHOTOS

16 Sea Watch Estates, Florence, Bank Failure Assessment/Mitigation
Site on January 17, 2011. View of Failure from N End. View E and S.
Panorama Generated from GeoScience Site Photos 1/17/2011

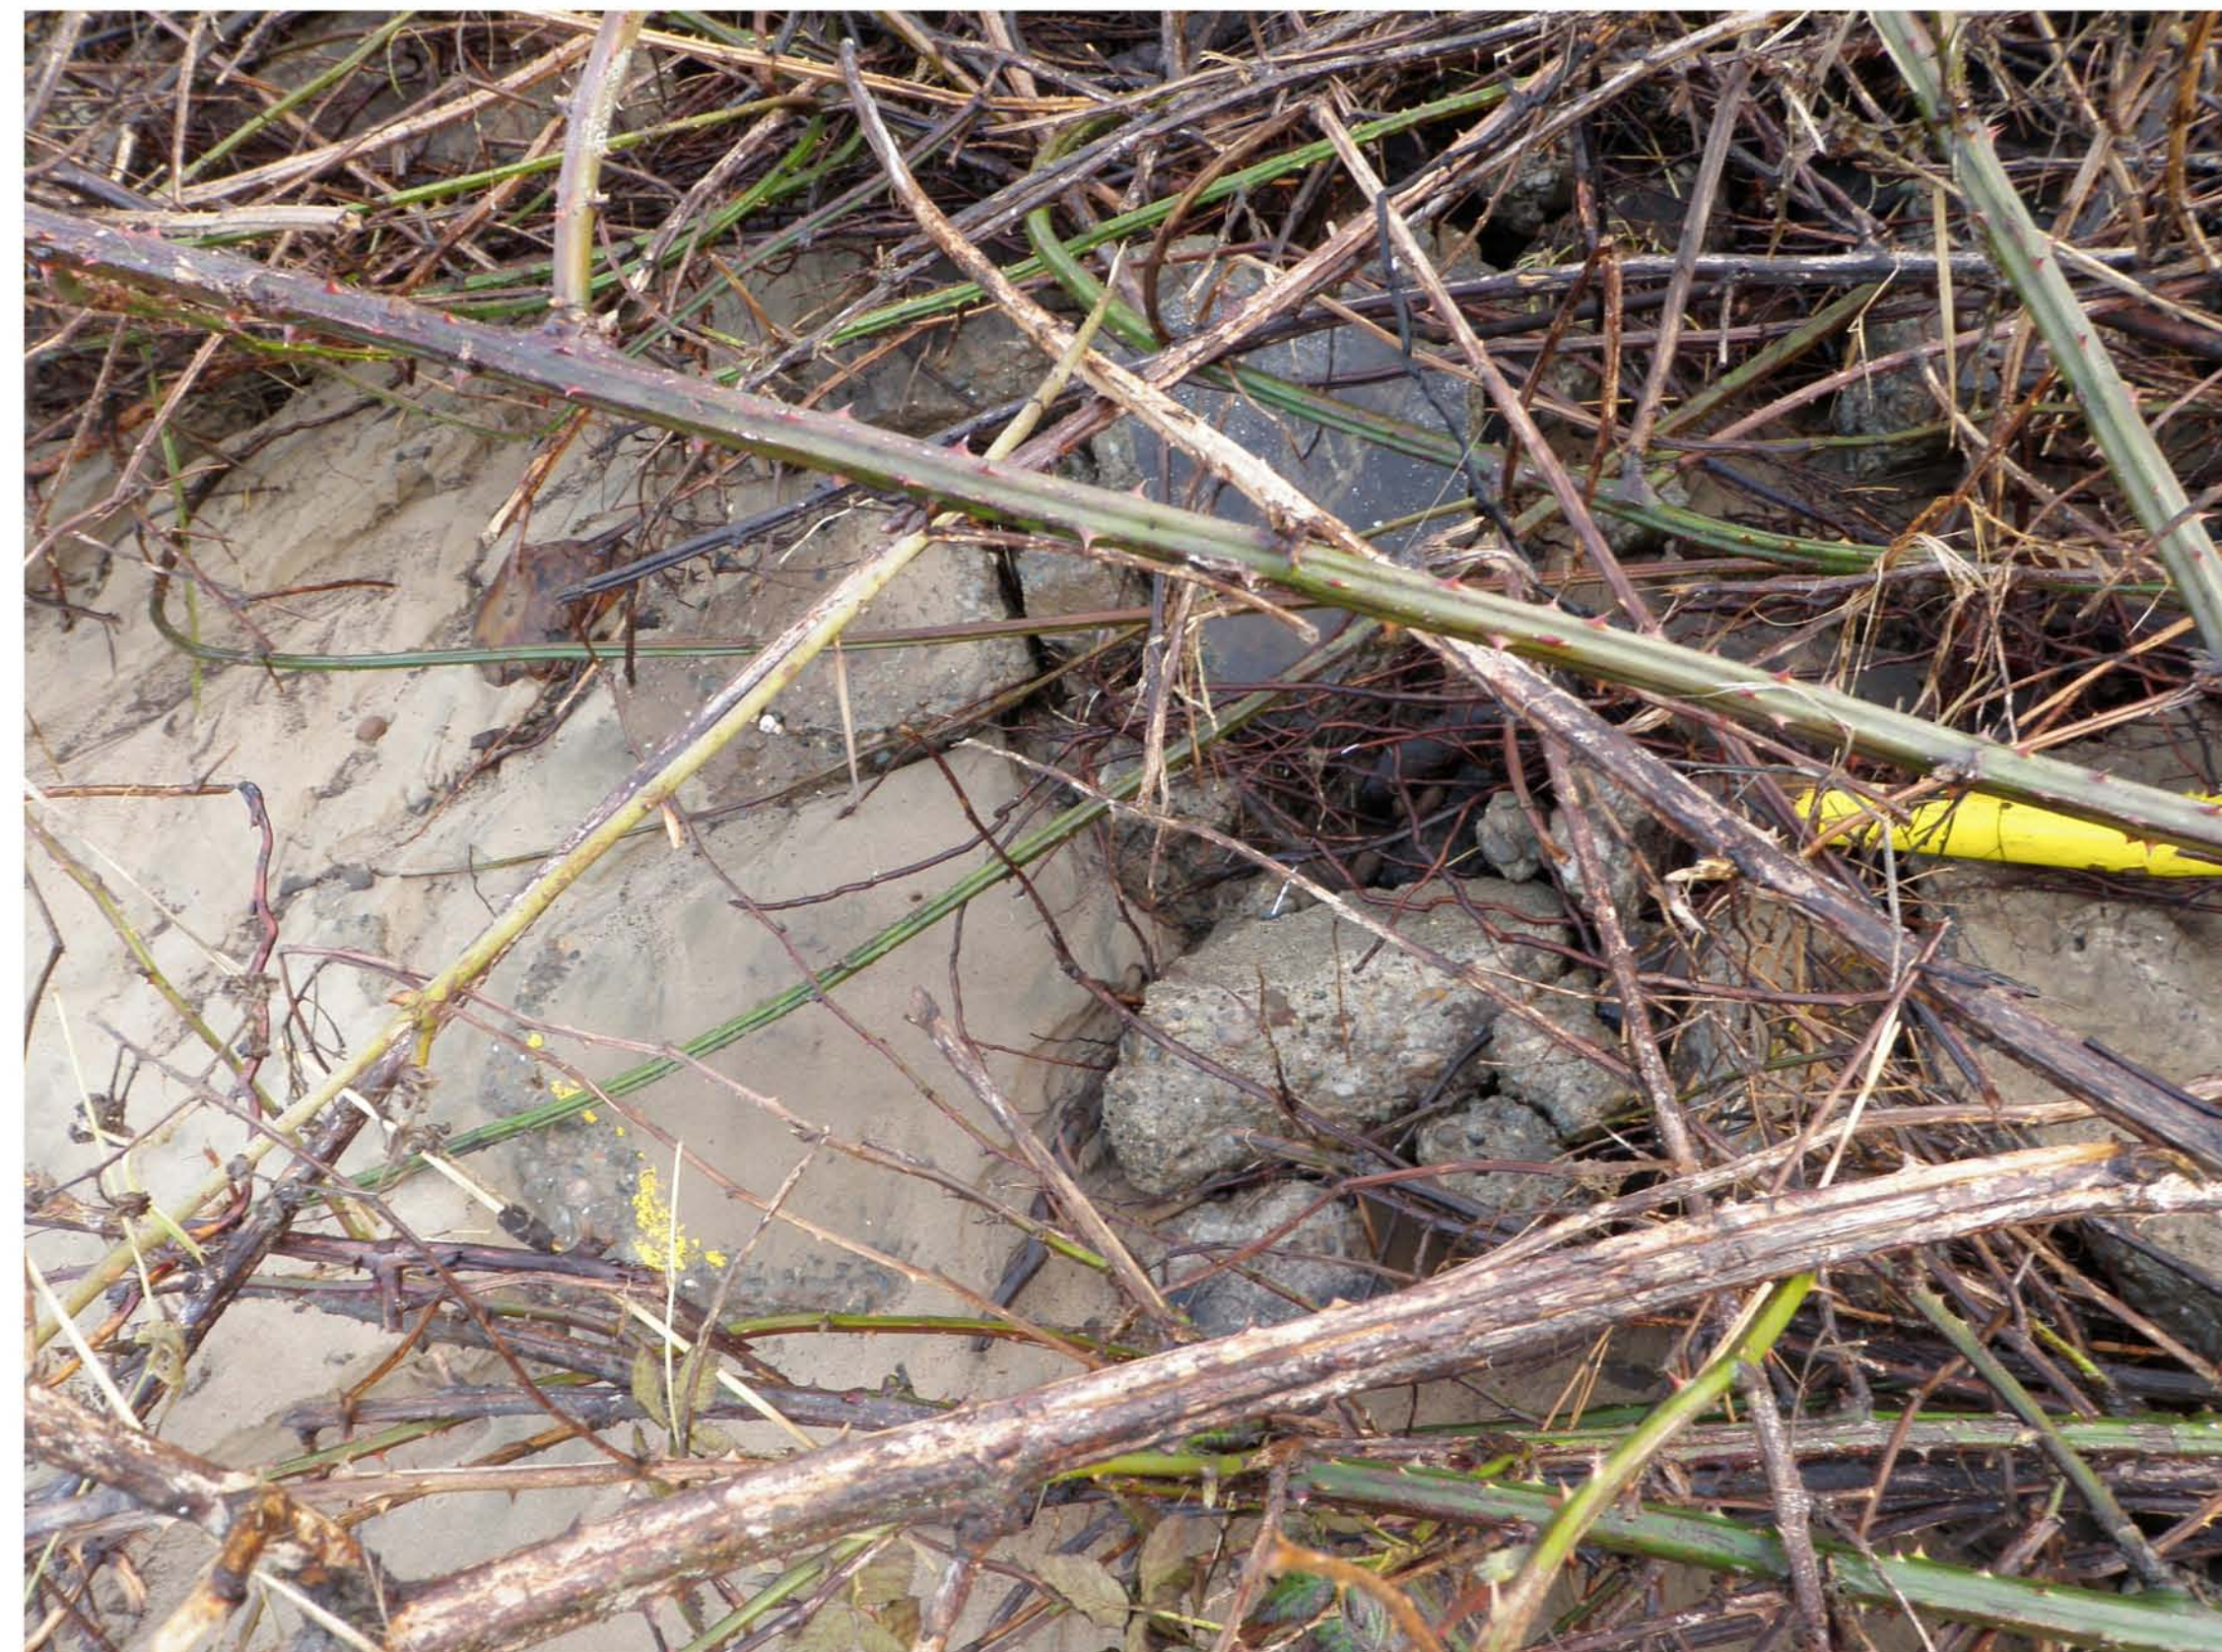
Rip rap in place exposed in N central area of slope movement deposit.

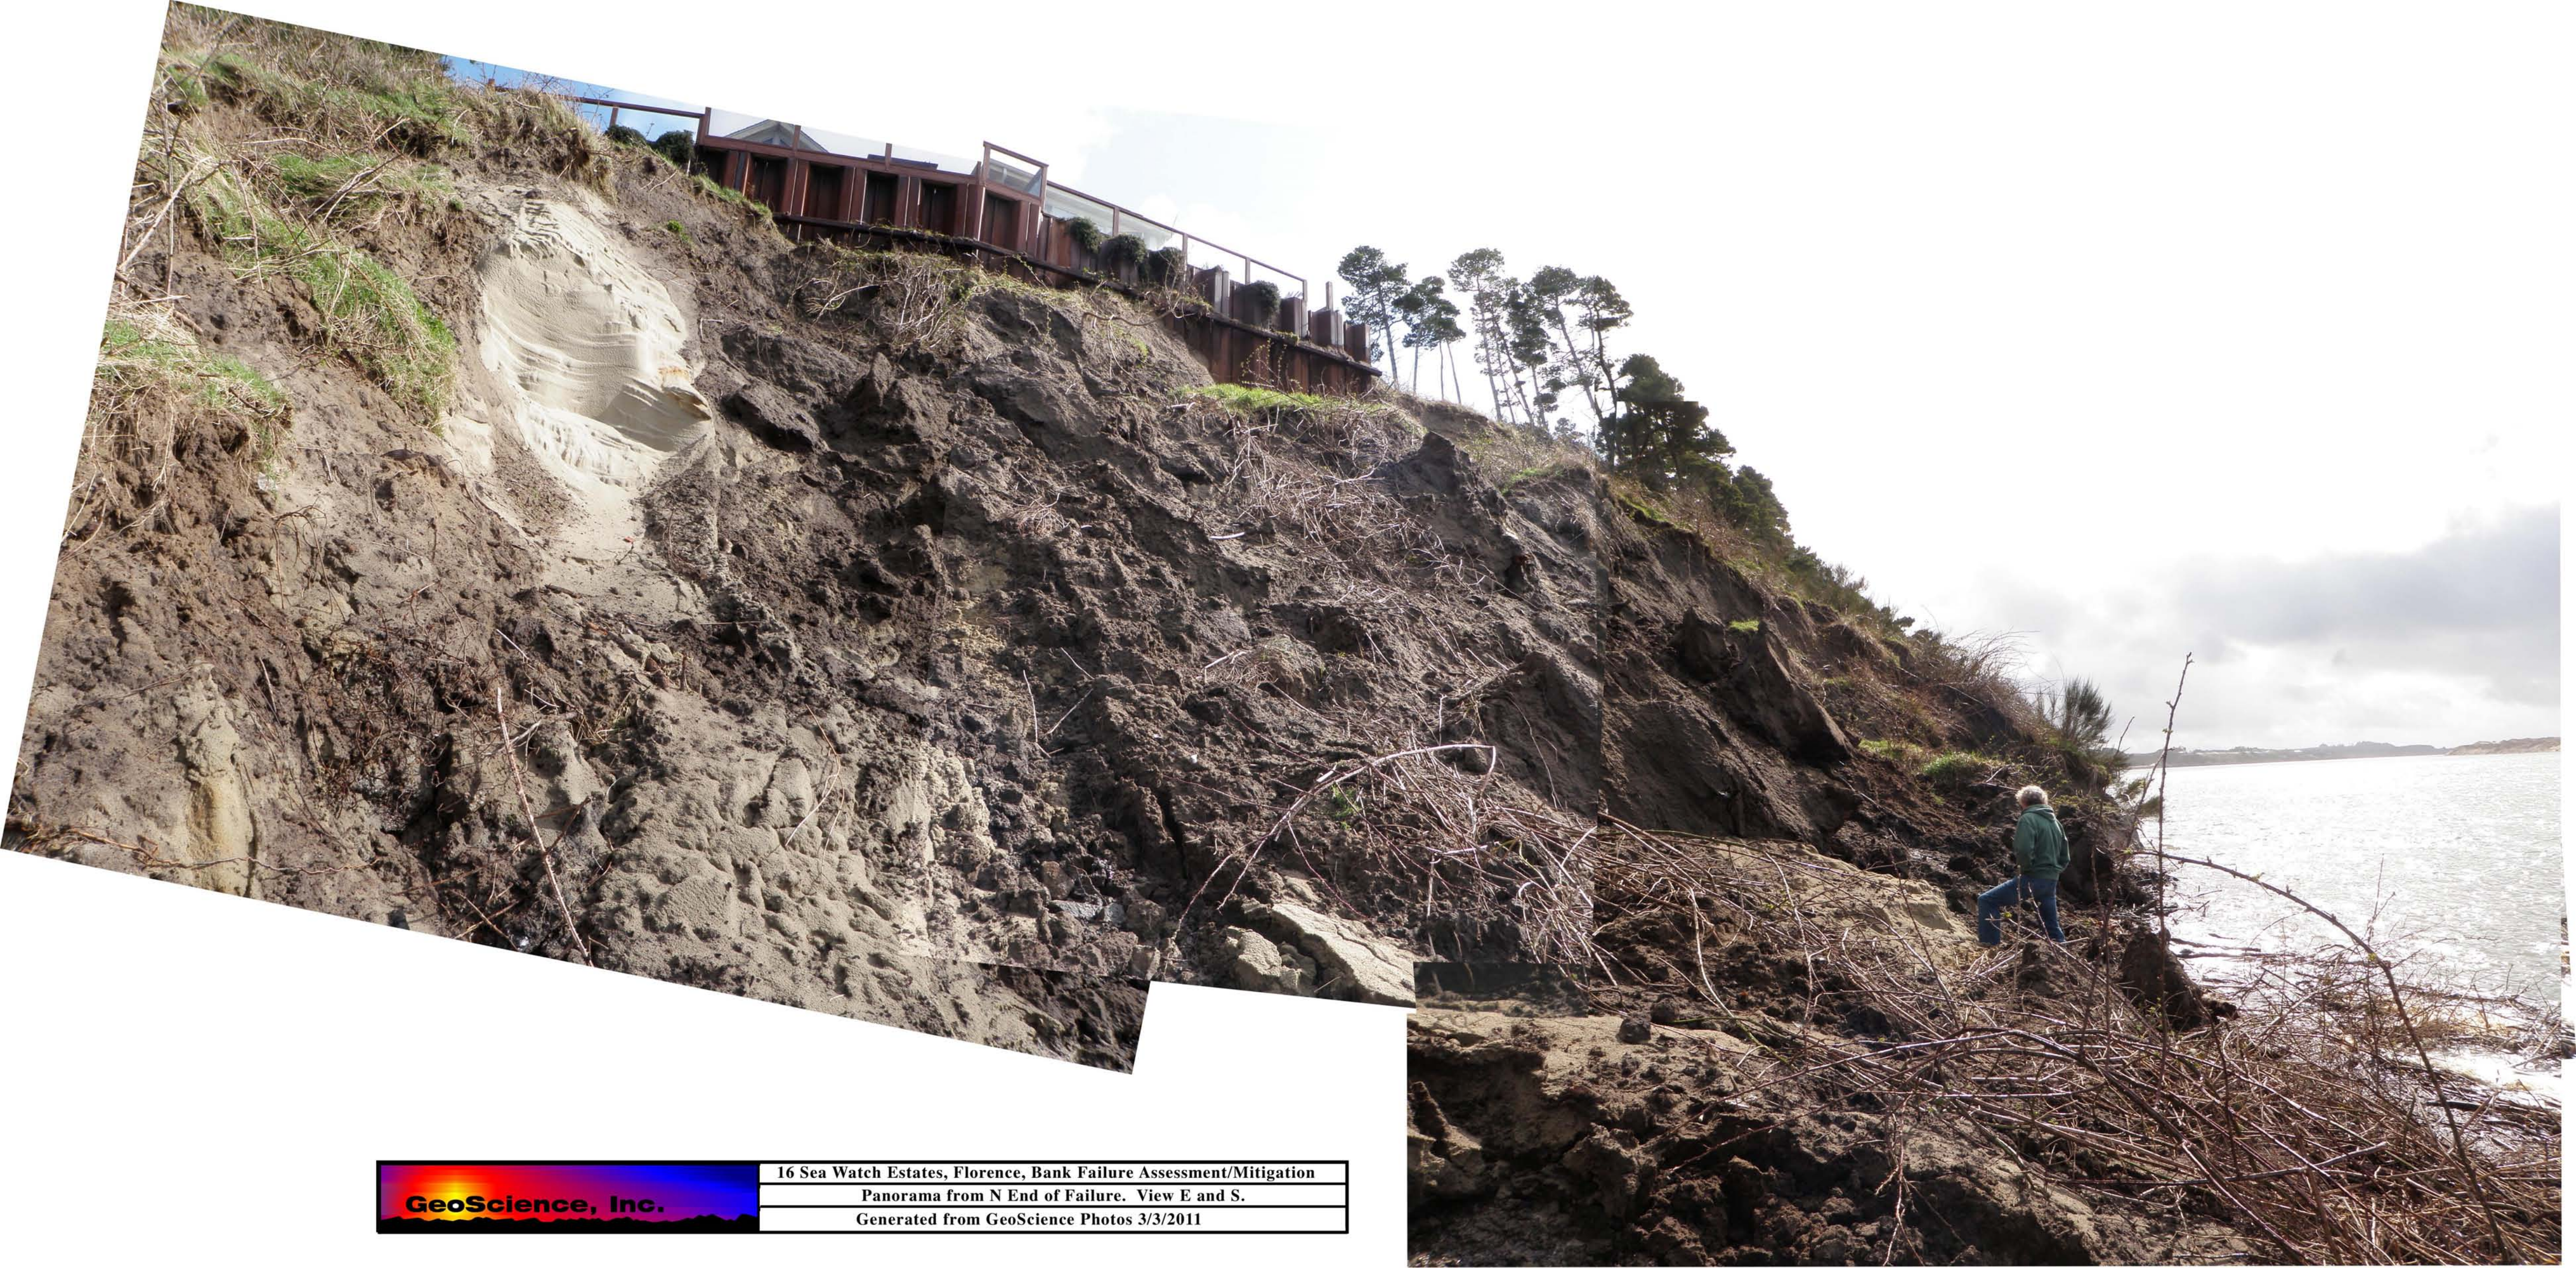
16 Sea Watch Estates, Florence, Bank Failure Assessment/Mitigation
Panorama from N End of Failure. View E and S.
Generated from GeoScience Photos 3/3/2011

Remaining Older Gabion Baskets

MTD

Slope Movement Deposit

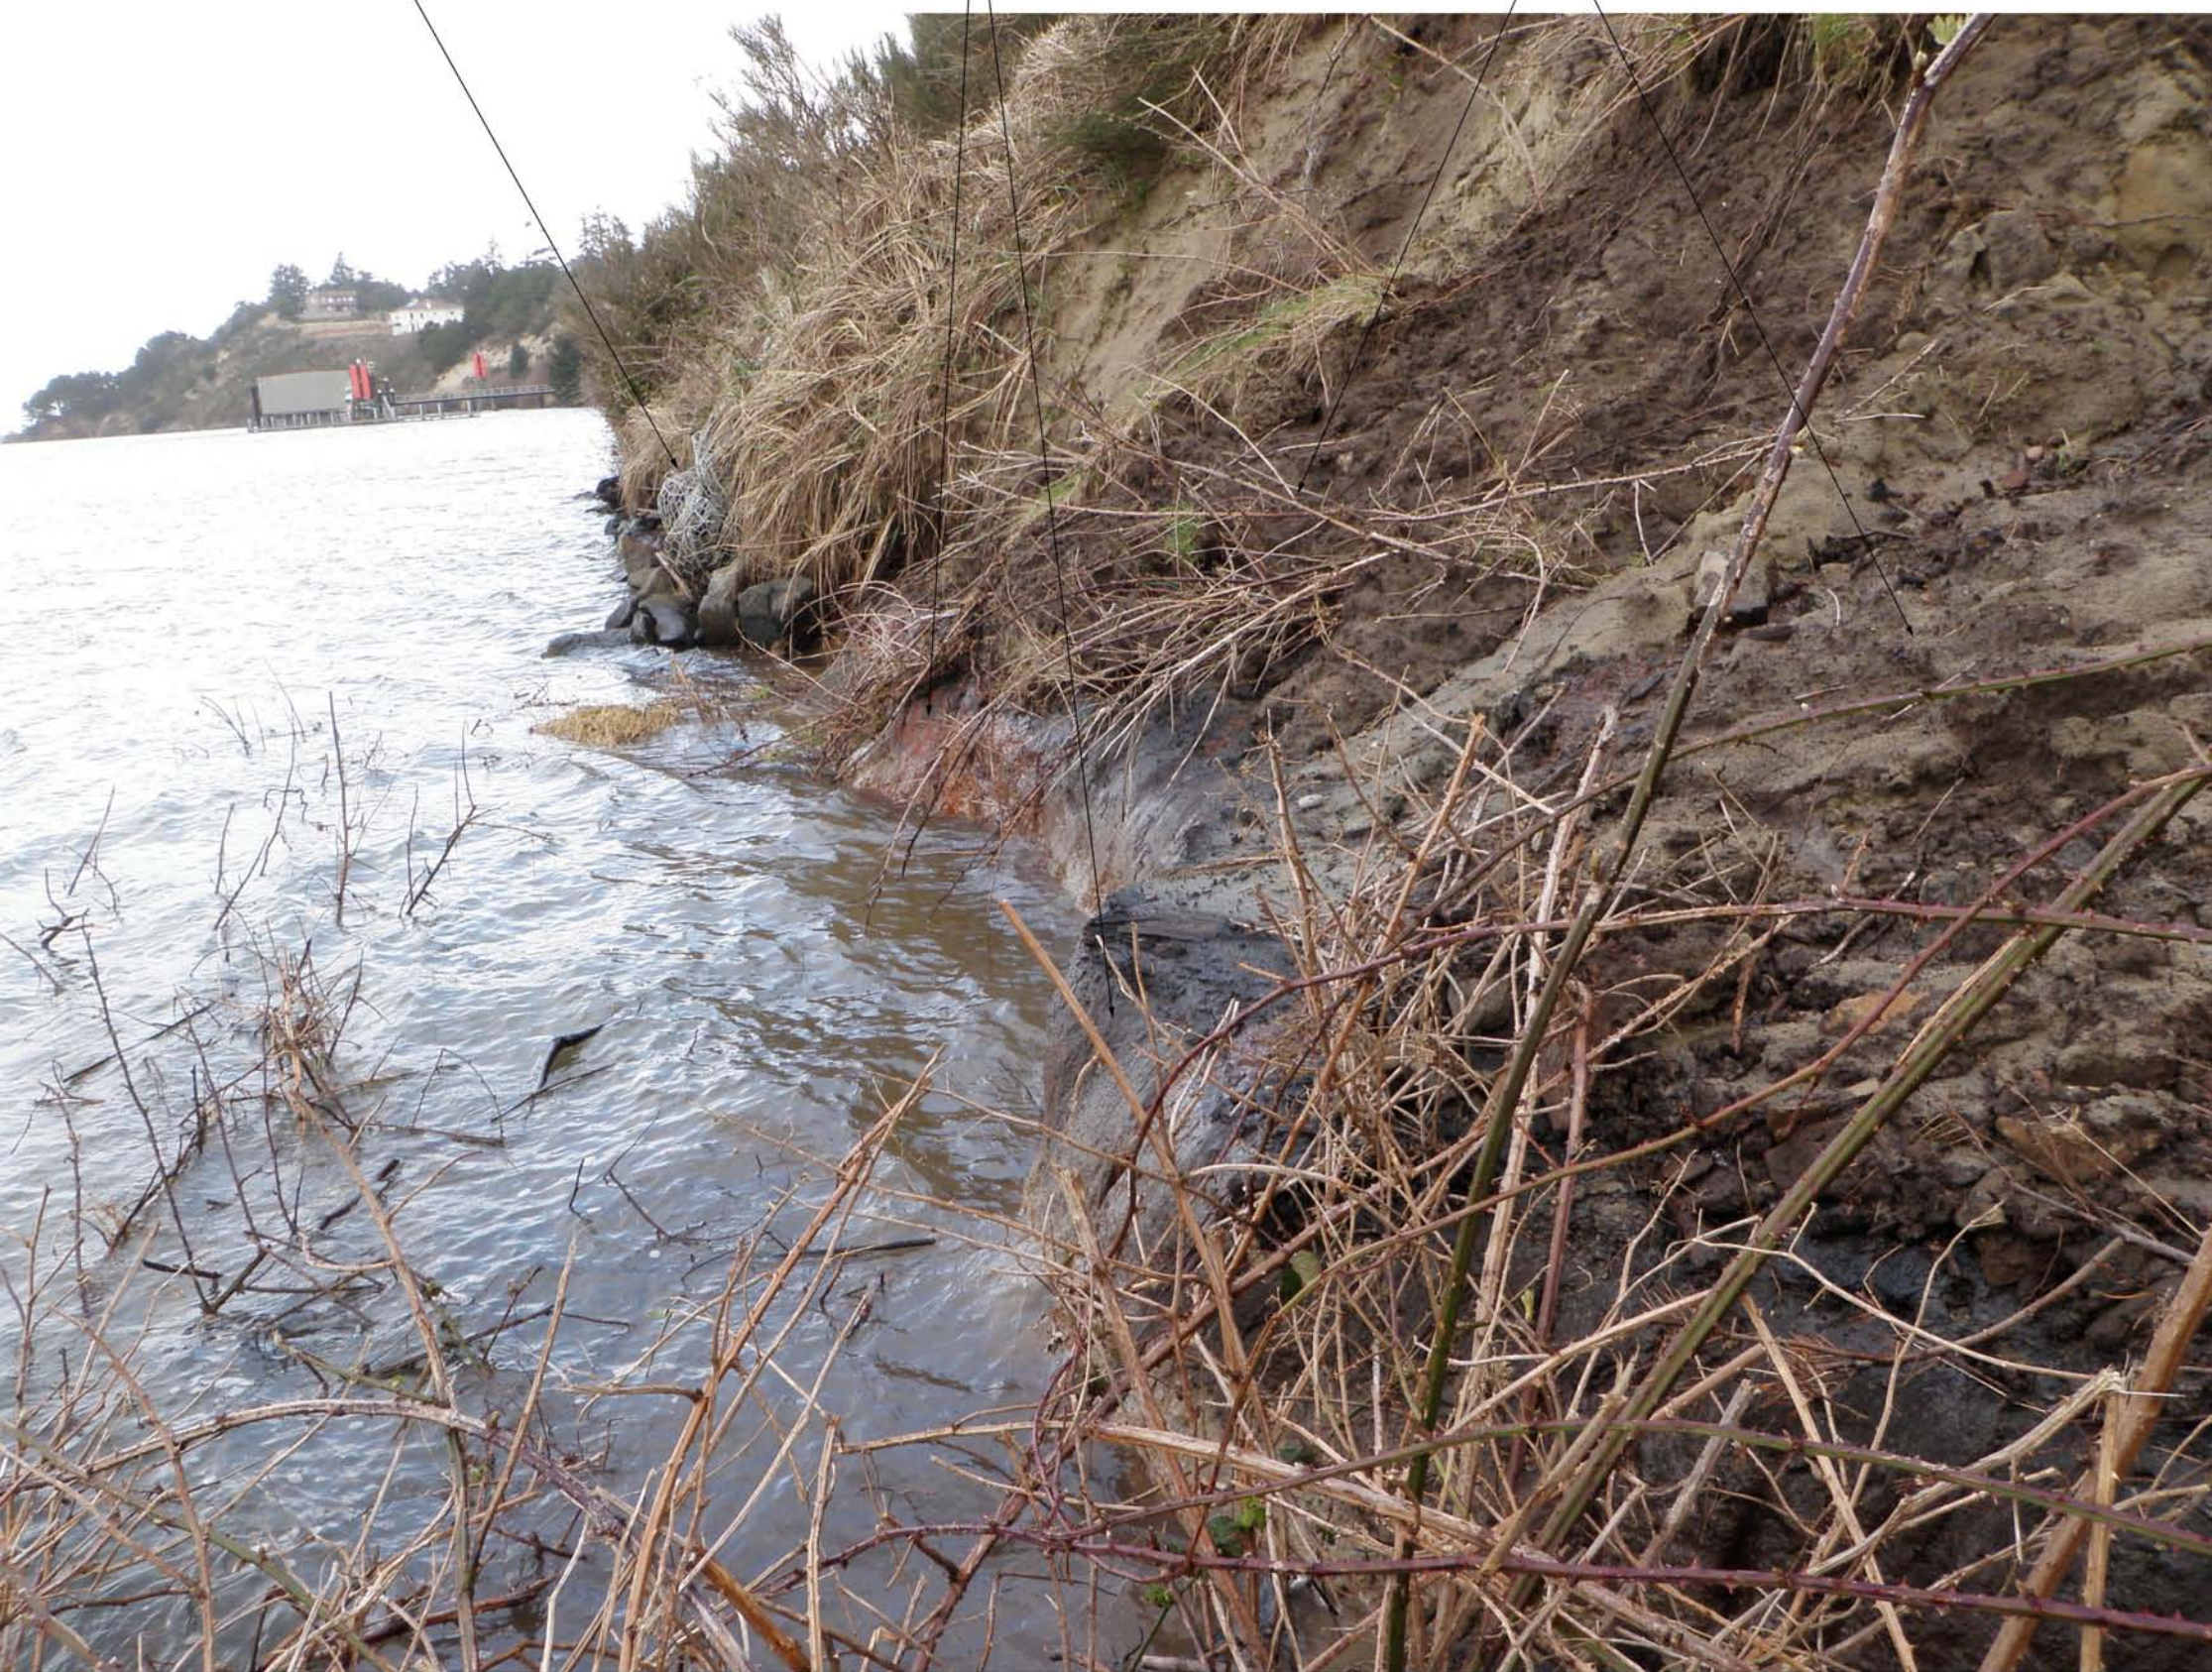
Exposure of MTDs (SU-3) in North Portion of Failure Area. View N

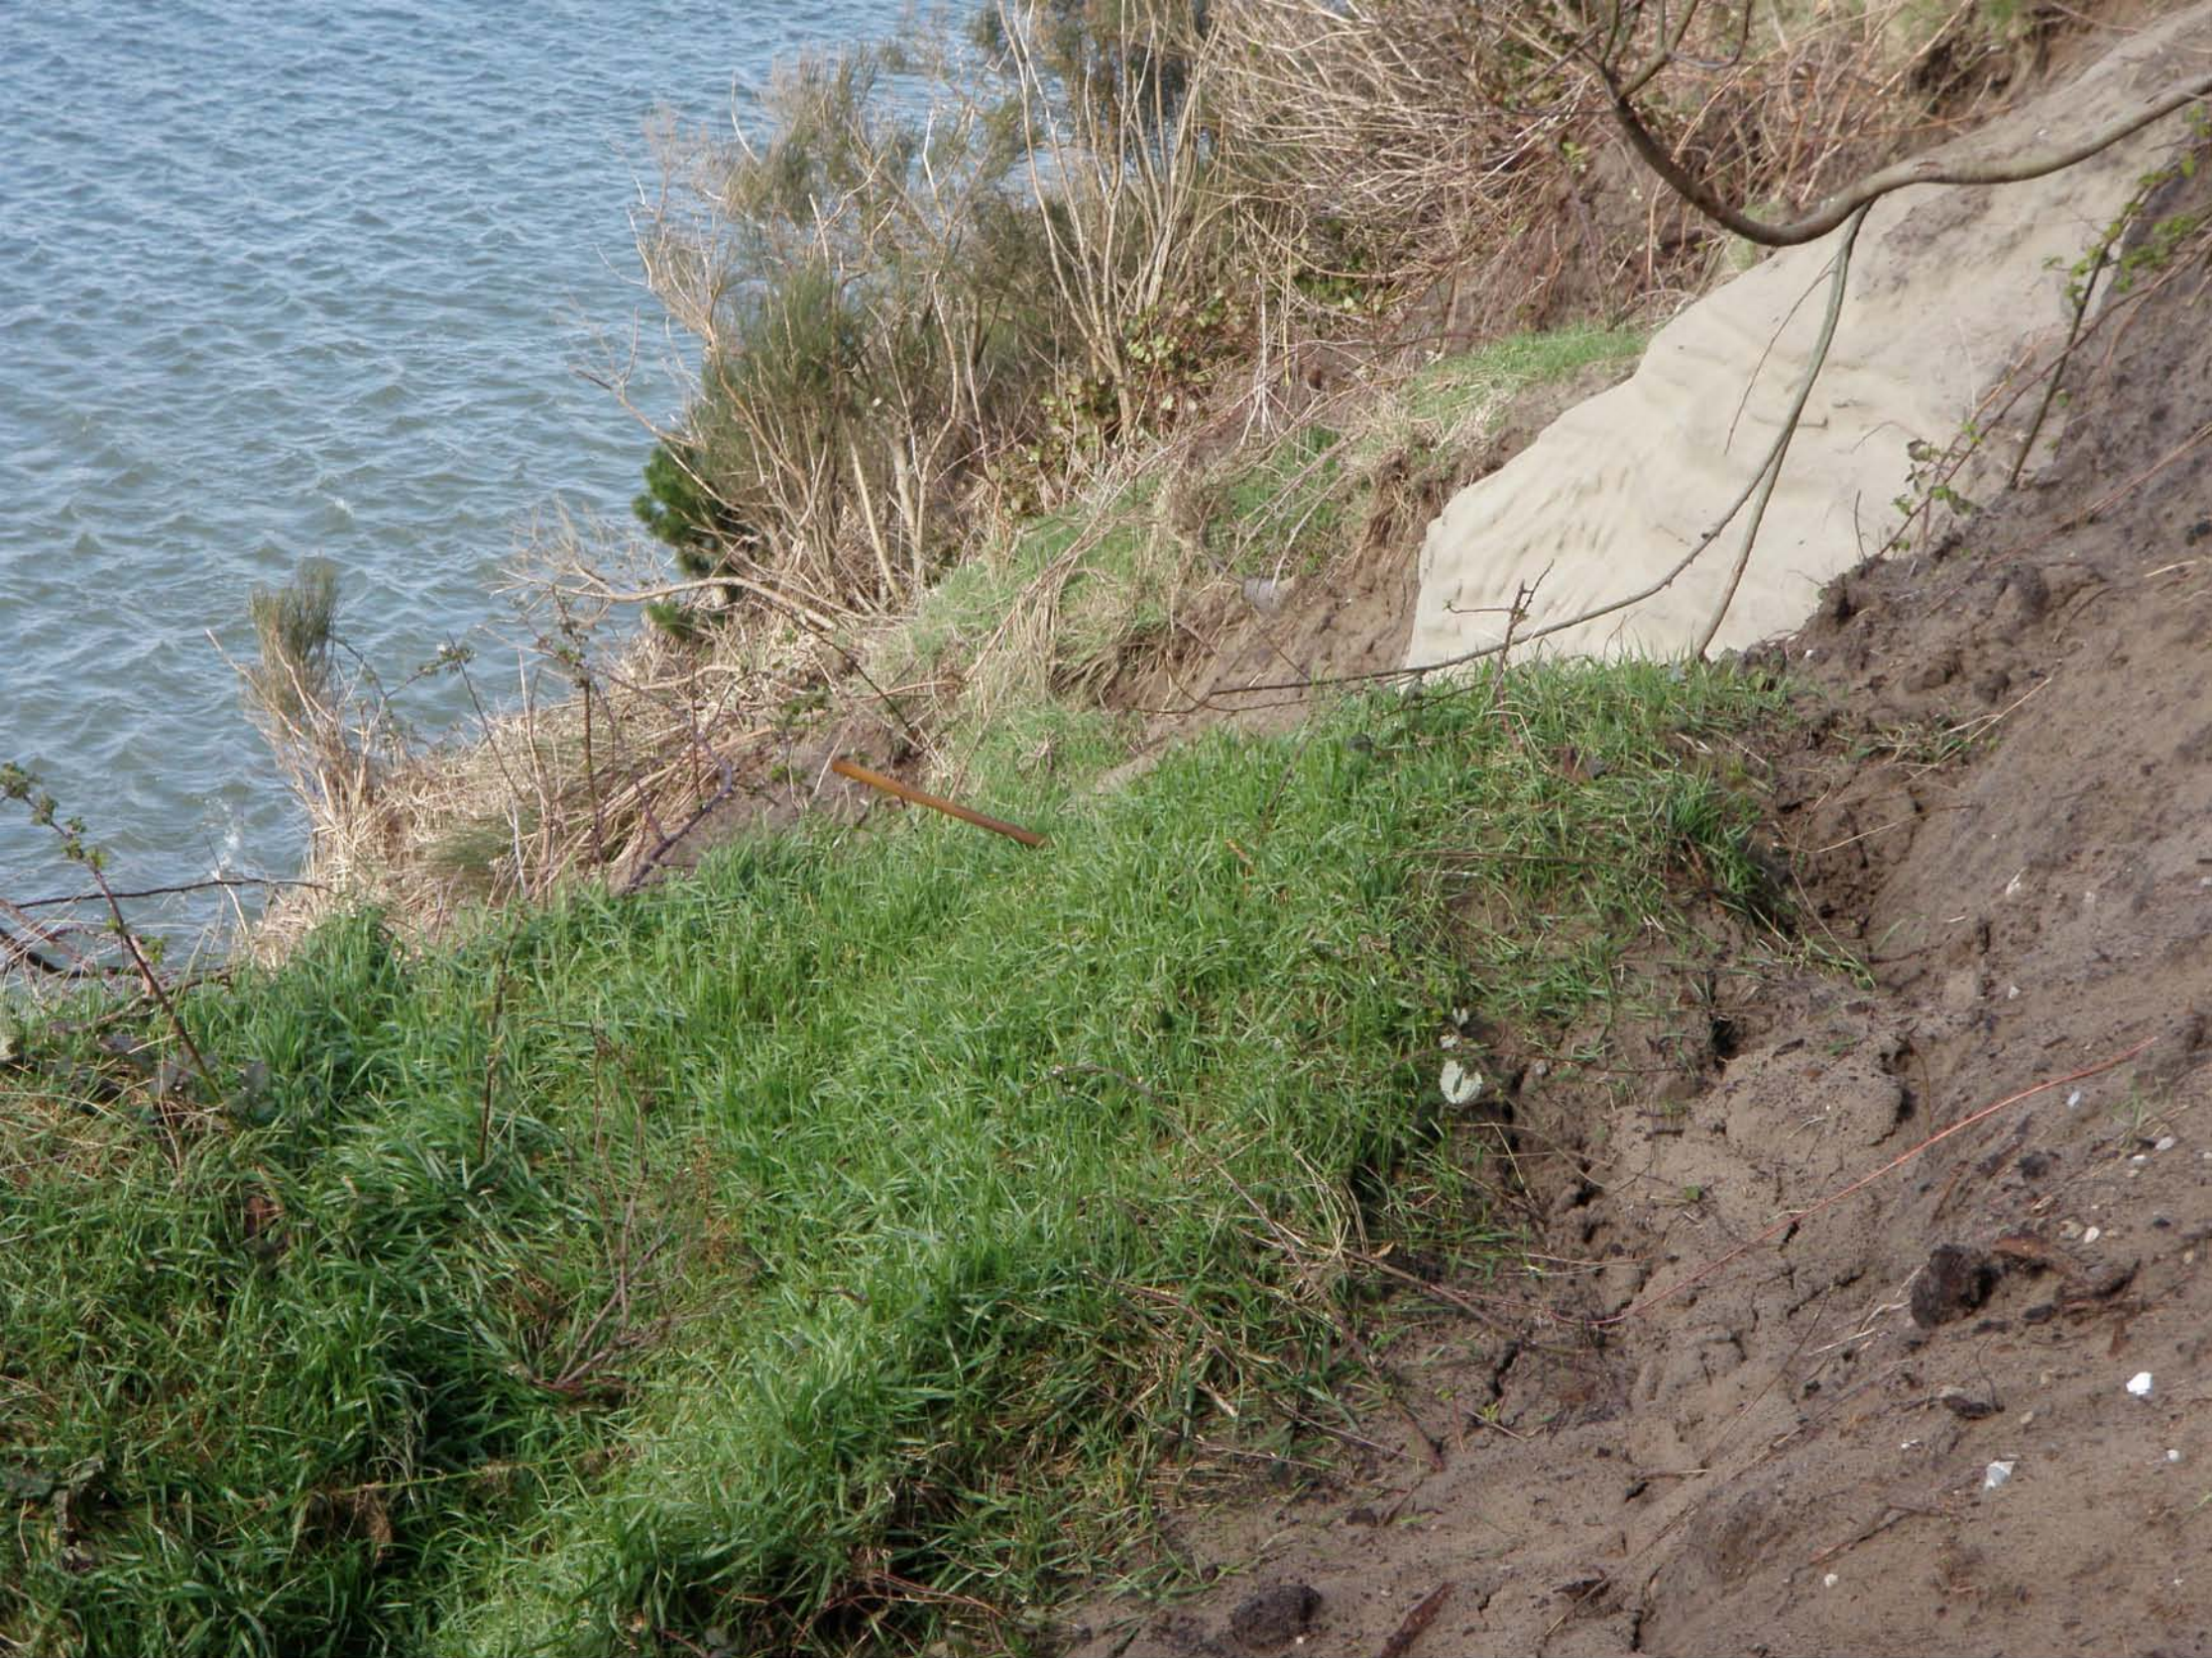
16 Sea Watch Estates, Florence, Bank Failure Assessment/Mitigation
Drive Probe Pipe Rotated from Vertical to Nearly Horizontal by Movement
GeoScience Photo 3/3/2011
