**BANK FAILURE ASSESSMENT
16 Sea Watch Court, Florence, OR**

March 18, 2011

Prepared for:
Patricia and Richard Lukens
16 Sea Watch Court
Florence OR 97439

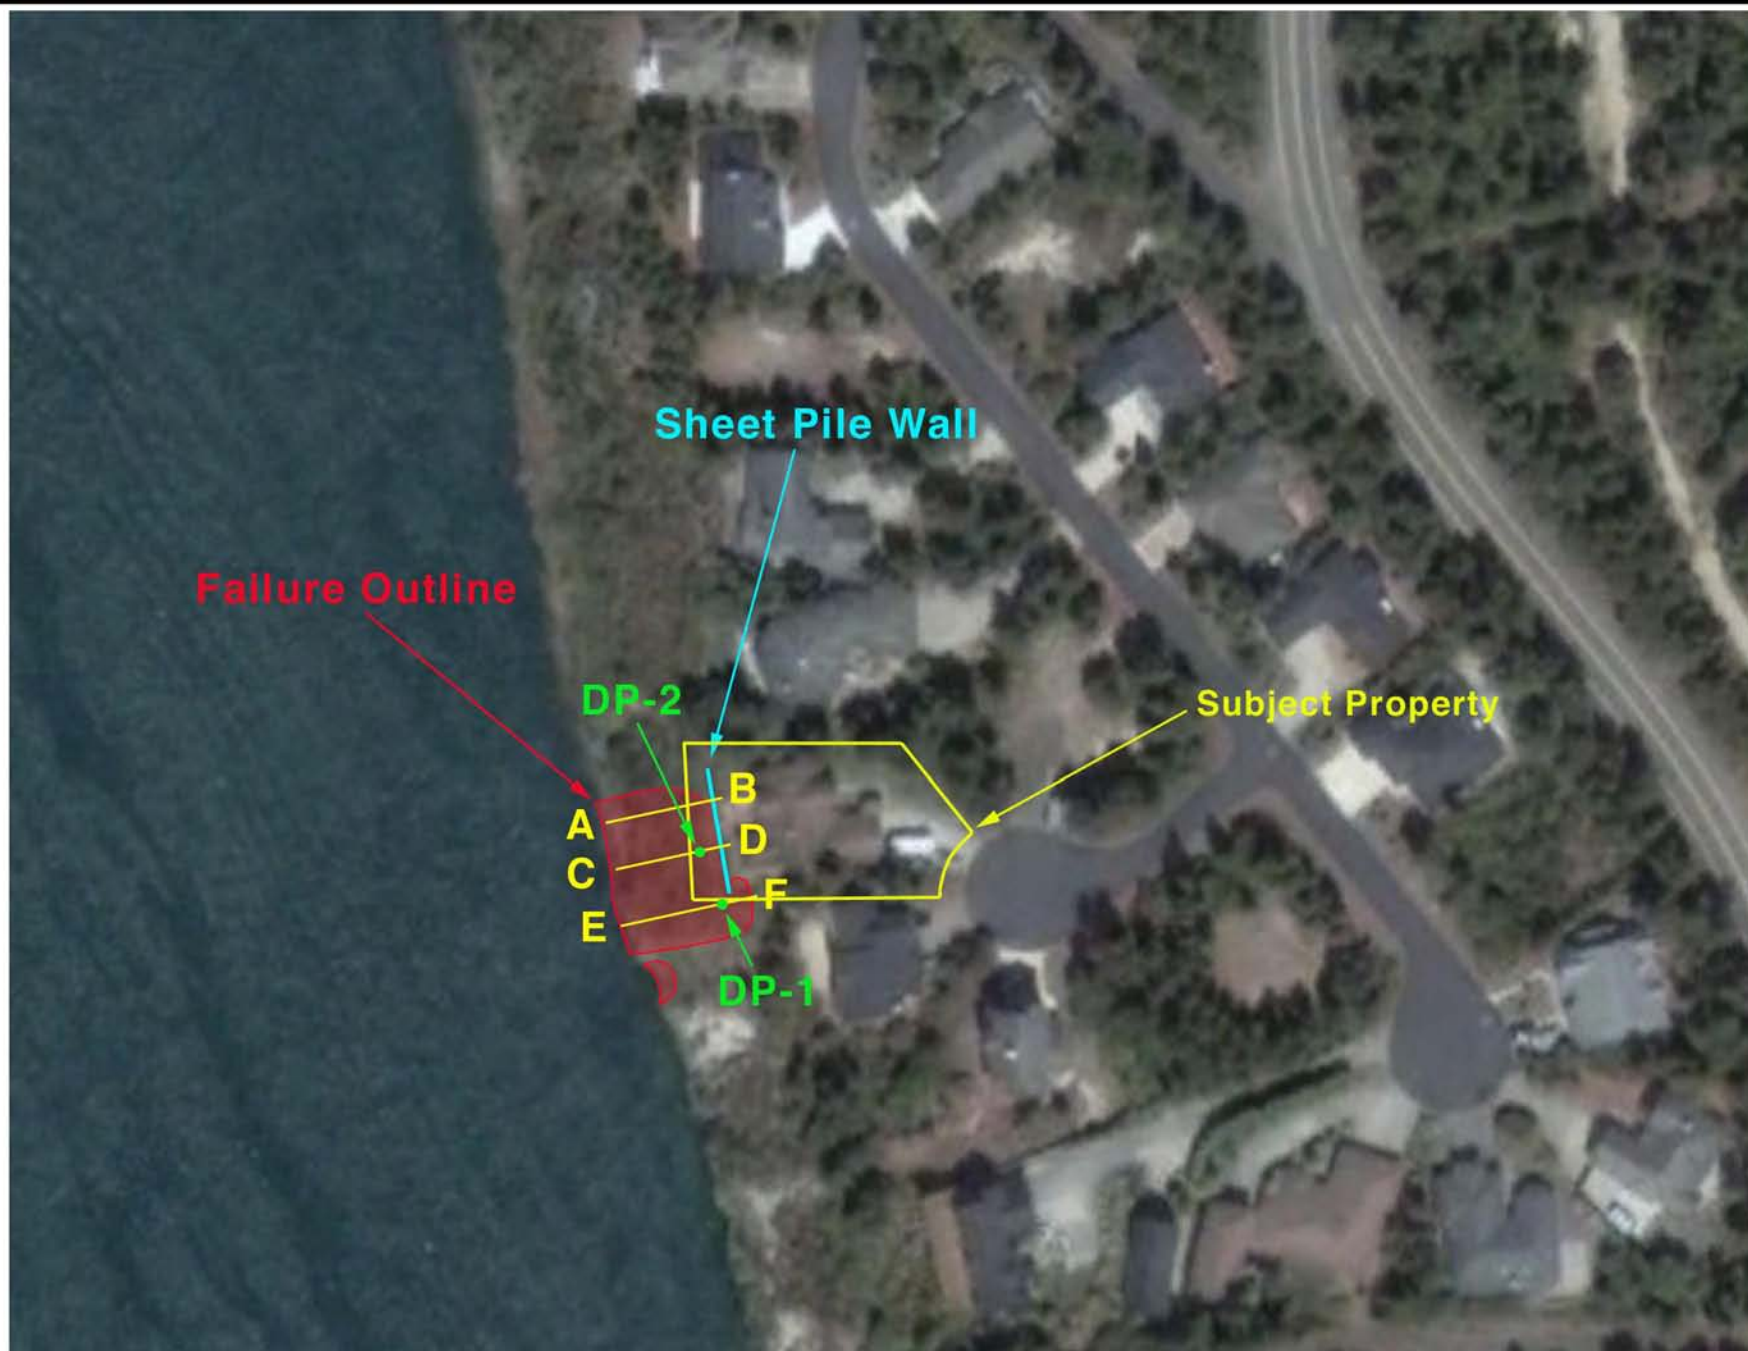
The currently active failure is approximately 80 feet wide (Figure 3) and, for the most part, extends from the steel sheetpile sea wall beyond the low water mark of the bank of the Siuslaw River. At the southern end, the failure extends eastward beyond the edge of the sheetpile wall and is encroaching north toward the house behind the seawall (see site photos, Appendix A). Figures 4, 5, and 6 show the three field-developed geologic cross sections measured at the site. The failure area is underlain by imported organic-rich sand ("root mat") overlying native clean, cross-bedded dune sand, which in turn overlies several older dune forms with variably well-developed paleosol horizons. The lowermost two (exposed) paleo-sol appear to be horizontal to very gently sloping. Another, higher paleosol has significant relief, rising towards the east at angles ranging from approximately 10 degrees to 36 degrees. The lower two paleo-sol form both a "ledge" (lowermost paleosol, designated SU-1, and exposed only at low tide) and a "cliff band" (second-lowest exposed paleosol, designated SU-3, mostly exposed even at ordinary high tide) which ranges in height from approximately 4 feet to as much as 8 feet or more south of the immediate failure area. All paleo-sol consist of former dune sand which is cemented by clay, derived from weathering of feldspar sand grains and, in places, by iron hydroxides (rust), derived from weathering of ferro-magnesian sand grains. Even the better-cemented portions of the material can be easily cut and craved with a pocket knife.
