16 Seawatch Ct., Florence, Bank Failure Mitigation Assessment

Figure 9: Cross Section E-F, Proposed Mitigation

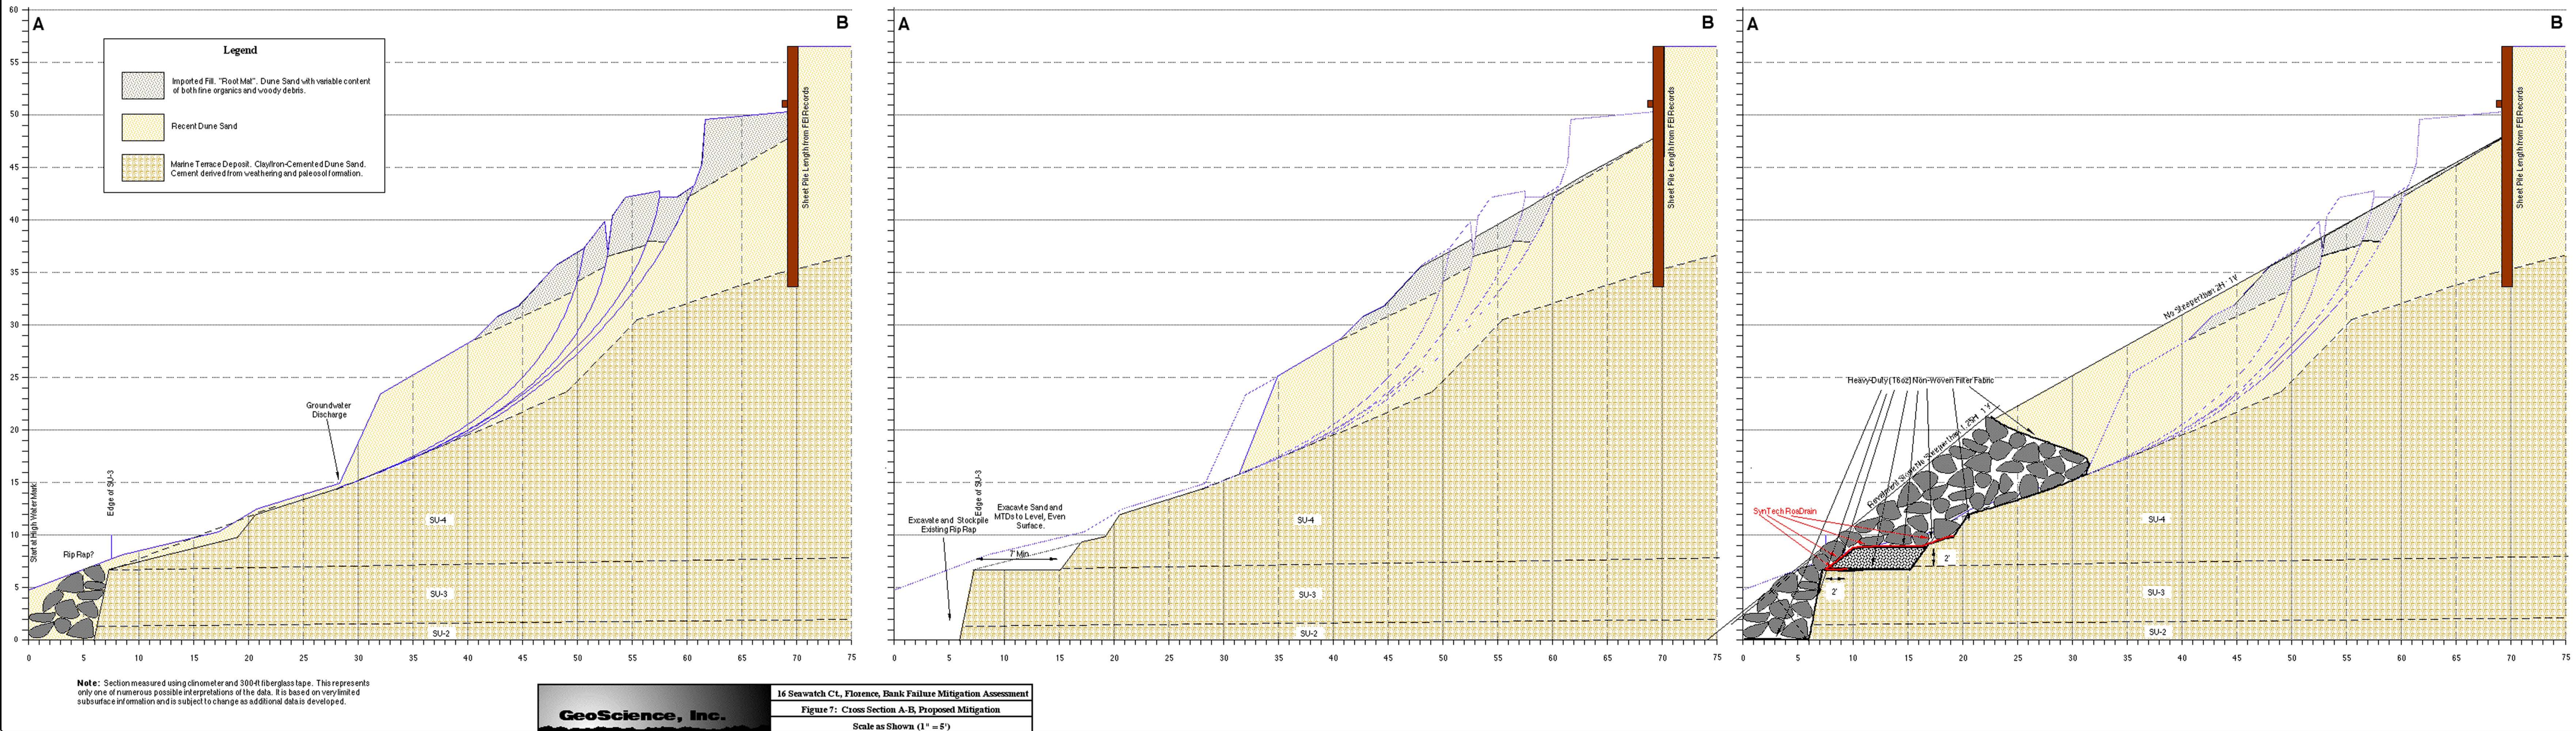
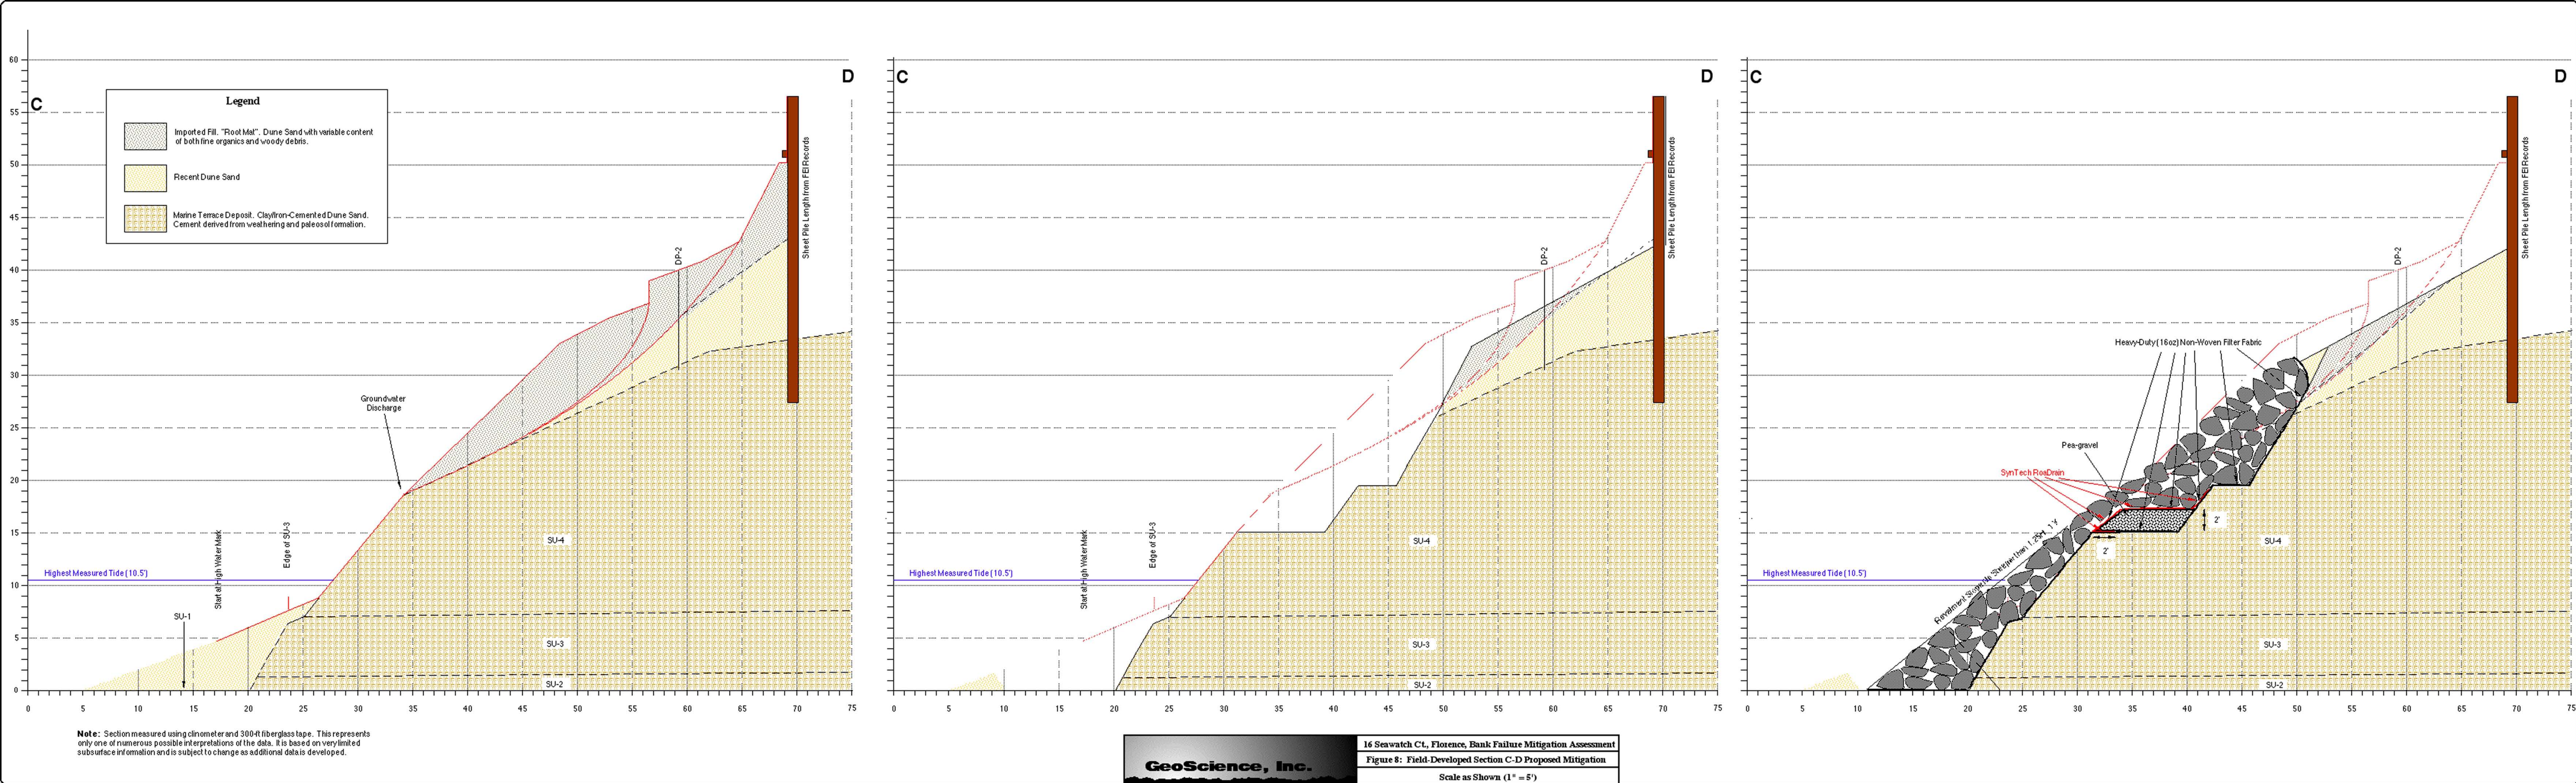
In order to ensure maximum longevity, any mitigation conducted at the site must address all mechanisms of retreat of the bank. This includes retreat of at least the lower two exposed paleo-sol (SU-1 and -3) and the intervening less cemented dune sand layer (SU-2), the erosion of the base of the recent dune sand by discharge of groundwater, and the failures higher on the slope resulting from loss of lateral support at the toe. The proposed typical mitigation is shown on the cross sections on Figures 7 through 9.

The rip rap should then be replaced up the slope at an angle not exceeding 1.25H : 1V (38 degrees), to the height required to have a 2H : 1V slope from the top intercept the sheet pile wall no lower than 15 feet from its top. The filter fabric should then be wrapped over the top portion of the rip rap and the top of the slope can be finished to the sheet pile wall with sand which should be installed no steeper than 2H : 1V.

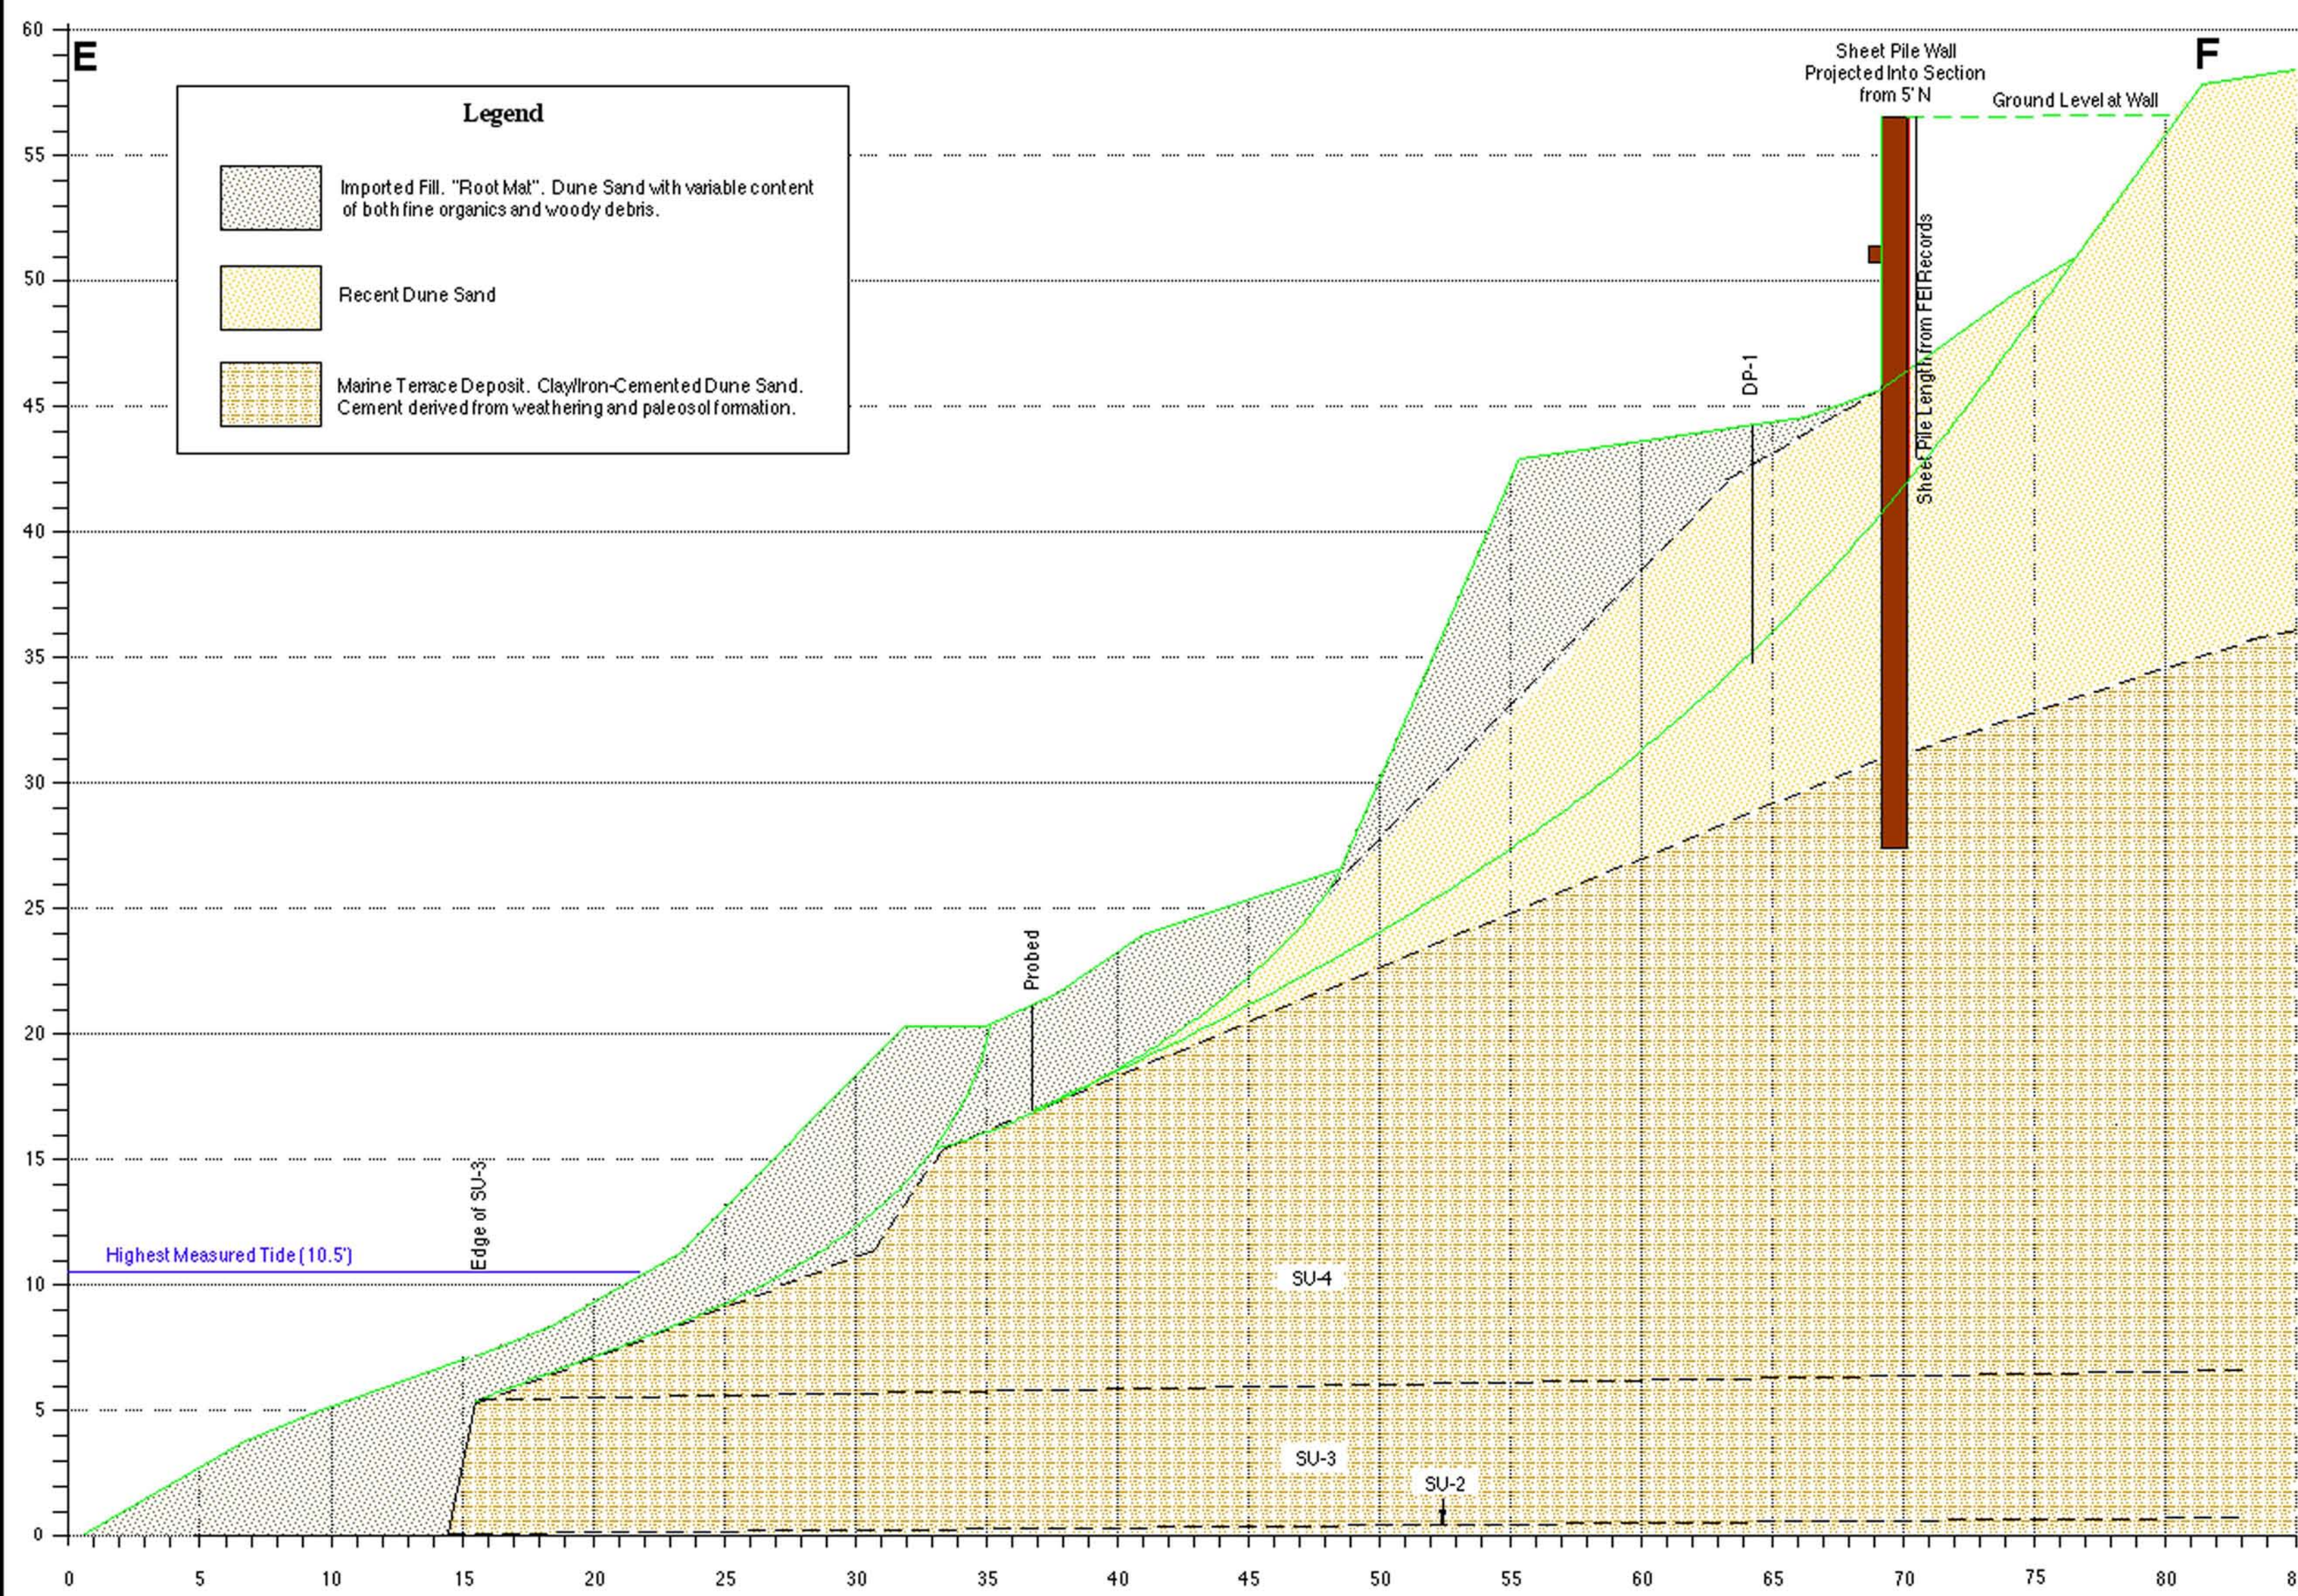
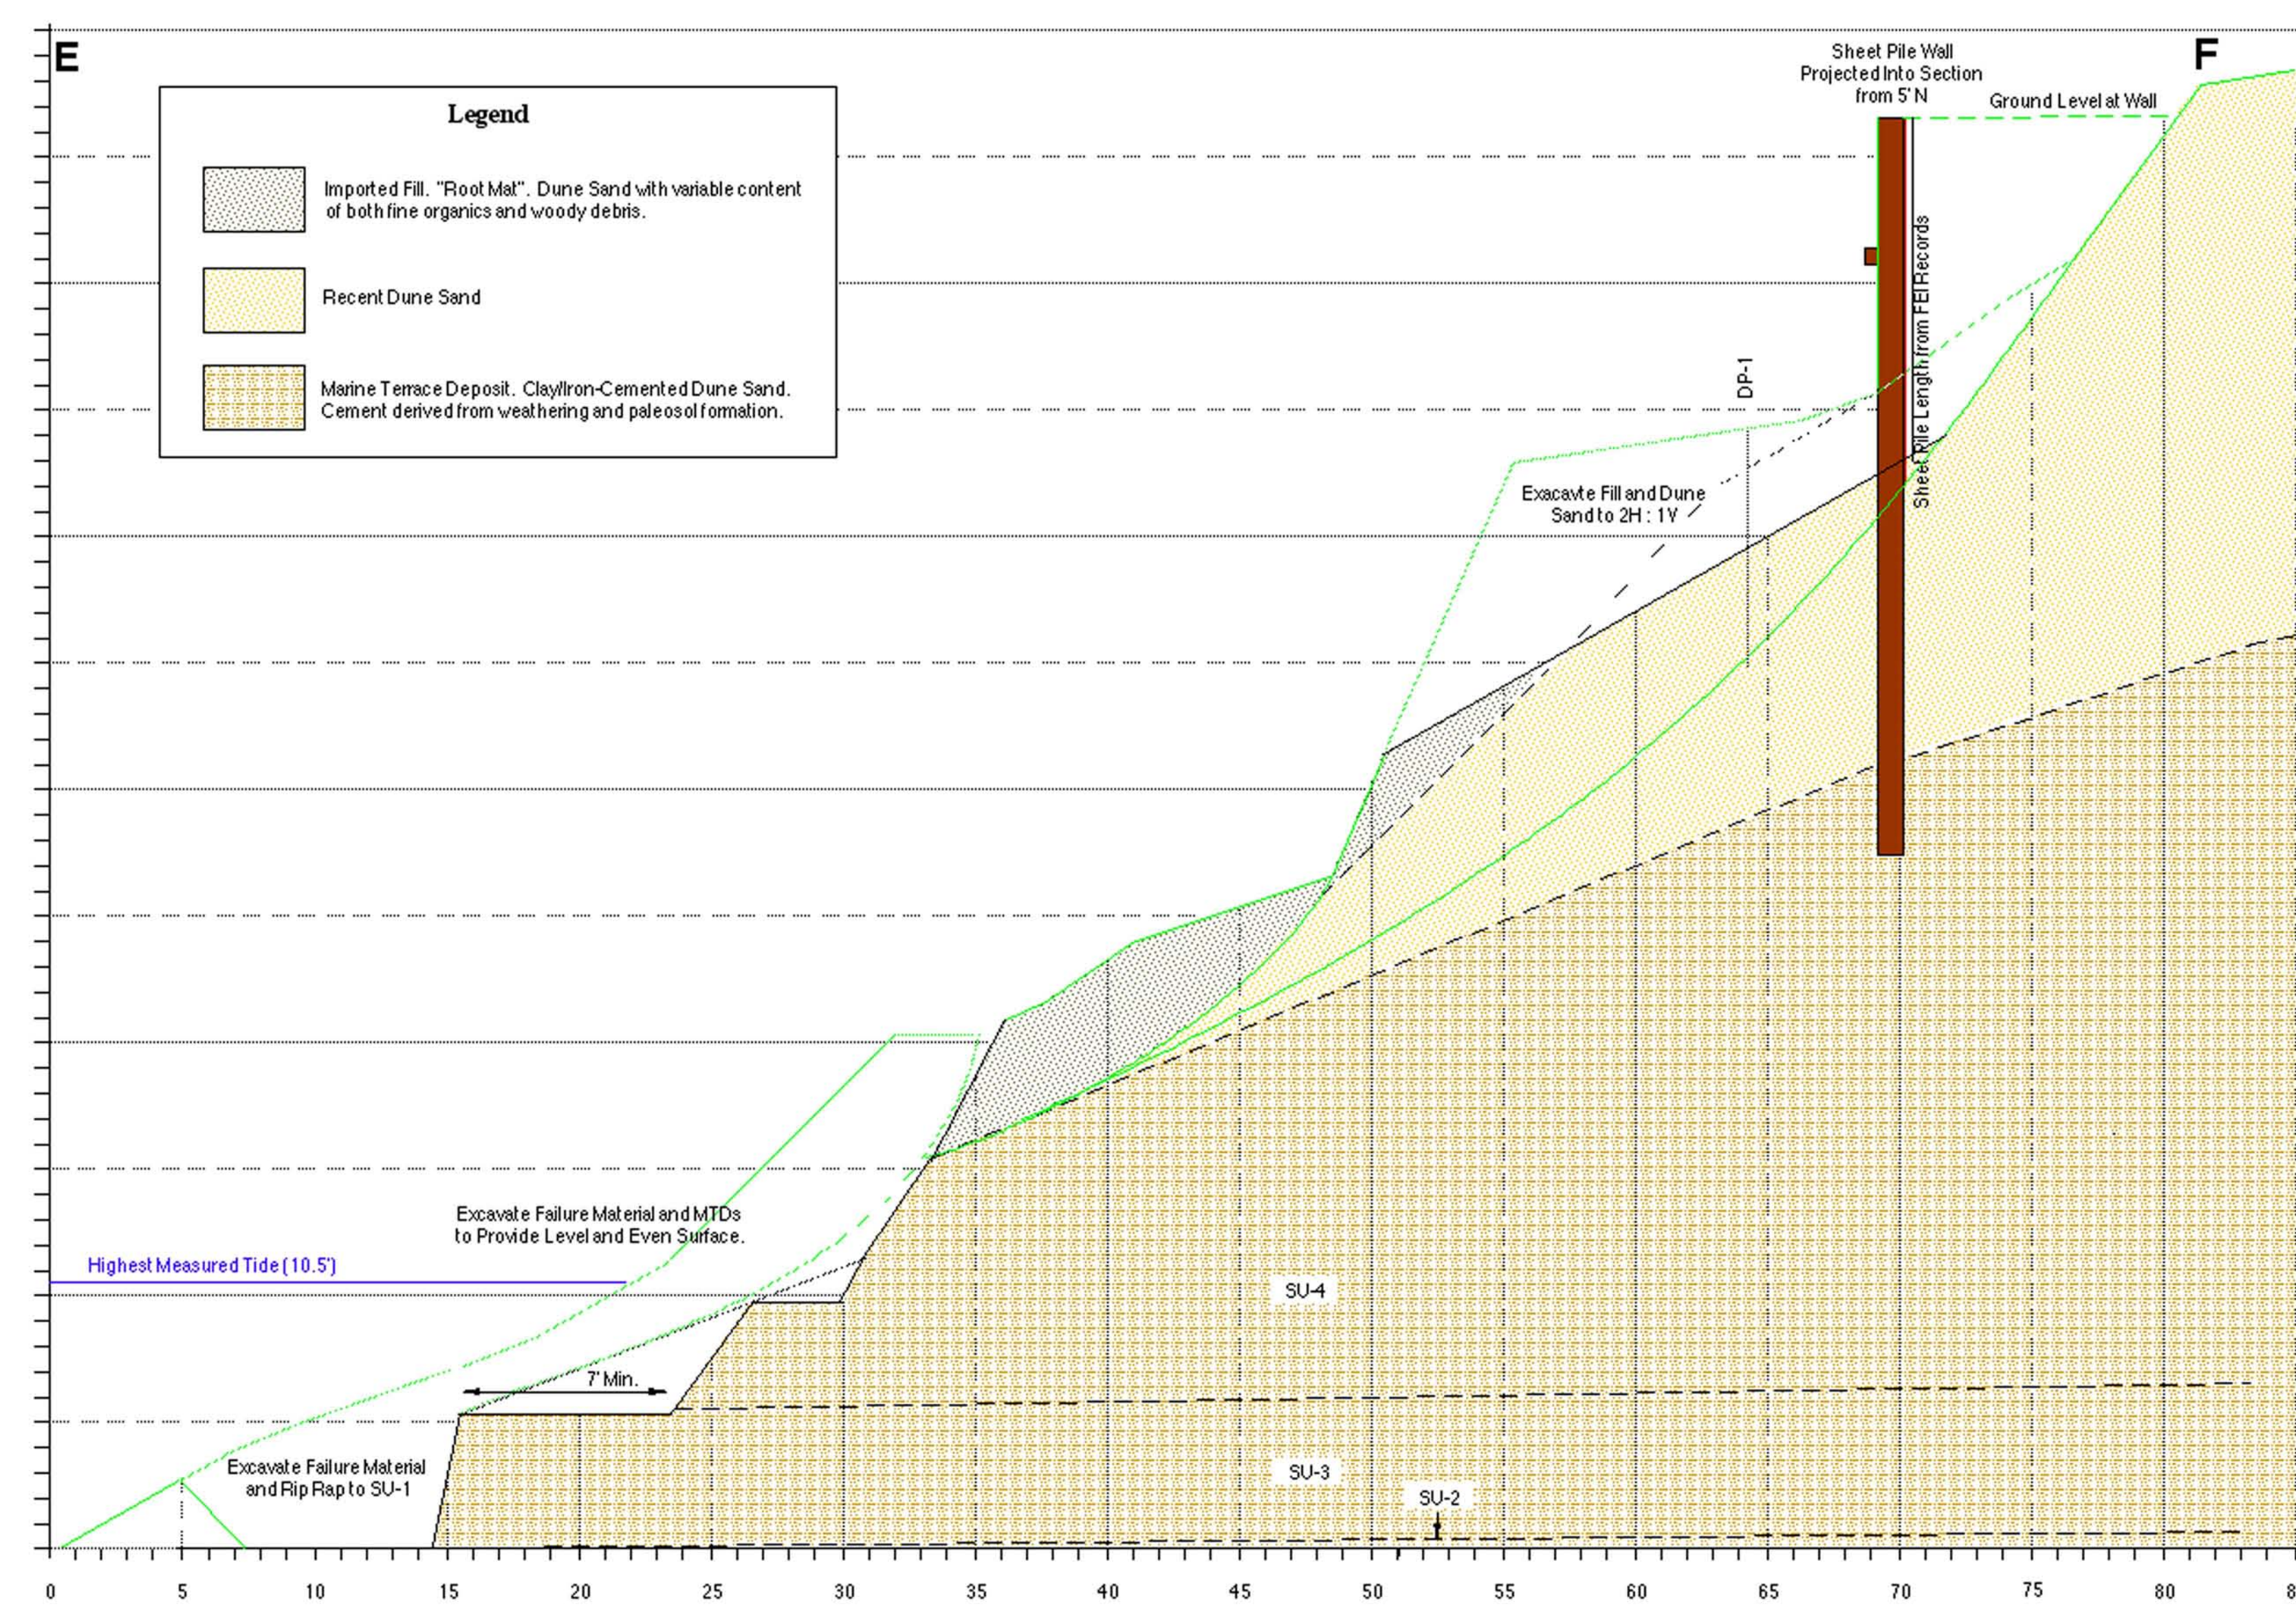
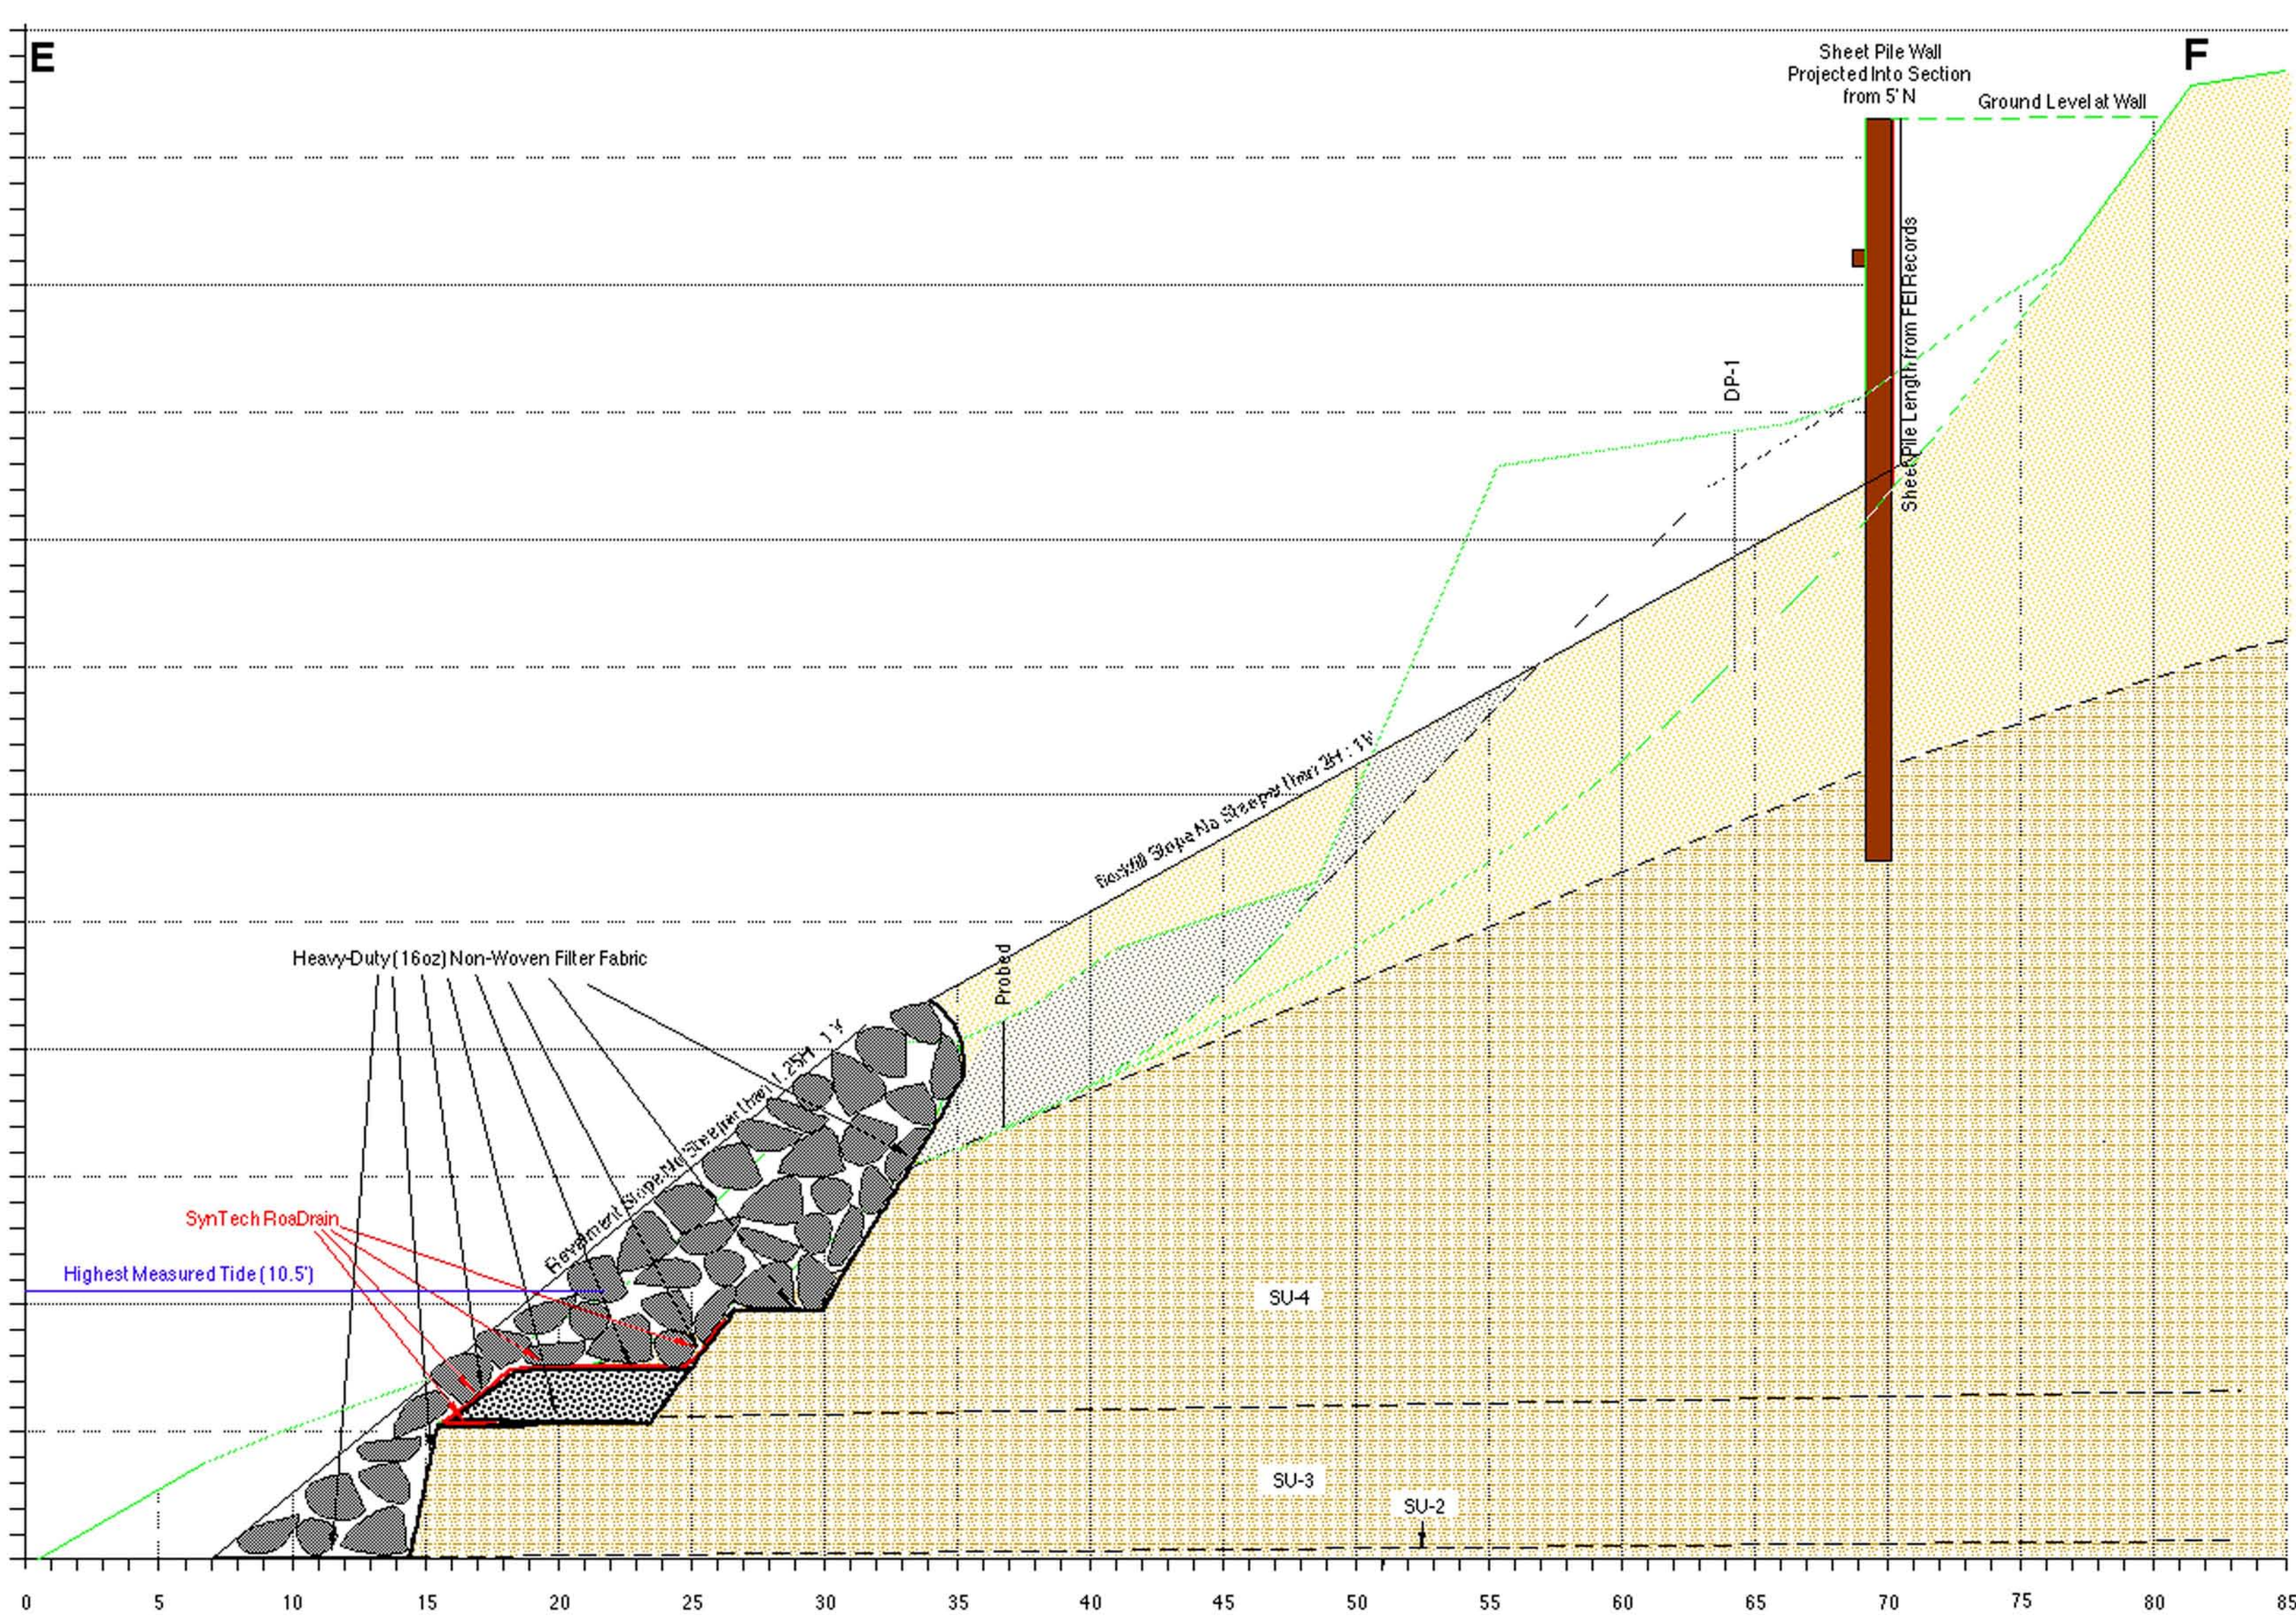
Note: Section measured using clinometer and 300-ft fiberglass tape. This represents only one of numerous possible interpretations of the data. It is based on very limited subsurface information and is subject to change as additional data is developed.
