A Resolution Approving the Florence Stormwater Master Plan Update, dated December 2018, including the Capital Improvement Plan in support of the Florence Realization 2020 Comprehensive Plan and Repealing Resolution No. 8, Series 2004.

STORM WATER MASTER PLAN UPDATE

DECEMBER 2018

Civil West

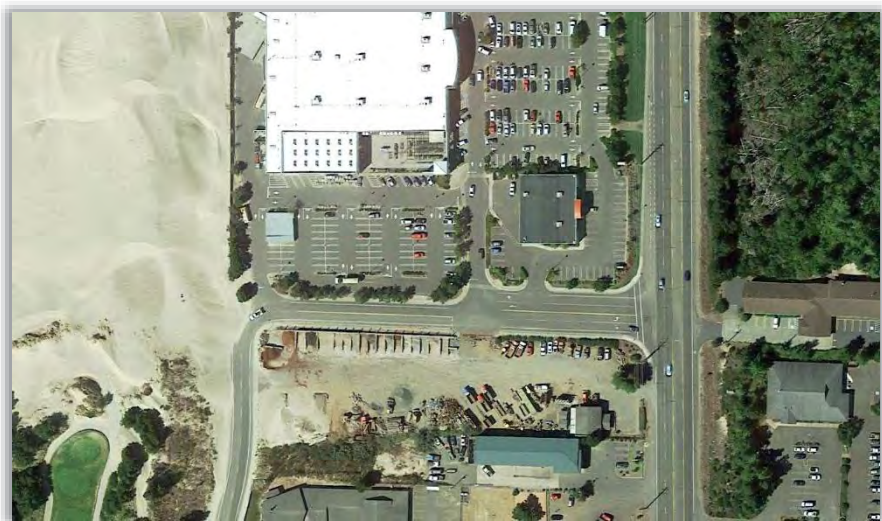
Another challenge to the drainage of 46th Street is presented by the sand dune that exists immediately west of Fred Meyer (see Figure 4-5). The wind blows sand from the dunes onto 46th Street and Oak Street, with virtually no obstructions. This causes the drainage infrastructure to become silted in, thus decreasing its effectiveness.

Figure 4-5 - Sand dune west of Fred Meyer blows onto 46th Street

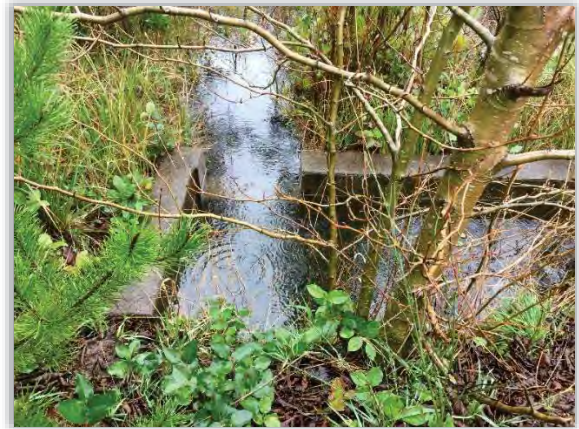
On the east side of Spruce Street, the existing concrete detention basins/ weirs are intended to combine storm water management with road-side aesthetics. These structures have been effective in controlling the flow and improving water quality in the swale toward Munsel Lake Road to the south. In the case of the weir directly east of the Siefert Ditch, City crews have cut a notch in the wall of the weir to lower the discharge elevation of that water quality basin below the grate elevation of the catch basin installed by the City on the southeast corner of Tax Lot #300 (see Figure 4-9).

Figure 4-9 - Make-shift Orifice

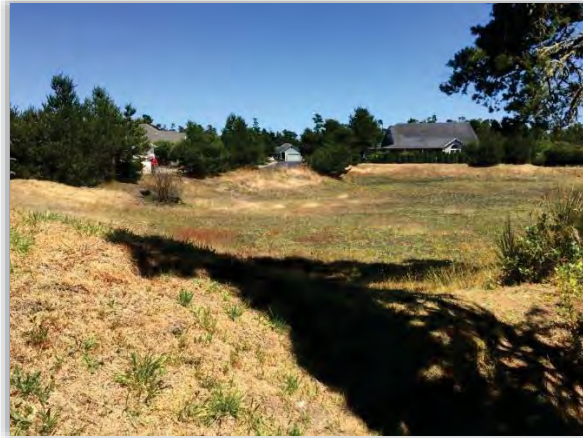
Figure 4-14 - Tax Lot #4600 used for infiltration becomes a seasonal wetland in winter months

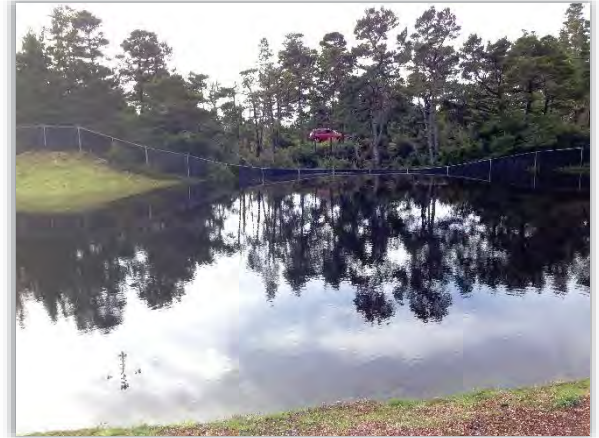
Figure 4-17 - Lot #4600 flooded. A car can be seen driving by on Rhododendron Drive.

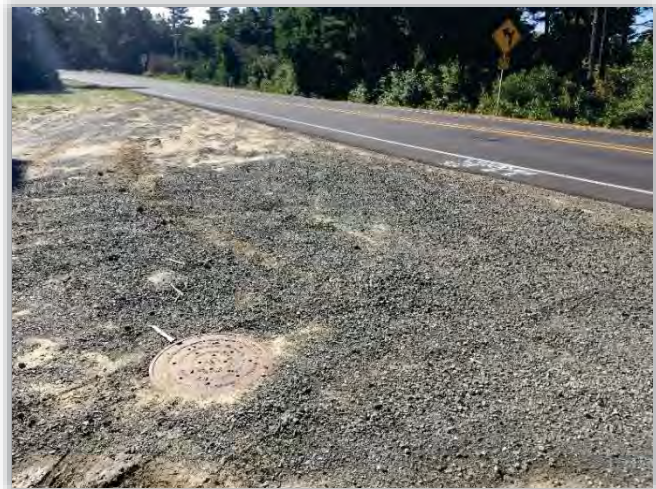
Figure 4-19 – Flow control manhole w/ no outfall constructed yet

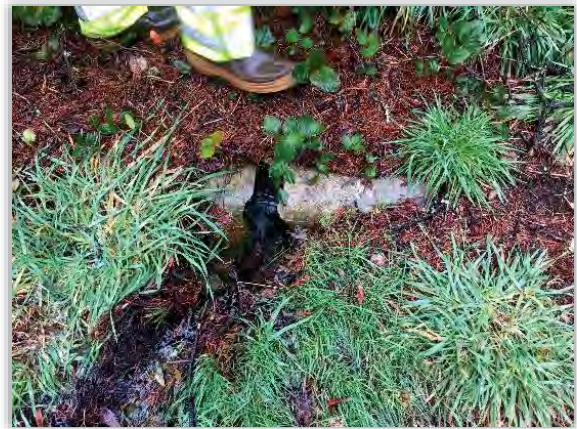
Because this pipe network is not allowed to discharge, the entire system has been observed to backup and overflow onto City streets. As a temporary fix, the 10-inch transite pipe between 29th Street and 28th Street has been exposed and broken open to allow water to drain into the undeveloped right-of-way (see Figure 4-20).

Figure 4-20 - Intentional break in 10" transite pipe for drainage

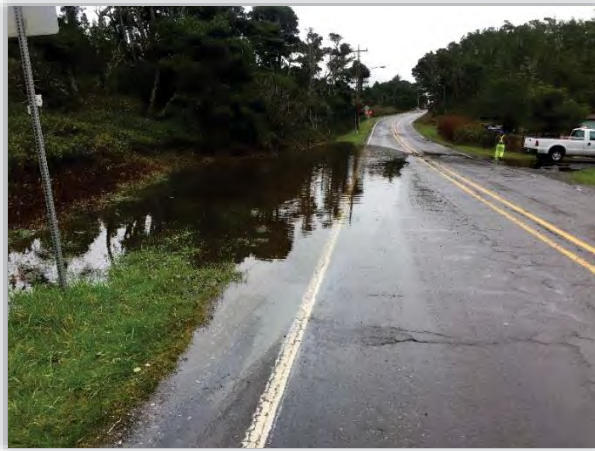
In the 2016-2017 wet season, flood waters had risen to a point where the north-bound lane of Rhododendron Drive was under water. This can be seen in Figure 4-23.

Figure 4-23 - Flooding on Rhododendron Drive

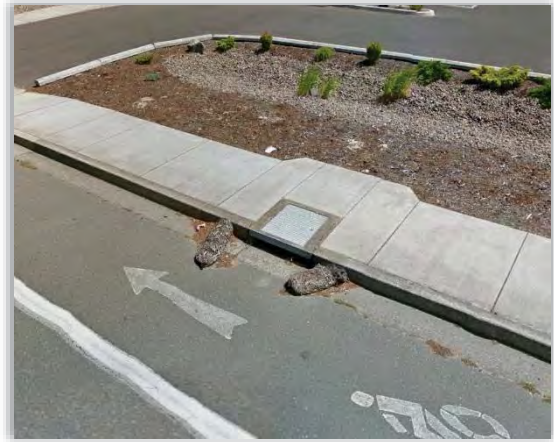
Figure 4-27 also shows that biorolls have been placed in the gutter surrounding the curb inlet. This is an erosion control measure that the City has used to slow the collection of pine needles in the curb inlet, but this solution has been shown to be temporary in nature and is insufficient, particularly during peak flow conditions.

Figure 4-27 - Biorolls placed by curb inlet

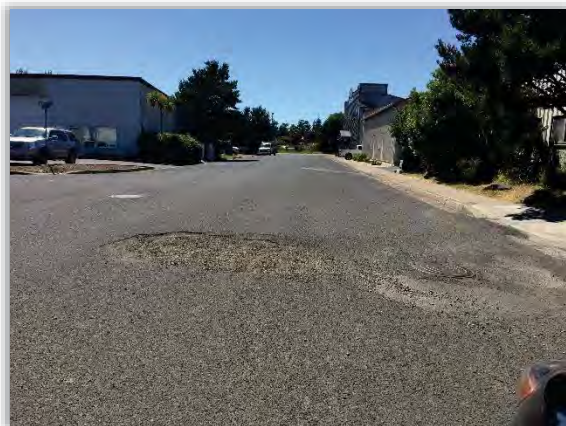
Sinkholes are an indicator that substantial deterioration has occurred in the underground pipe network. City records confirm that the 18-inch corrugated metal pipe (CMP) which is meant to convey storm water from 18th Street, Laurel Way, and 17th Place to the south along Kingwood Street, has indeed failed. As a result, storm water that would be contained within this pipe escapes, undermining the road above.

Figure 4-28 - Sinkhole on 18th St. caused by failed storm pipe

1. The 18-inch CMP drainage main has deteriorated and needs to be replaced.
2. Deteriorated pipes have caused the roadway to be damaged, requiring repair of the storm water infrastructure, and restorative improvements to the roadway.
3. There is excessive debris (pine needles) entering the pipe network at this location. Preventative measures should be included in any improvements to the drainage network in this area.

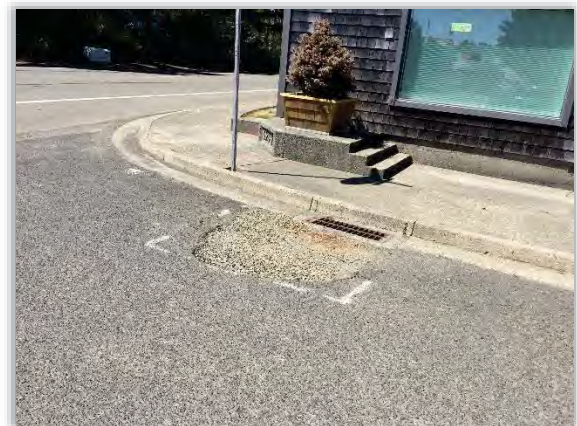
Figure 4-29 - Sinkhole on 18th St. caused by failed storm pipe

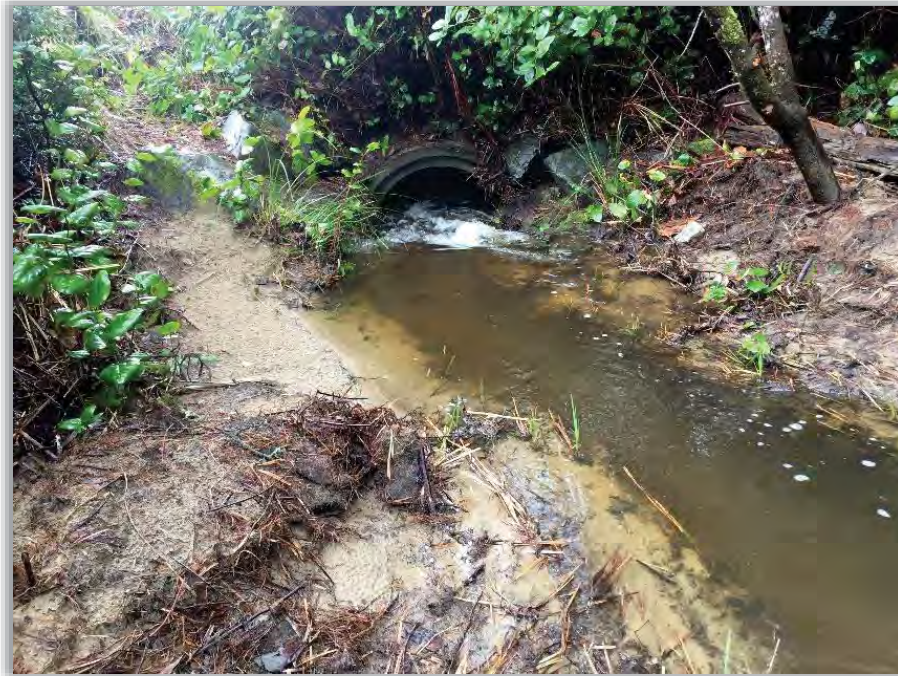
the culvert pipe. This is problematic considering the drainage issues we have just described for the Seabrook Townhomes. Lack of sufficient capacity in the culvert may cause the ditch to backup and overflow on to the property of the townhomes. However, with a thorough cleaning, and control of incoming sediment, it is likely that the culvert will perform as needed.

Figure 4-35 - 42-inch concrete culvert inlet, heavy sedimentation, evidence of exceeded capacity

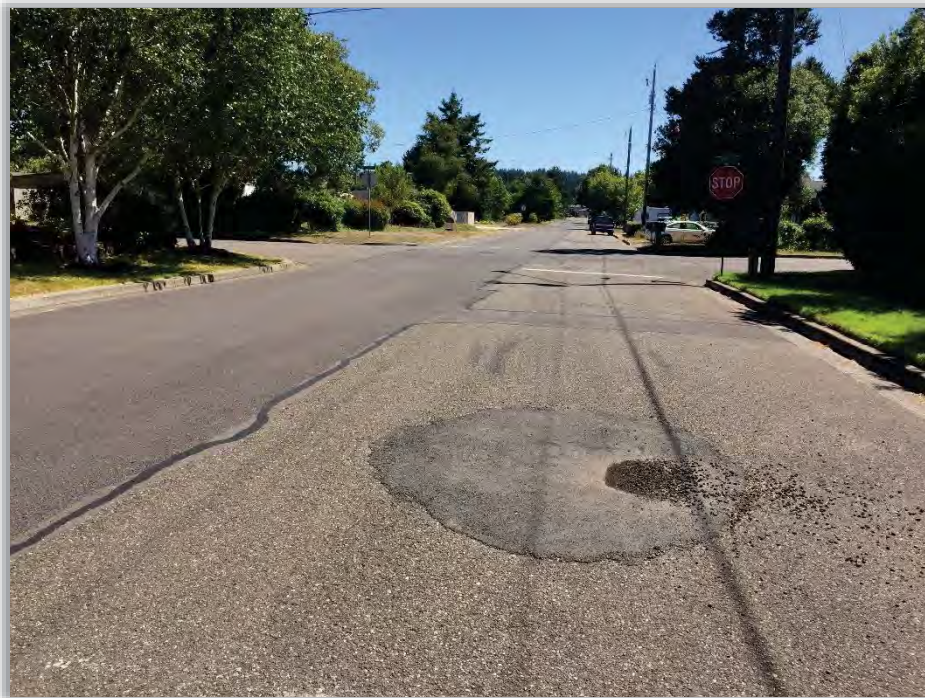
At the intersection of 6th Street and Ivy Street, a storm water manhole is connected to an influent 24-inch PVC pipe, from the north. Just upstream of the manhole connection, the PVC pipe is coupled to an older Concrete pipe of the same diameter. Upstream from here, at the intersection of 7th and Ivy, the pipe increases size to 30-inches. These two pipes, along with the connected catch basin and curb inlet runs have deteriorated to the point of failure. As shown in Figure 4-38, sinkholes have begun to form in the roadway, along the alignment of the storm water system.

Figure 4-38 - Sinkholes forming directly above drainage lines. Evidence of pipe failure.

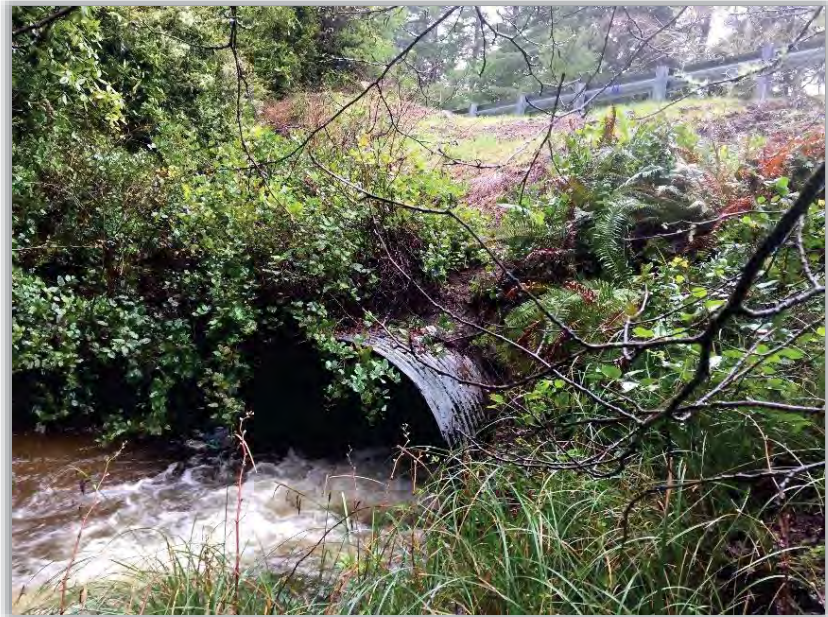
Currently, the creek passes underneath Spruce Street via a single 84-inch corrugated metal culvert, which is shown in Figure 5-1. Field inspection of this culvert revealed that the corrugated metal pipe is severely dislocated in multiple locations (Figure 5-4), and the wall of the pipe has experienced significant corrosion (Figure 5-3). The factory treatment of coal-tar epoxy applied to the interior of the pipe wall has eroded away, leaving the pipe exposed to environmental degradation.

Figure 5-1 - 84-inch CMP culvert, outlet side, looking NE

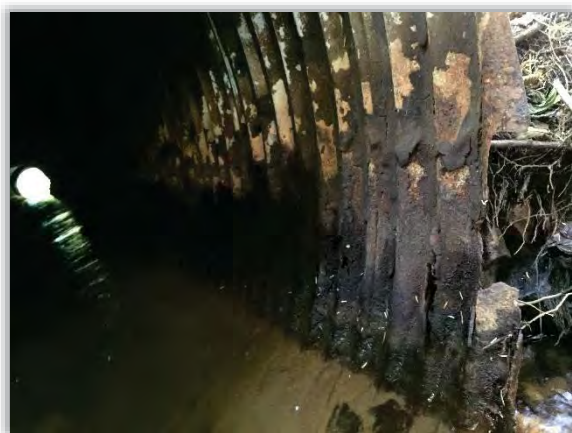
Figure 5-4 also shows that the pipe has experienced deformation under the load of the road above. When combined with the evidence of severe corrosion and dramatic dislocations, this culvert should be considered unsafe for entry by maintenance personnel.

Figure 5-2 – Deteriorated factory coating

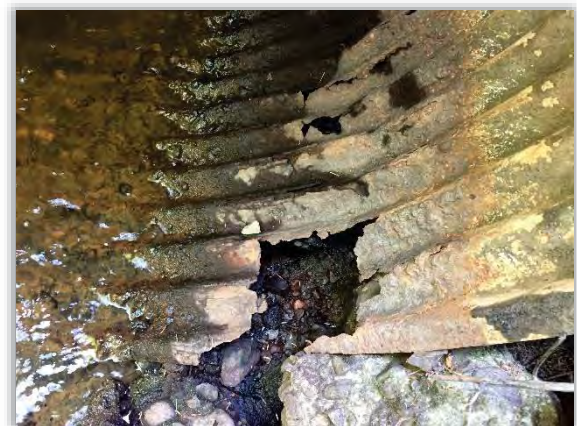
Figure 5-3 - Evidence of severe corrosion in pipe wall

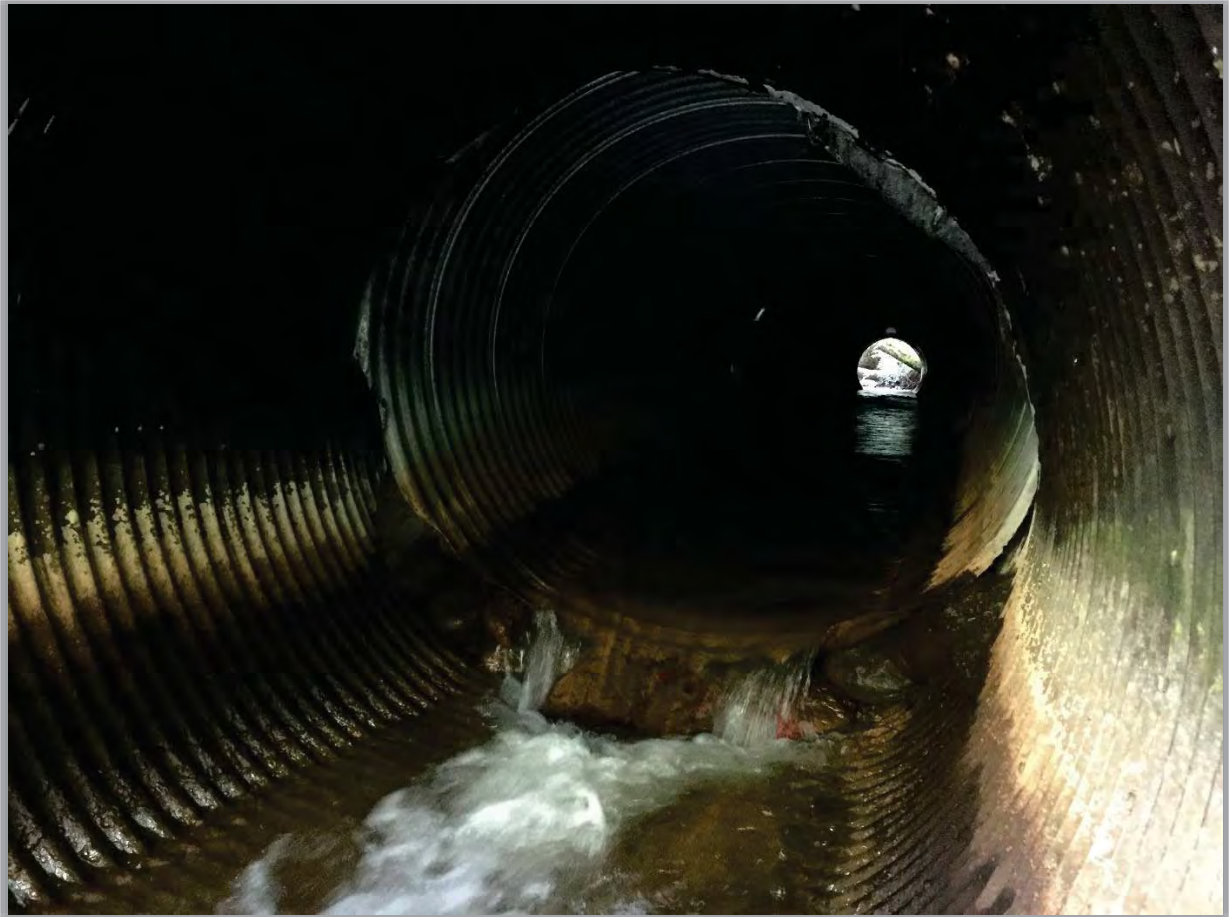
Wet-season observation of this culvert suggests that it has adequate capacity but may experience flows of up to two-thirds its capacity. Any design to replace this culvert should include a formal capacity analysis to verify that flow is not impeded at this location, particularly due to the number of systems upstream which rely on this crossing.

Figure 5-4 - 84-inch CMP culvert; Severe dislocations and significant deformation of pipe under roadway load. The forefront dislocation shown in this photograph is the location where a repair was completed on this culvert in 2011.

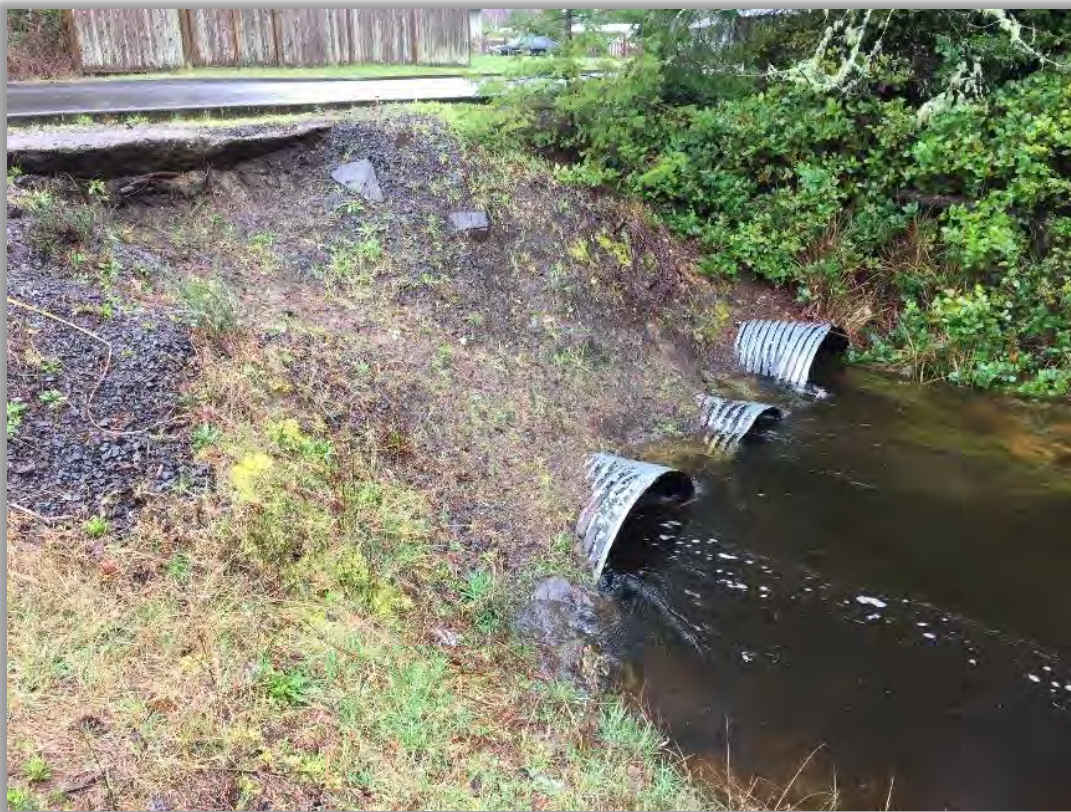
Figure 5-8 - Three 42-inch CMP culverts; insufficient capacity, roadside erosion

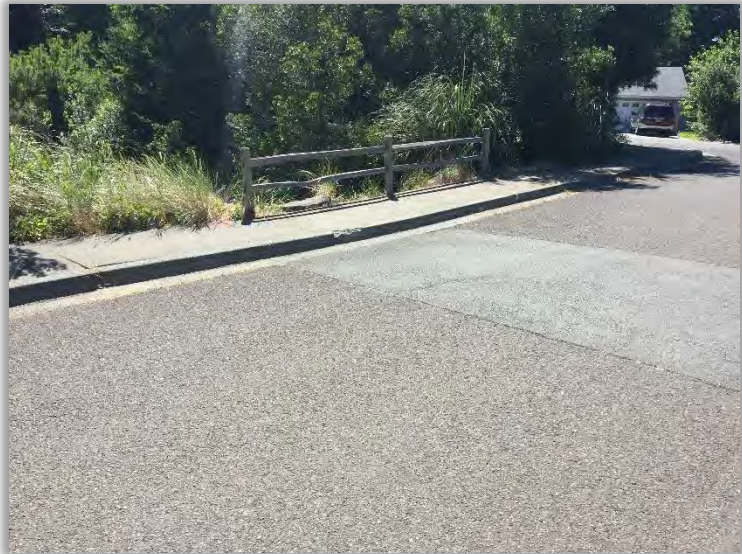
Figure 5-9 - Additional settlement has occurred after City trench patched with CLSM backfill

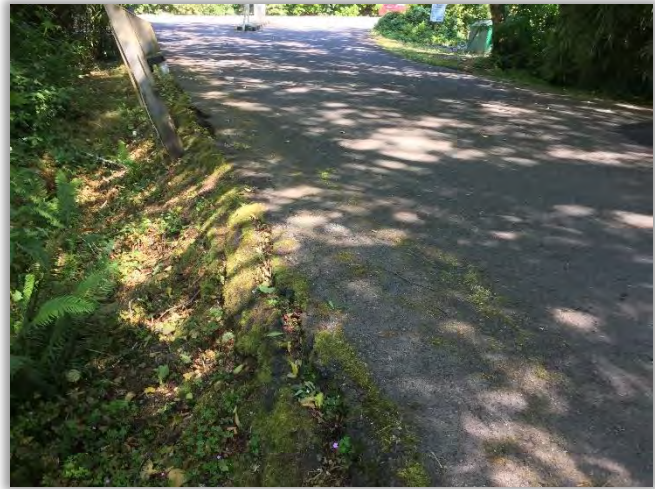
Figure 5-12 - Erosion at the roadway edge, steep slope, 31st Street, North side

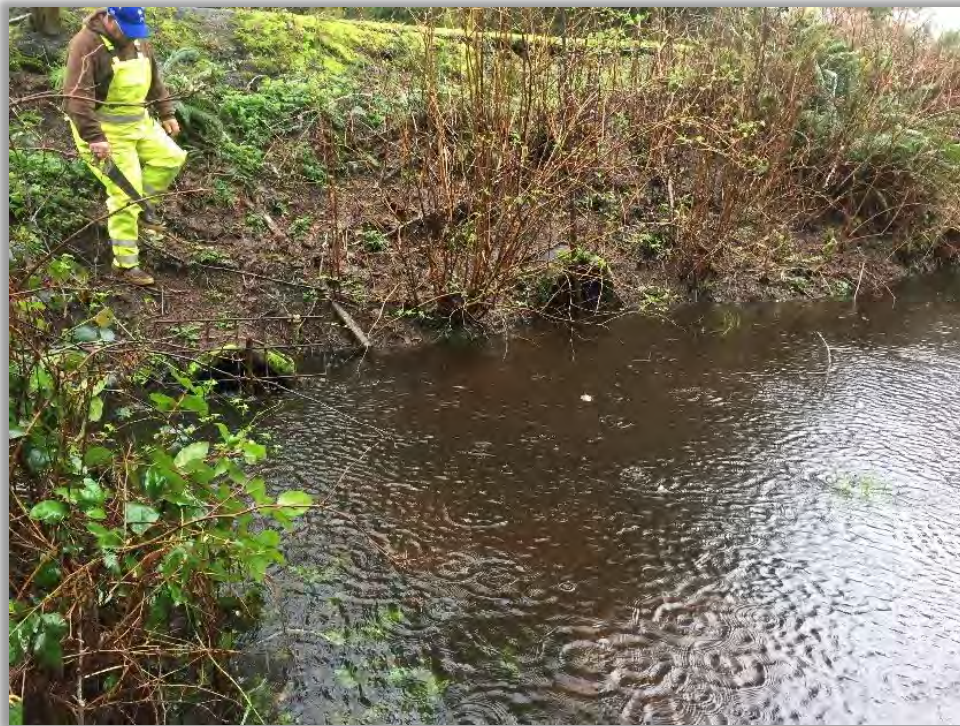
Figure 5-13 - Two 24-inch concrete culverts, one inactive, insufficient capacity

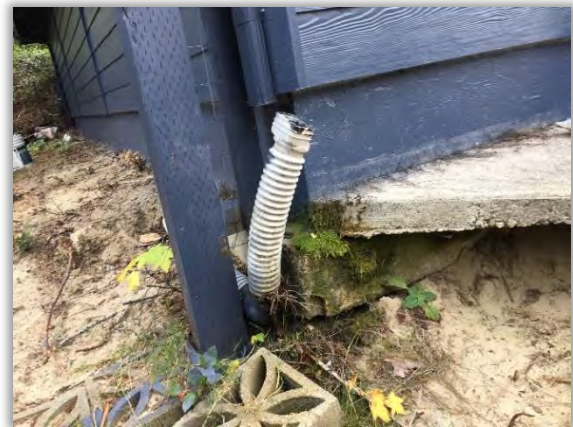
Figure 6-8 - 3515 Rhododendron Drive 3-car garage foundation exposed

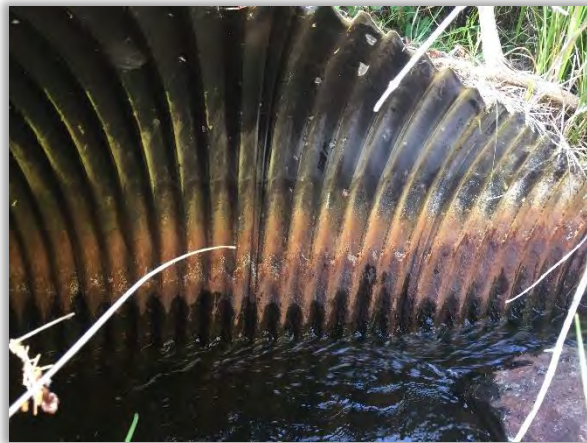
Figure 6-26 - Evidence of corrosion in existing pipe wall

Figure 6-27 - Geosynthetic cementitious composite mat applied to CMP culvert to extend lifetime of culvert (example)

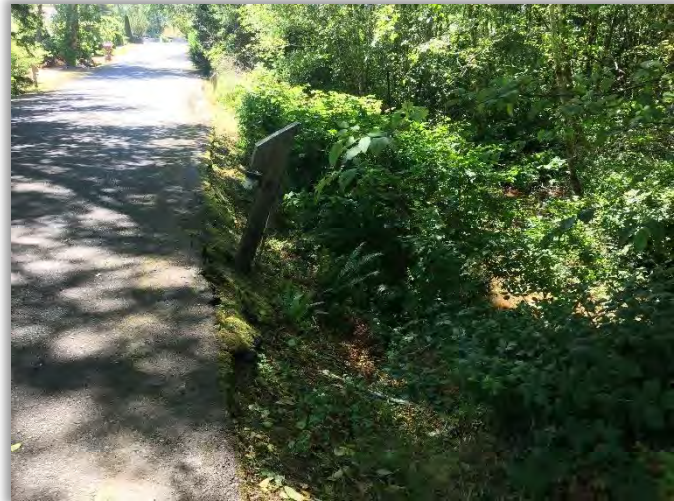
Figure 6-28 - Eroded edge of pavement. Address by replacing/extending culvert and adding fill material
