Existing Structures Exhibit

Port of Siuslaw: Old Town Wharf Improvements

Existing Conditions Photos

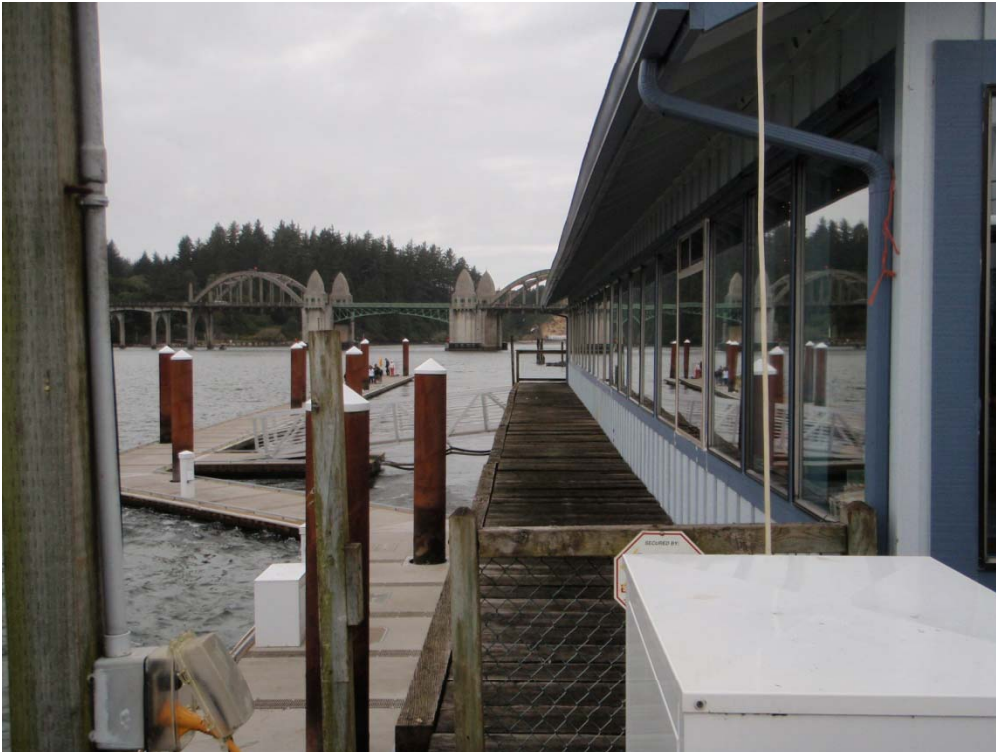
1. South side of Mo's showing adequate clearance to drive pile through deck within existing footprint without damage to building.

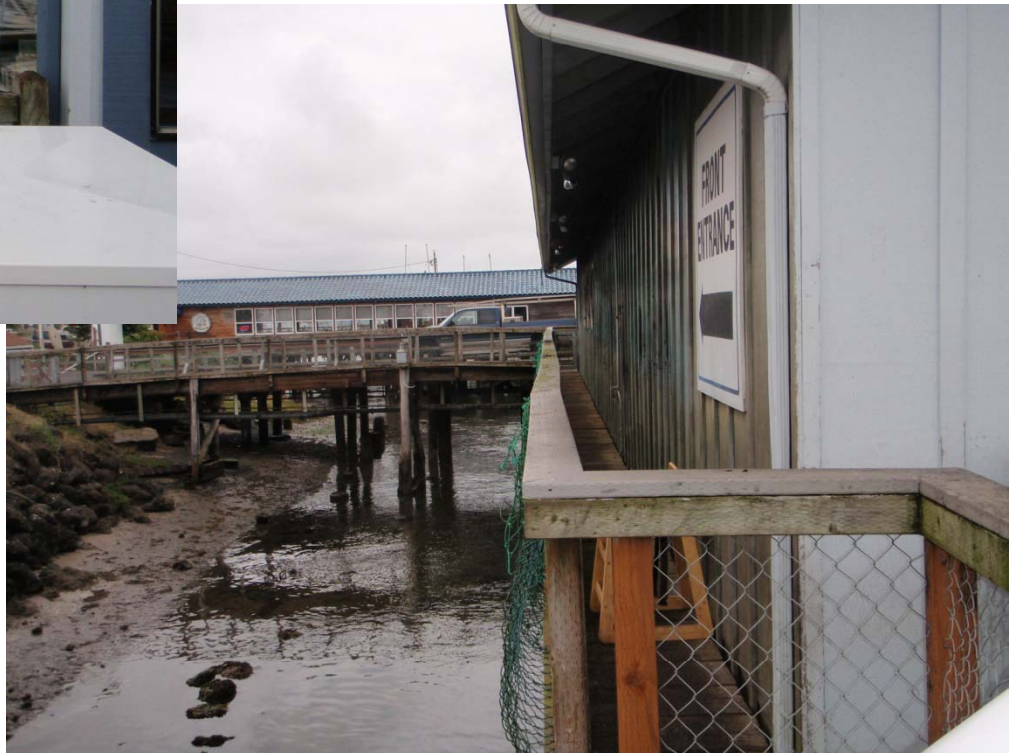
2. North side of Mo's showing eave directly over deck, thus pile cannot be driven within existing footprint without damage to building. Note condition of shoreline.
