City of Florence, Oregon

# STORM WATER MASTER PLAN UPDATE

DECEMBER 2018

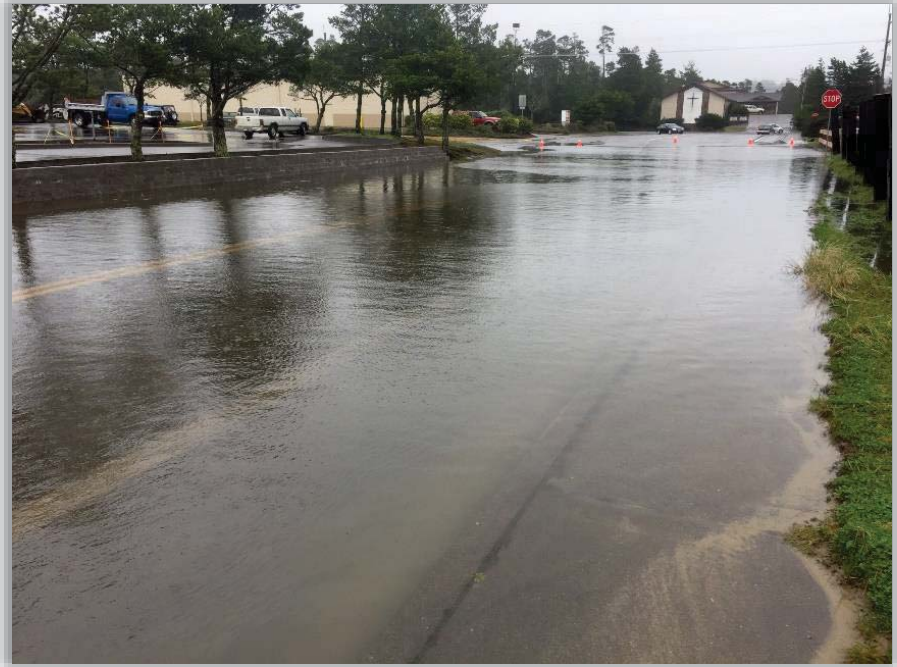
The City owns 42-inch drainage piping that flows south along the east side of Highway 101, across from Fred Meyer. However, drainage infrastructure on the Fred Meyer property, and in 46<sup>th</sup> Street to the south, does not connect to this 42-inch drainage pipe, nor does it discharge into the state-owned system that runs along the west side of Highway 101 at this location. Instead, 46<sup>th</sup> Street, and Fred Meyer drainage infrastructure, rely on local infiltration for discharge.

*Figure 4-4 - 46th Street, looking East*

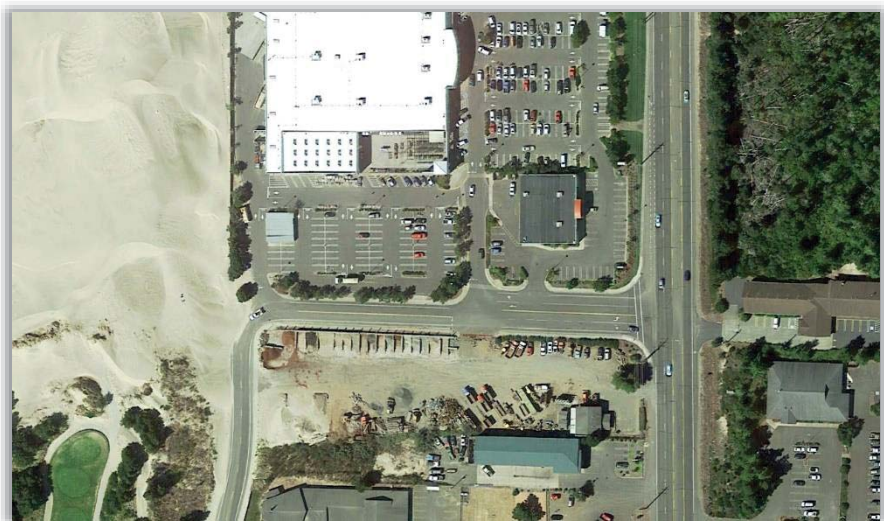
Another challenge to the drainage of 46<sup>th</sup> Street is presented by the sand dune that exists immediately west of Fred Meyer (see Figure 4-5). The wind blows sand from the dunes onto 46<sup>th</sup> Street and Oak Street, with virtually no obstructions. This causes the drainage infrastructure to become silted in, thus decreasing its effectiveness.

*Figure 4-5 - Sand dune west of Fred Meyer blows onto 46th Street*

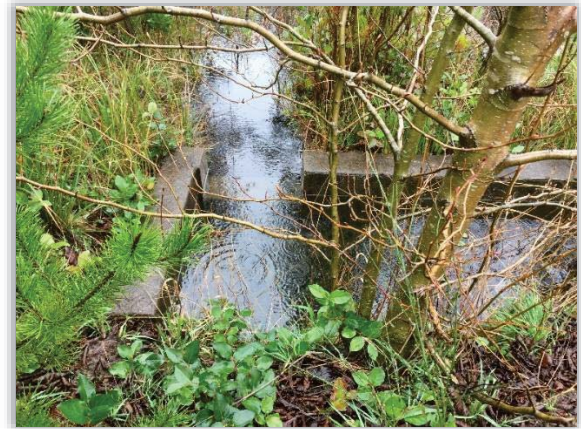
*Figure 4-9 - Make-shift Orifice*

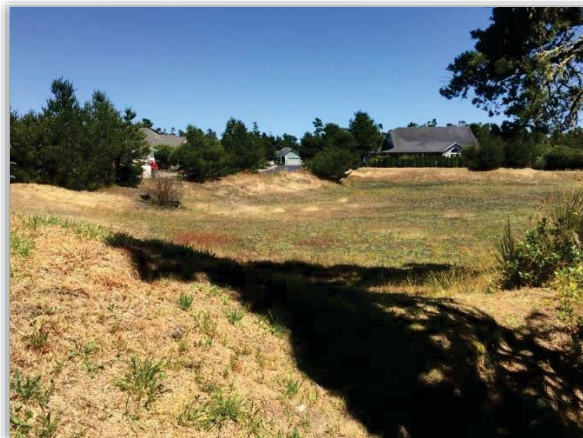
*Figure 4-14 - Tax Lot #4600 used for infiltration becomes a seasonal wetland in winter months*

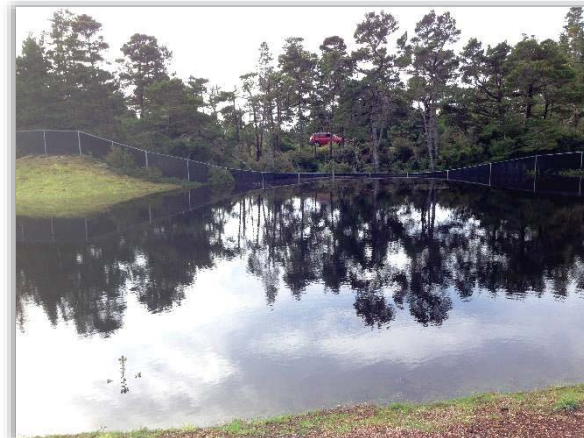
*Figure 4-17 - Lot #4600 flooded. A car can be seen driving by on Rhododendron Drive.*

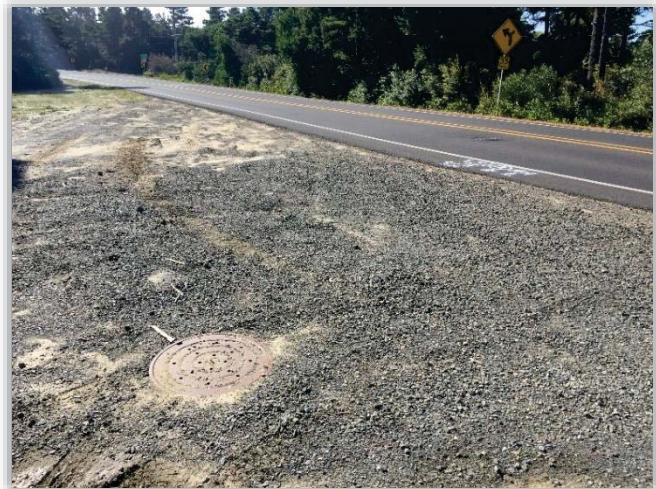
*Figure 4-19 – Flow control manhole w/ no outfall constructed yet*

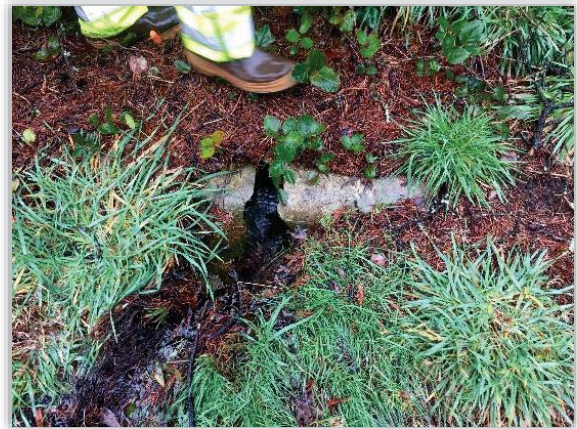
Because this pipe network is not allowed to discharge, the entire system has been observed to backup and overflow onto City streets. As a temporary fix, the 10-inch transite pipe between 29<sup>th</sup> Street and 28<sup>th</sup> Street has been exposed and broken open to allow water to drain into the undeveloped right-of-way (see Figure 4-20).

*Figure 4-20 - Intentional break in 10" transite pipe for drainage*

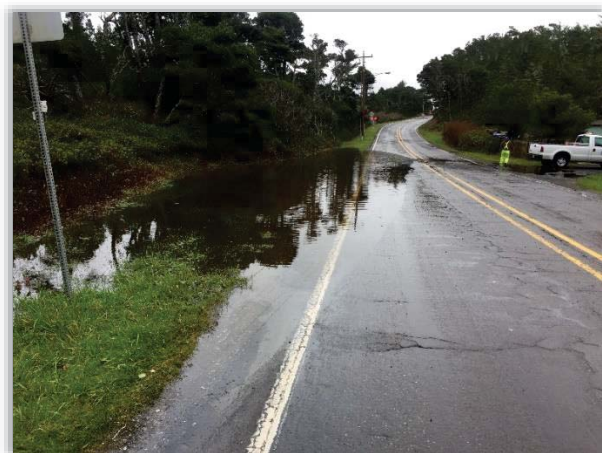
In the 2016-2017 wet season, flood waters had risen to a point where the north-bound lane of Rhododendron Drive was under water. This can be seen in Figure 4-23.

*Figure 4-23 - Flooding on Rhododendron Drive*

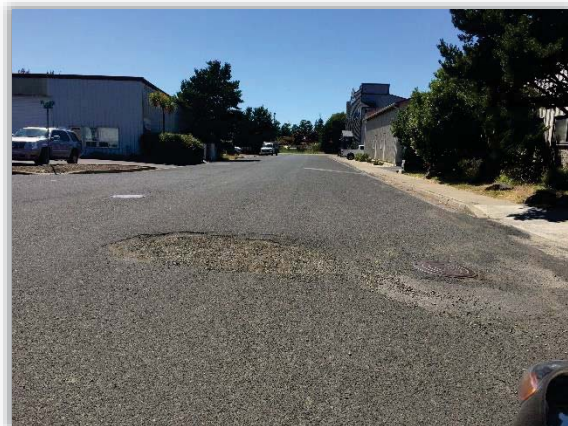
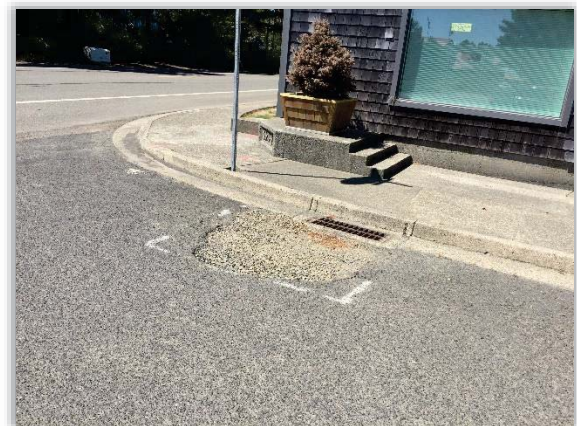
records confirm that the 18-inch corrugated metal pipe (CMP) which is meant to convey storm water from 18<sup>th</sup> Street, Laurel Way, and 17<sup>th</sup> Place to the south along Kingwood Street, has indeed failed. As a result, storm water that would be contained within this pipe escapes, undermining the road above.

*Figure 4-28 - Sinkhole on 18th St. caused by failed storm pipe*

*Figure 4-29 - Sinkhole on 18th St. caused by failed storm pipe*

1. The 18-inch CMP drainage main has deteriorated and needs to be replaced.
2. Deteriorated pipes have caused the roadway to be damaged, requiring repair of the storm water infrastructure, and restorative improvements to the roadway.
3. There is excessive debris (pine needles) entering the pipe network at this location. Preventative measures should be included in any improvements to the drainage network in this area.

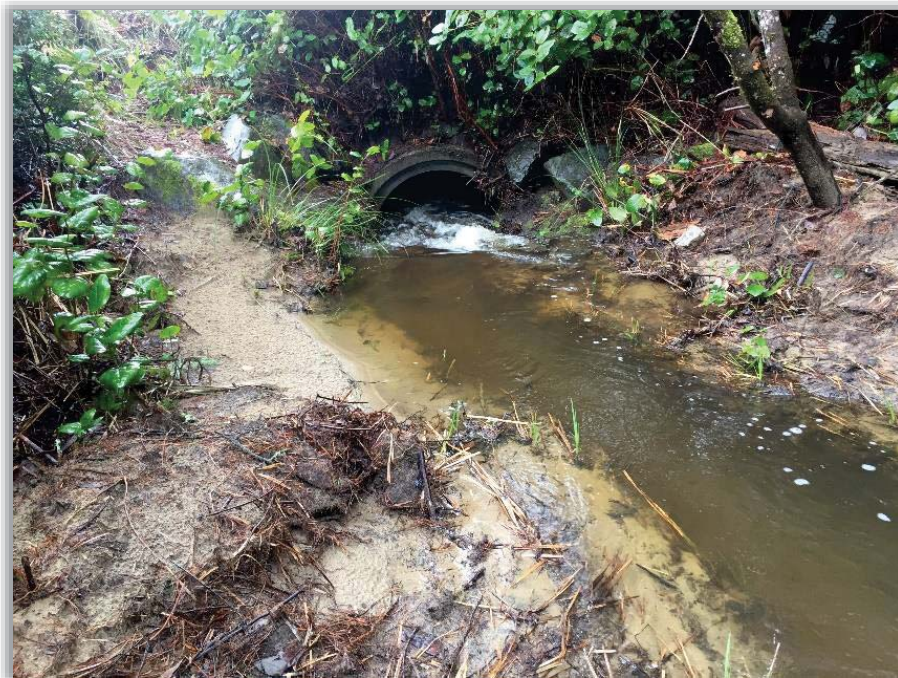
the culvert pipe. This is problematic considering the drainage issues we have just described for the Seabrook Townhomes. Lack of sufficient capacity in the culvert may cause the ditch to backup and overflow on to the property of the townhomes. However, with a thorough cleaning, and control of incoming sediment, it is likely that the culvert will perform as needed.

*Figure 4-35 - 42-inch concrete culvert inlet, heavy sedimentation, evidence of exceeded capacity*

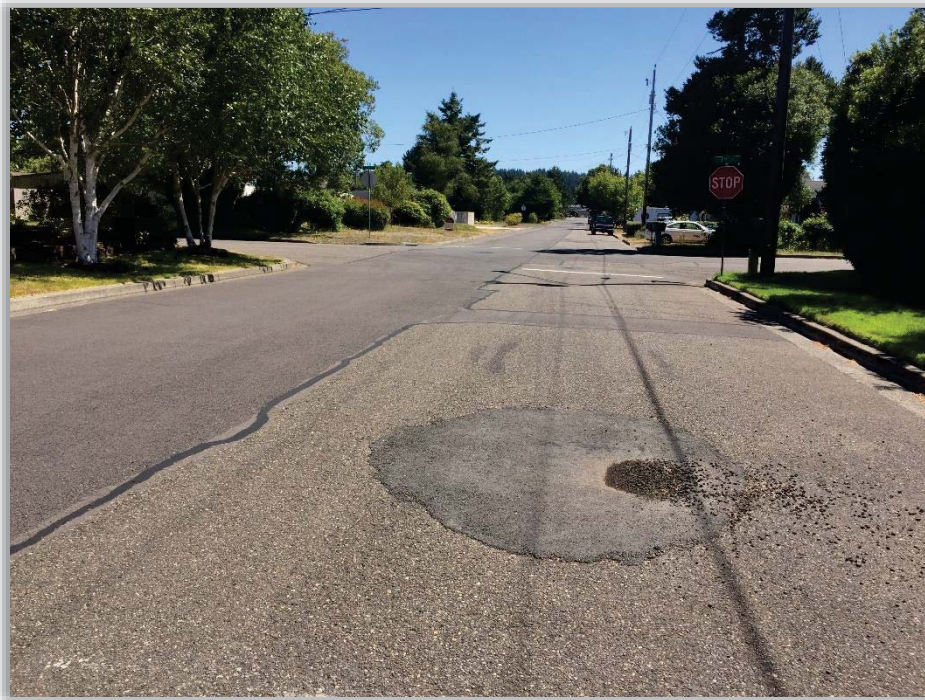
At the intersection of 6<sup>th</sup> Street and Ivy Street, a storm water manhole is connected to an influent 24-inch PVC pipe, from the north. Just upstream of the manhole connection, the PVC pipe is coupled to an older Concrete pipe of the same diameter. Upstream from here, at the intersection of 7<sup>th</sup> and Ivy, the pipe increases size to 30-inches. These two pipes, along with the connected catch basin and curb inlet runs have deteriorated to the point of failure. As shown in Figure 4-38, sinkholes have begun to form in the roadway, along the alignment of the storm water system.

*Figure 4-38 - Sinkholes forming directly above drainage lines. Evidence of pipe failure.*

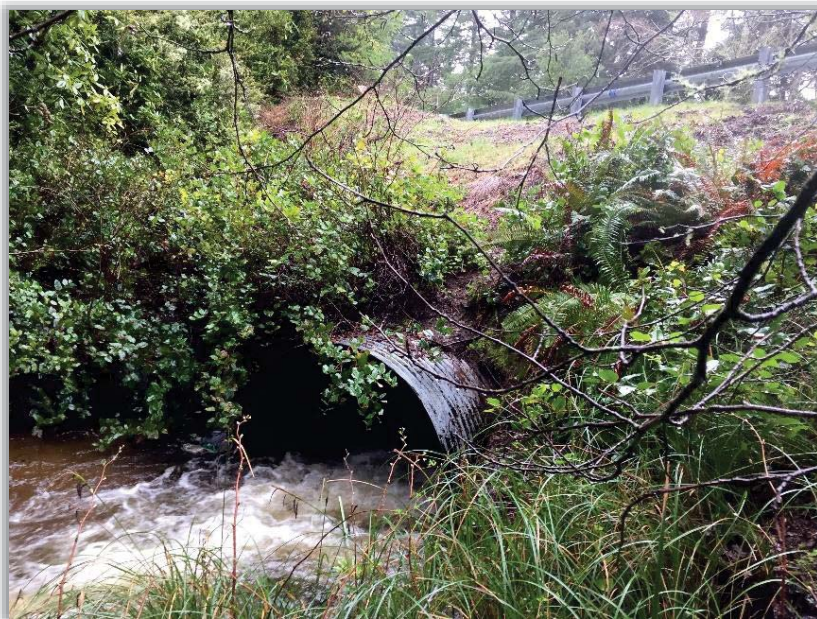
Currently, the creek passes underneath Spruce Street via a single 84-inch corrugated metal culvert, which is shown in Figure 5-1. Field inspection of this culvert revealed that the corrugated metal pipe is severely dislocated in multiple locations (Figure 5-4), and the wall of the pipe has experienced significant corrosion (Figure 5-3). The factory treatment of coal-tar epoxy applied to the interior of the pipe wall has eroded away, leaving the pipe exposed to environmental degradation.

*Figure 5-1 - 84-inch CMP culvert, outlet side, looking NE*

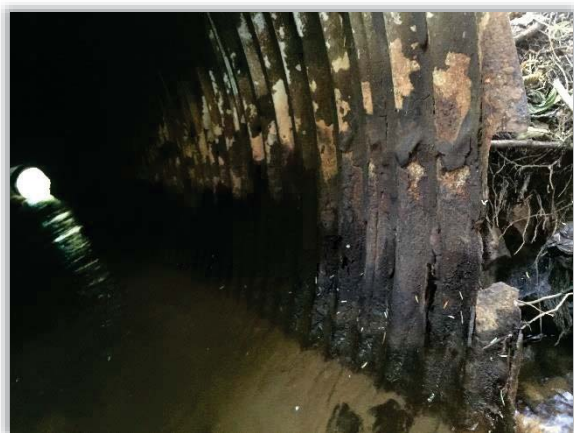
*Figure 5-2 – Deteriorated factory coating*

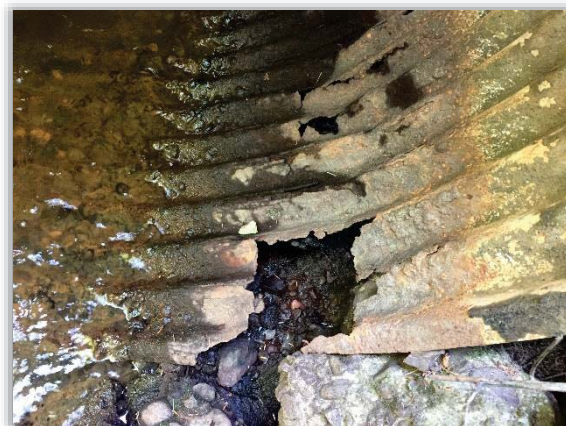
*Figure 5-3 - Evidence of severe corrosion in pipe wall*

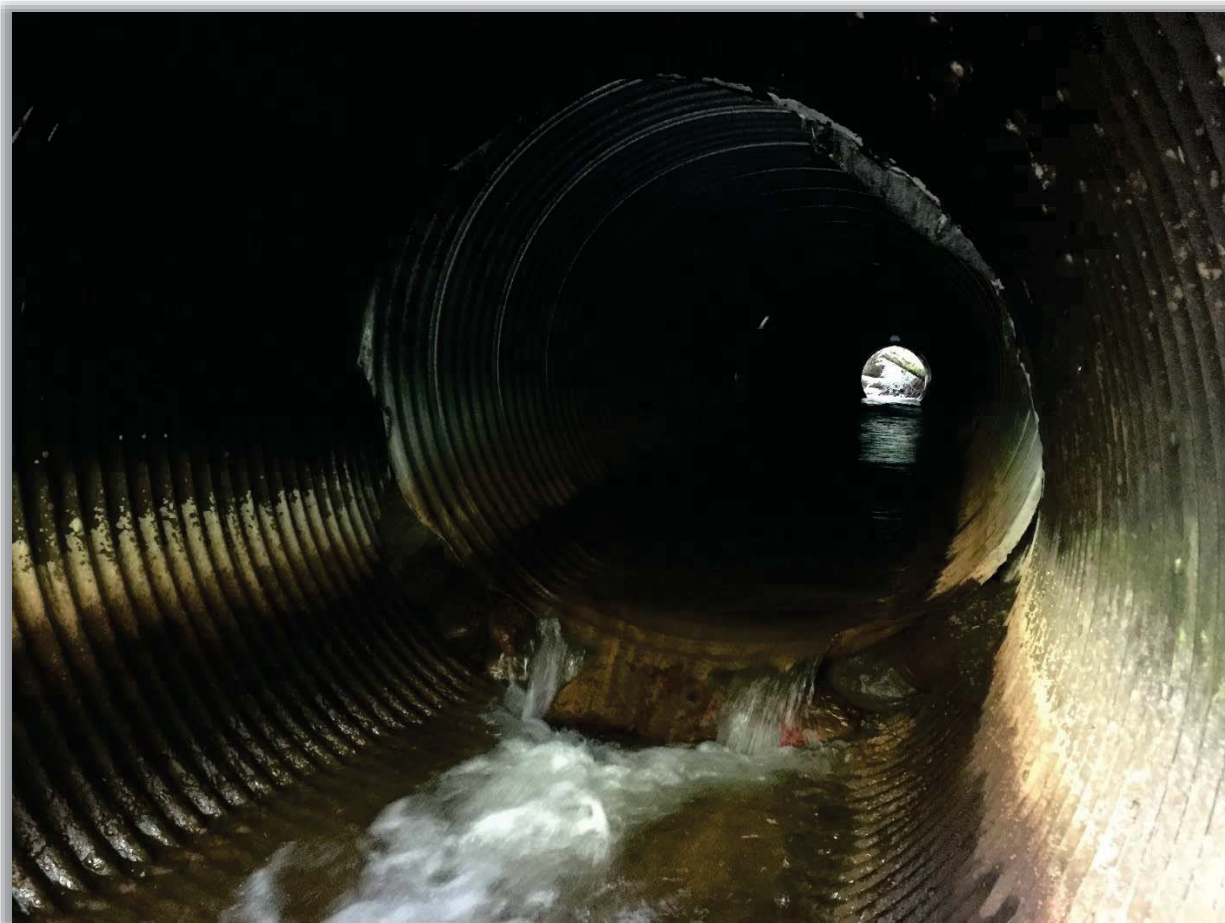
Figure 5-4 also shows that the pipe has experienced deformation under the load of the road above. When combined with the evidence of severe corrosion and dramatic dislocations, this culvert should be considered unsafe for entry by maintenance personnel.

*Figure 5-4 - 84-inch CMP culvert; Severe dislocations and significant deformation of pipe under roadway load. The forefront dislocation shown in this photograph is the location where a repair was completed on this culvert in 2011.*

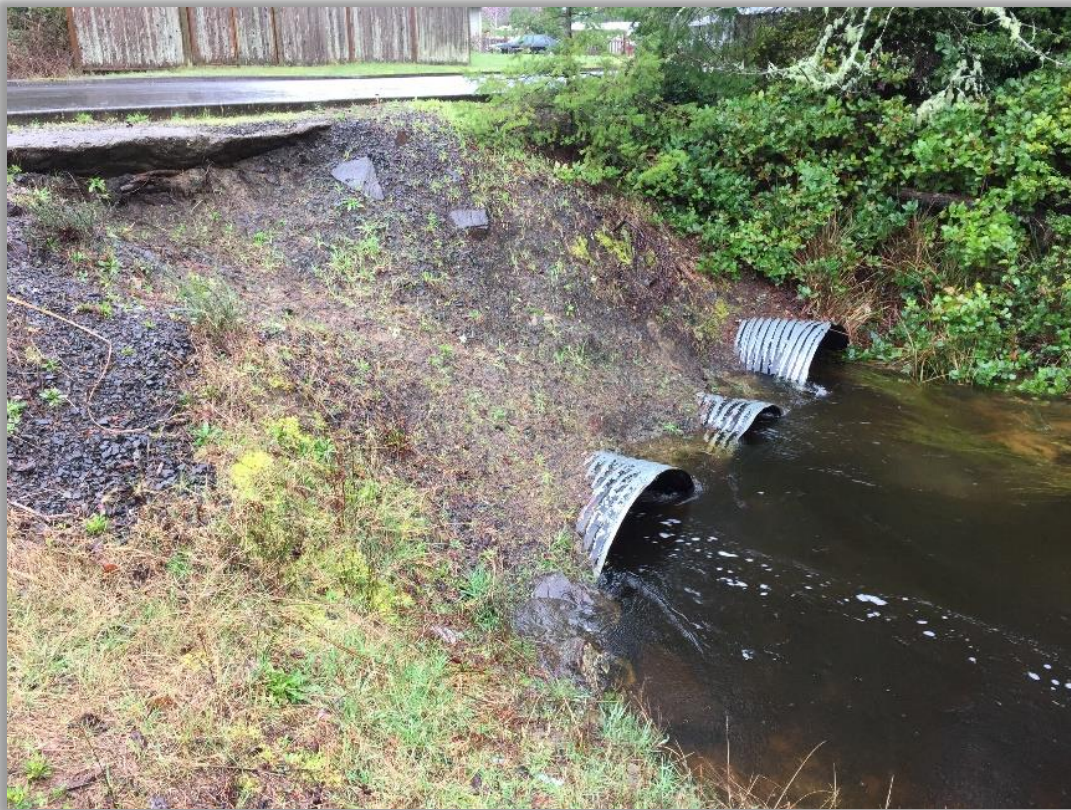
*Figure 5-8 - Three 42-inch CMP culverts; insufficient capacity, roadside erosion*

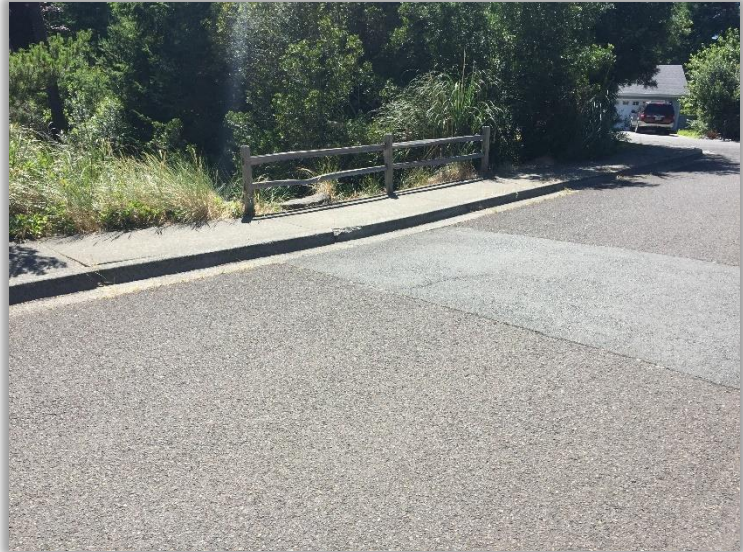
*Figure 5-9 - Additional settlement has occurred after City trench patched with CLSM backfill*

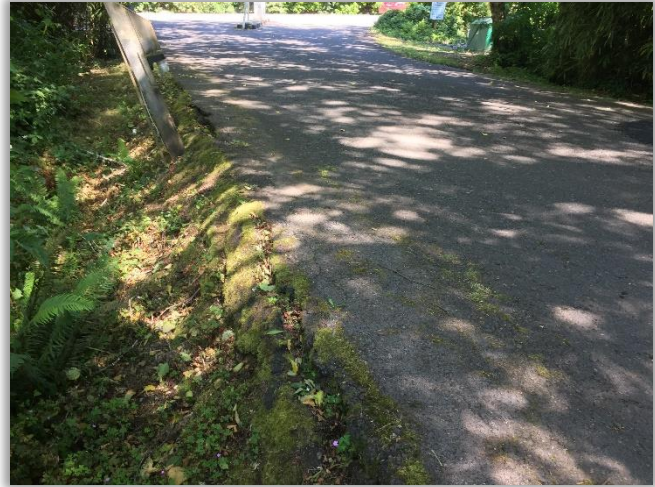
*Figure 5-12 - Erosion at the roadway edge, steep slope, 31st Street, North side*

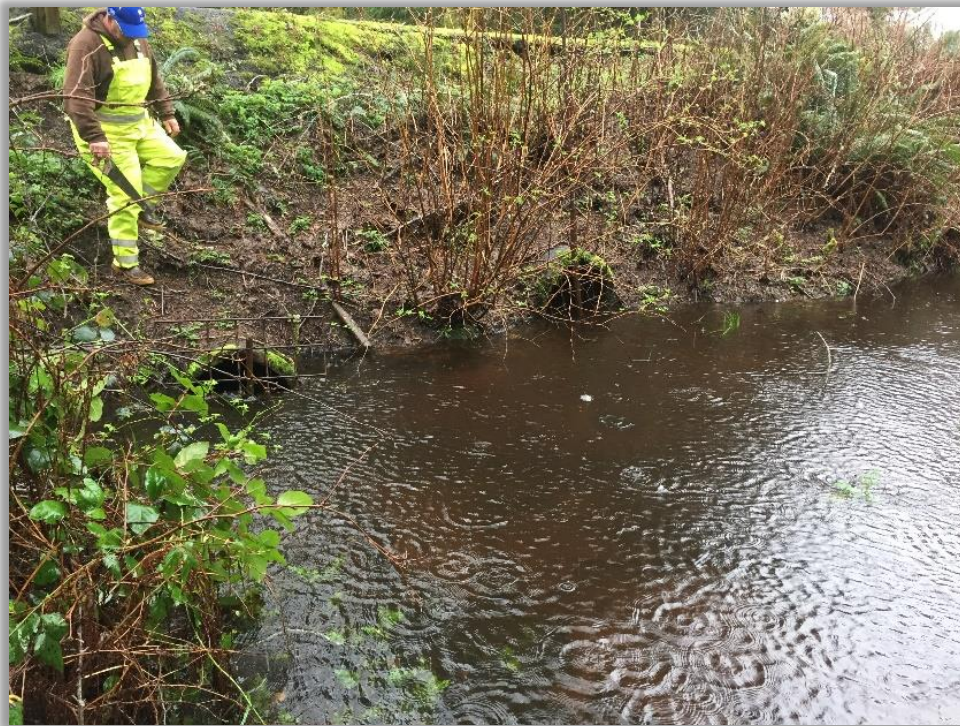
*Figure 5-13 - Two 24-inch concrete culverts, one inactive, insufficient capacity*

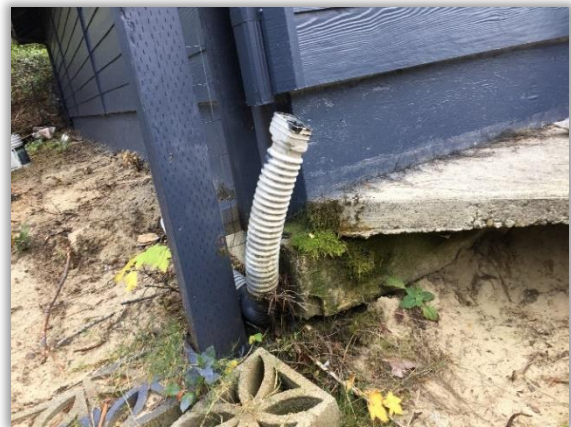
*Figure 6-8 - 3515 Rhododendron Drive 3-car garage foundation exposed*

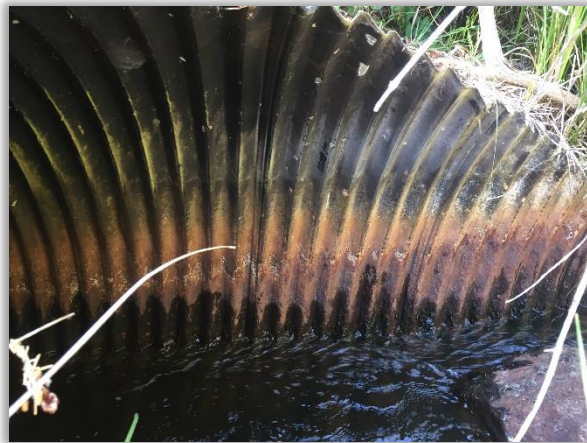
*Figure 6-26 - Evidence of corrosion in existing pipe wall*

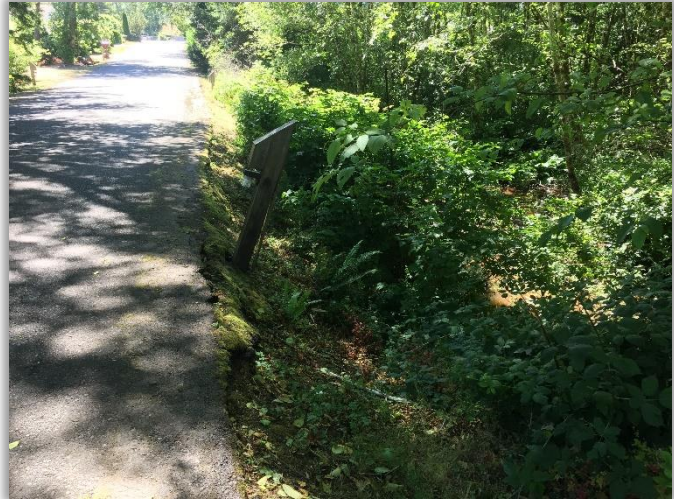
*Figure 6-28 - Eroded edge of pavement. Address by replacing/extending culvert and adding fill material*
