FINDINGS OF FACT FLORENCE PLANNING COMMISSION Exhibit "A"

Application: PC 22 04 SIR2 01

Proposal: Application for a Phase II Site Investigation Report (SIR) related to slope stability

PC 22 04 SIR2 01: Lot 37/56 Shoreline Dr.

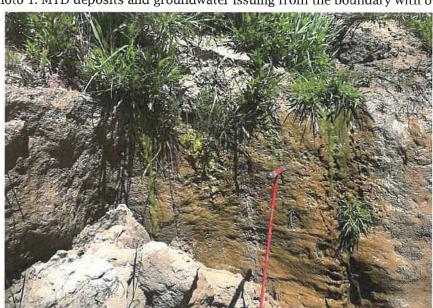
To assess the soil type and groundwater during the May 31, 2022 site investigation BEI staff accessed the bay frontage of the property. The MTD deposits along the adjacent lot to the north were exposed and consisted of dense partially cemented, poorly graded sand with silt and clay. The MTD deposits above the waterline stood vertical for approximately 3- to 7-feet in height, the MTD deposits extended below the waterline to an unknown depth. An area of deposition along the piers near Cannery Point was noted from drone photos. In this area it appears the MTD deposits extend further out into the bay. Hand probing areas close to shore had 1- to 2-feet of loose sand overlying the MTD shelf that projected out into the bay. Groundwater was noted issuing from the boundary between the MTD deposits and the overlying sand. The rate varied, but was estimated to be at least a gallon per minute in areas where erosion had concentrated the flow. Piping of the overlying sand deposits was noted where the groundwater flow volume was highest. Deposits of the sand were also noted in the water below these areas.

Photo 1: MTD deposits and groundwater issuing from the boundary with overlying sand.

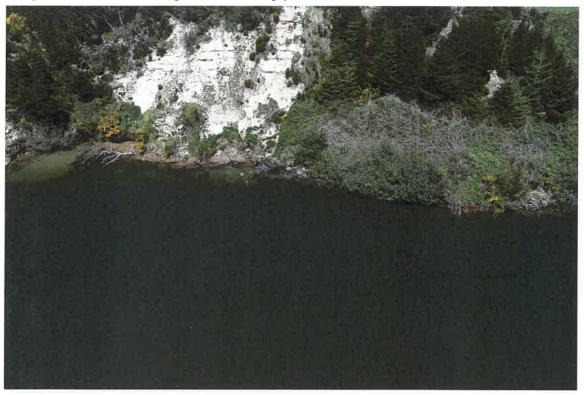
Based on historical imagery obtained from EDR Lightbox (attached) for the following years 1954, 1976, 1982, 1988, 1994, 2000, 2005, 2009, 2012, 2016, and Google Earth Imagery for the years 2005, 2012, 2016, and 2019, the site has experienced periods of bay shore erosion; however, the most significant alternation to the site is associated with mass grading of the area during the development of the Shelter Cove subdivision. The resolution of the aerial images also makes determining a rate of erosion for the site difficult as the precision of any measurements would be on the order of tens of feet. The 1954 aerial photo shows the site vicinity as partially vegetated dunes descending as sand clear of vegetation to the river bank. By 1976 a series of four groins (constructed in 1974) on the south bank of Siuslaw Bay. One of the groins is directly across the bay from the site. Also visible in the 1976 aerial photo is an area of sand clear of vegetation in the site vicinity. This area was vegetated in the 1954 aerial photo. The site vicinity remains relativity unchanged until the 1994 aerial image that shows construction of the Shelter Cove subdivision altering the site and vicinity by removing vegetation and performing mass grading operations. Mass grading of the site appears to consist of a flattening of the dune for a building pad and clearing of the slope to the bay. In the 1994 aerial photo the slopes descending to Siuslaw Bay are mostly clear of vegetation and remain relatively clear until the 2009 to 2012 aerial photos that show sparse vegetation in 2009, and relatively dense vegetation in 2012. Sometime between 2012 and the next available aerial image in 2016, a shallow landslide begins to develop on the adjacent lot's bayside slopes to the north. At the time of BEI site visits in 2021 and 2022 the landslide appeared to be entirely within the adjacent lot to the north; however, we were not able to locate property corners so this could not be confirmed. The exact cause of the landslide is unknown, but based on the lack of rip-rap armoring, we suspect that a combination of piping of the sand overlying the MTD deposits, and erosion of the MTD deposits lead to recession at the toe of the slope to the point where the overlying sand experienced a loss of lateral support and translational landslide resulted. Because of the dense vegetation along the slope and bay frontage of Lot 37, the site investigation was limited to the periphery and aerial reconnaissance using a drone. The bay frontage of the site appears to be composed of rip-rap that extends up into the vegetation a distance of 3- to 4-feet where it was visible. Below the vegetation line, which roughly corresponds to the high-water line, the rip-rap extends for a short distance before the shore drops off near vertical, to vertical with depths greater than 6-feet (estimated with a stick at the northwest corner). Drone photographs show the conditions observed in the northwest corner to be consistent along the length of the property. Shadows along the submerged bank indicate possible areas of concavity that may be undercut submerged banks in the MTD deposits.

Photo 2: Lot 36 (presumed left of vegetation line) and part of Lot 37 are visible in this photo. Note the exposed sand from the landslide on Lot 36, loose sand deposited below the waterline on left half of photo, and the dense vegetation and deeply incised banks below the waterline on Lot 37.

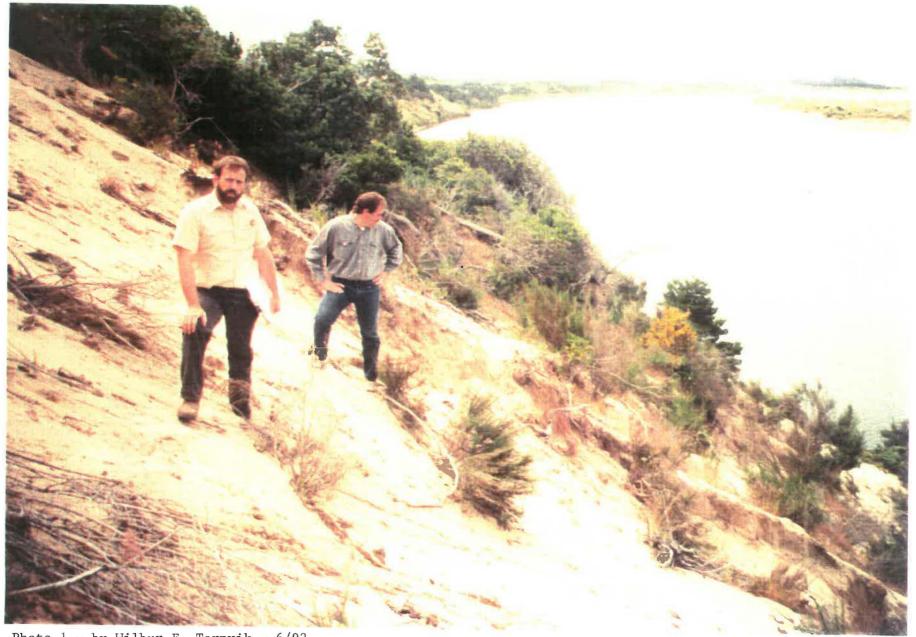
Photo 1 - by Wilbur E. Ternyik - 6/92

Location - Jim Hurst's Shelter Cove Subdivision, Siuslaw River, Florence, Oregon.

Note - Progressive nature of slope failure and shrubs sliding down the slope, into the river.

Restoration of riparian vegetation is impossible until river toe of slope is stablized.
