# **WAVE BEACH GRASS NURSERY**

May 18, 2006

Re: Initial Siuslaw estuary *Zostera* locations

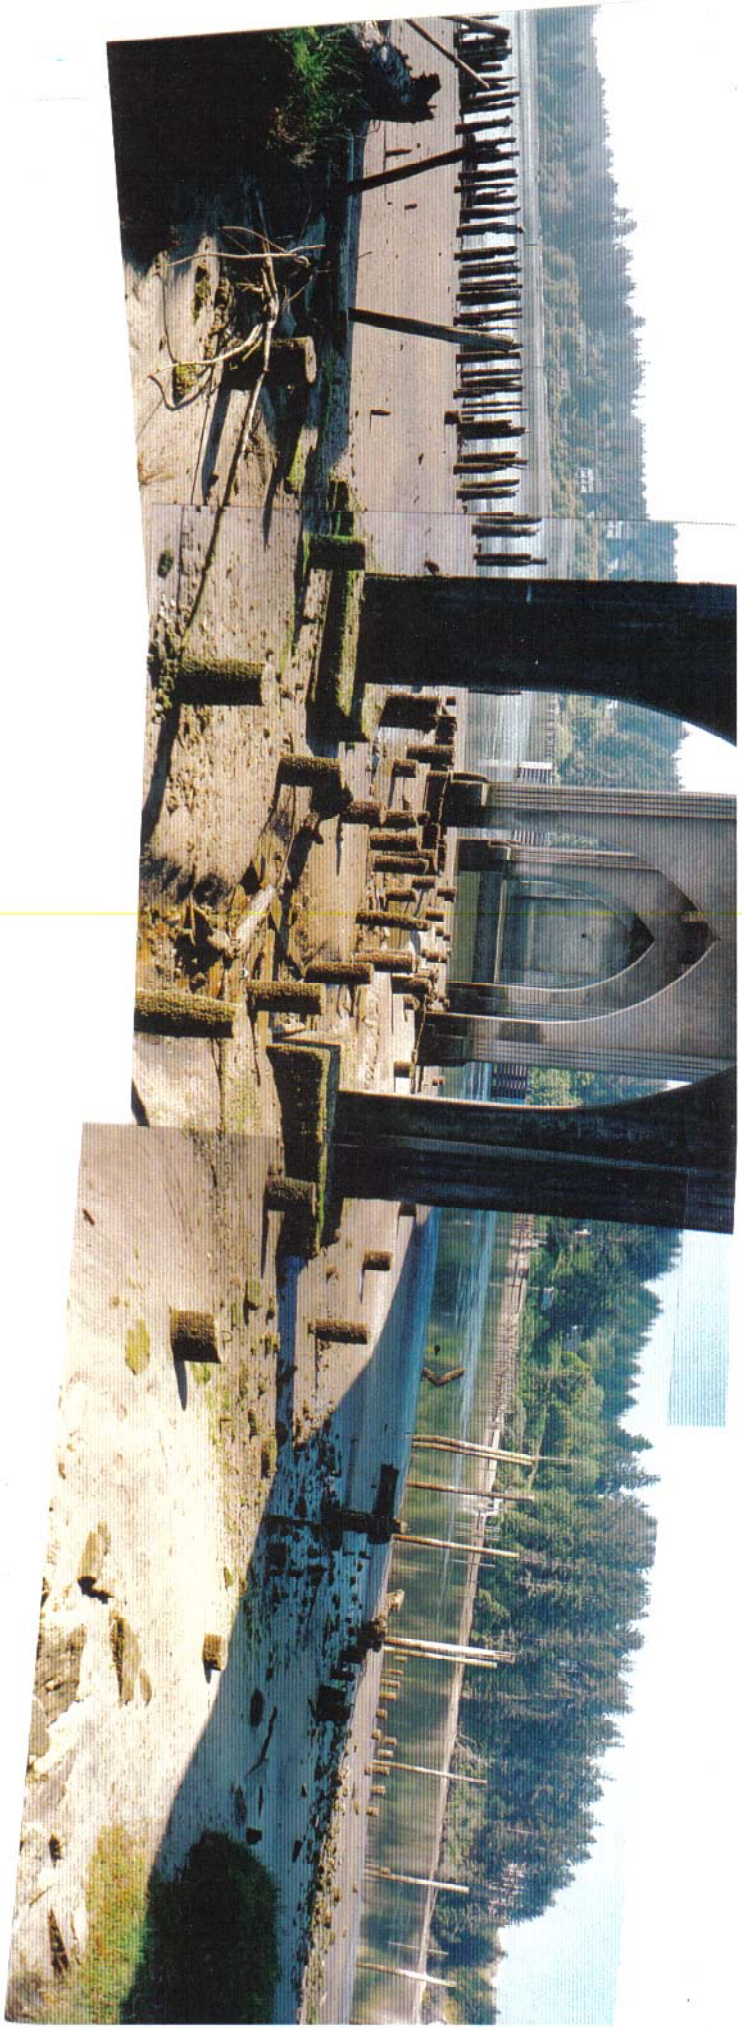
Photo 2

Location: North side of Highway 101 Bridge; looking south to under side of bridge. Note zero evidence of *Zostera* above and below the bridge.

There is zero *Zostera* under the Highway 101 bridge area. Out going tide velocity due to restricted passage presents it from growing at this location. The only significant *Zostera* stands are just below the Port of Siuslaw Boardwalk. Large areas where it formerly was located are now gone. *Zostera* comes and goes with a whole set of conditions that affects its survival. Further study by boat is needed.

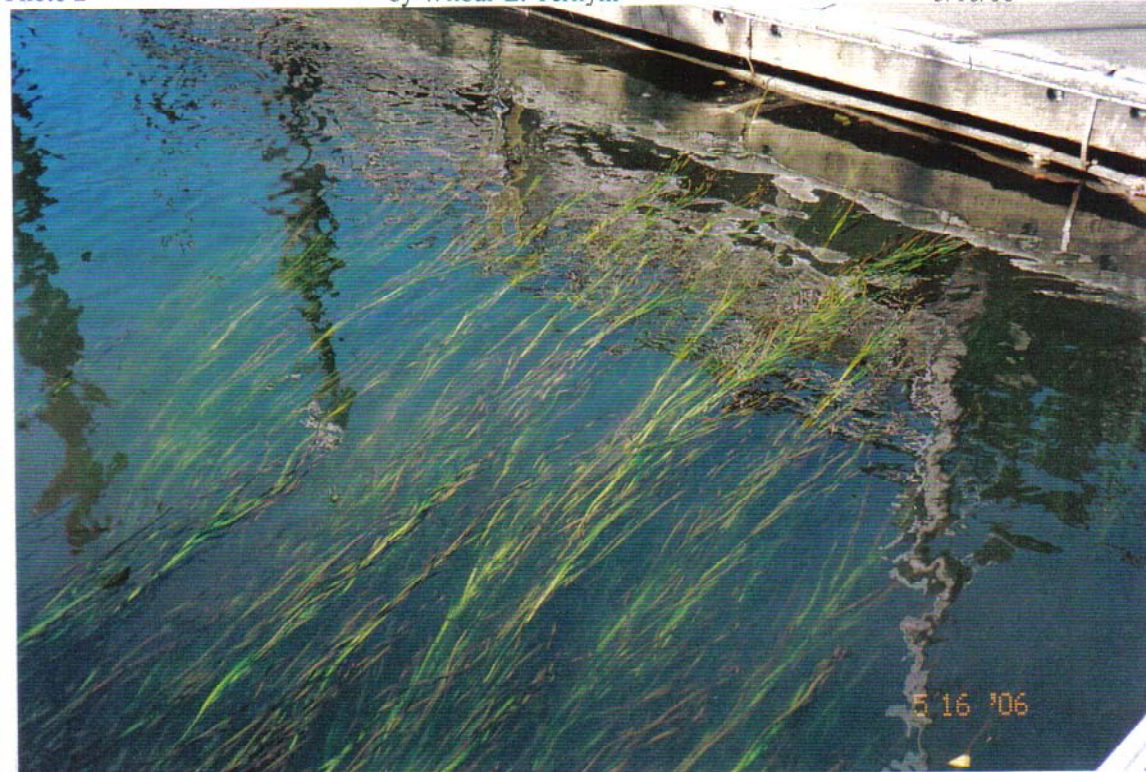
Photo 3

Location: Port of Siuslaw commercial fishing boat moorage. Dense stand of *Zostera* just out board of north walkway.

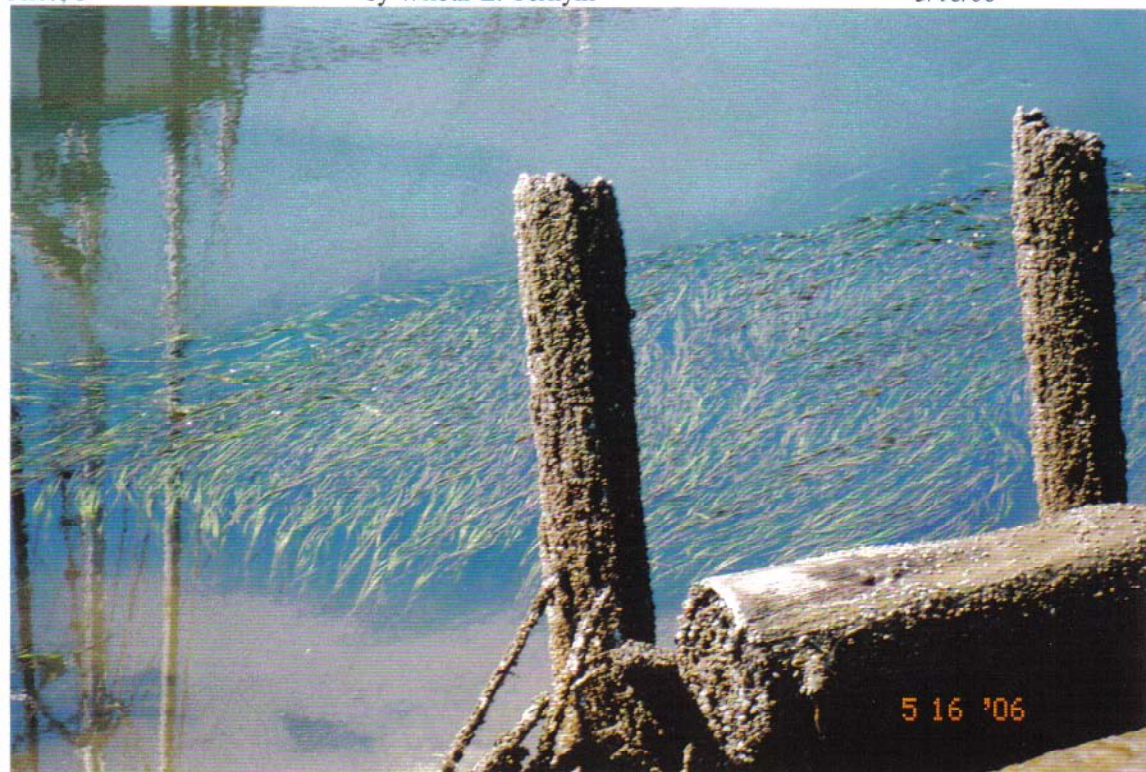
Photo 4

Location: Port of Siuslaw commercial fishing boat moorage. Looking north from same walkway. *Zostera* stand just up river.

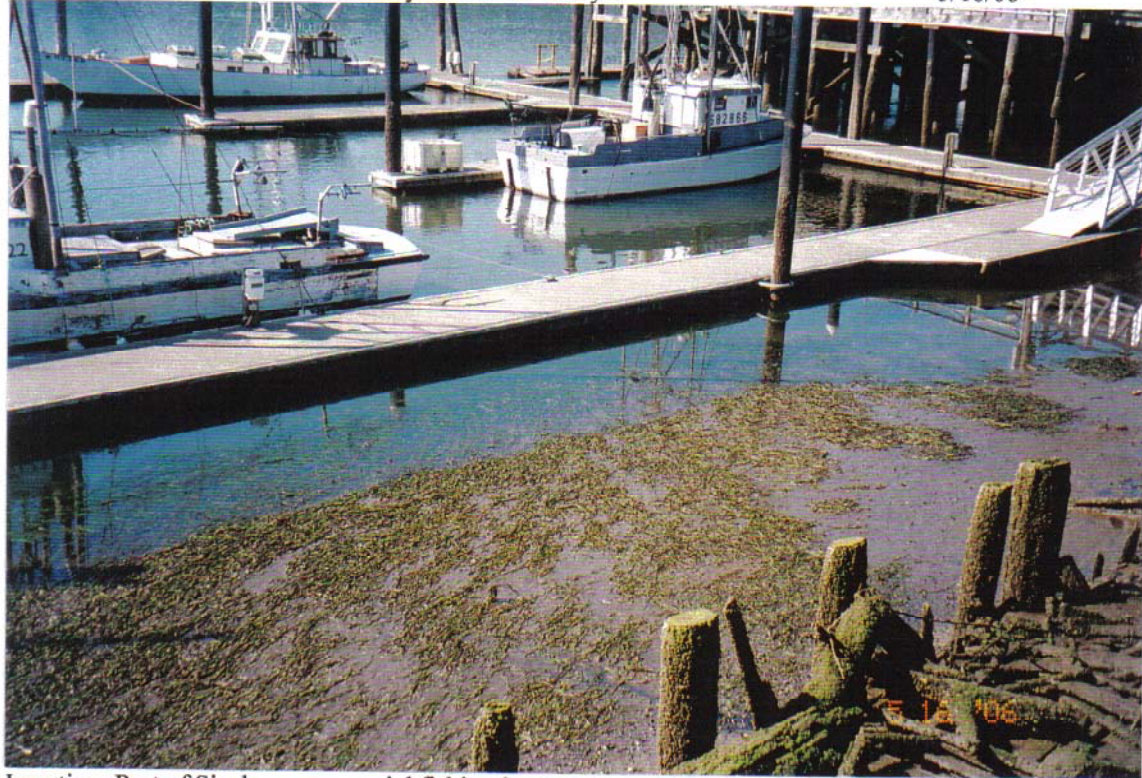
Photo 5

Location: Port of Siuslaw commercial fishing boat moorage. Looking SE from Boardwalk at Zostora areas shown in photos 2 & 3.

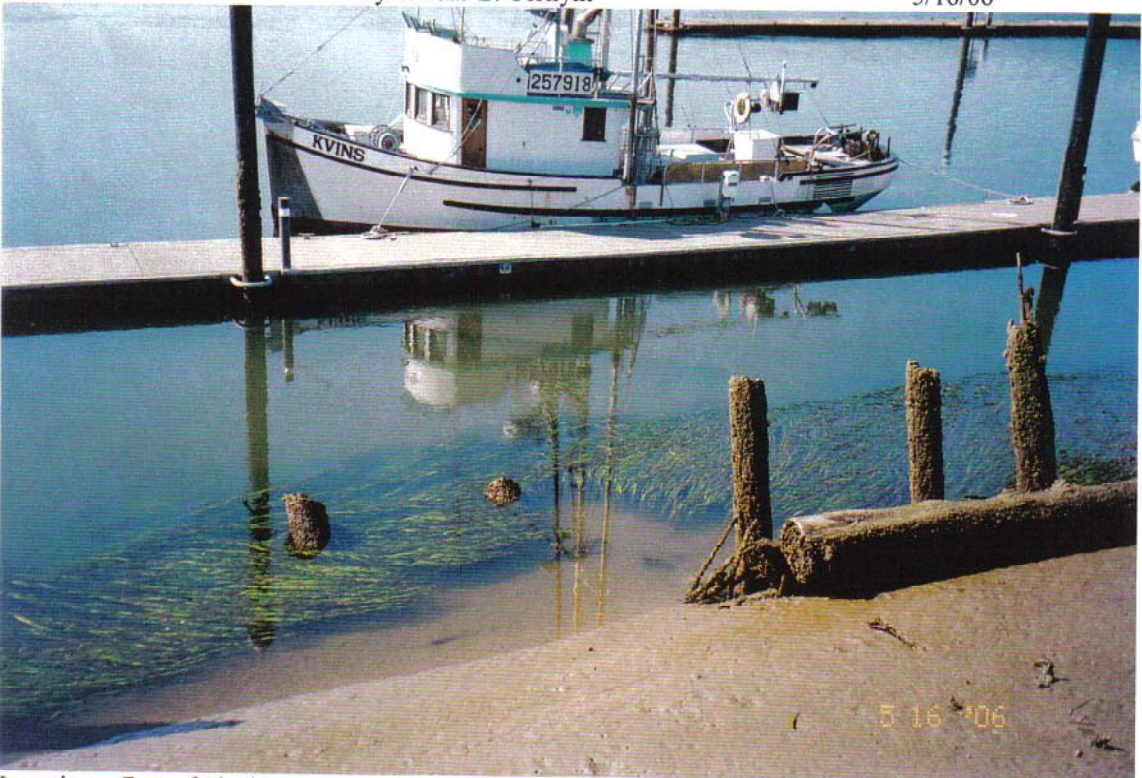
Photo 6 by Wilbur E. Ternyik 5/16/06

Location: Port of Siuslaw commercial fishing boat moorage. Same as photo 4 only further upstream. More Zostora beds growing in still water conditions.

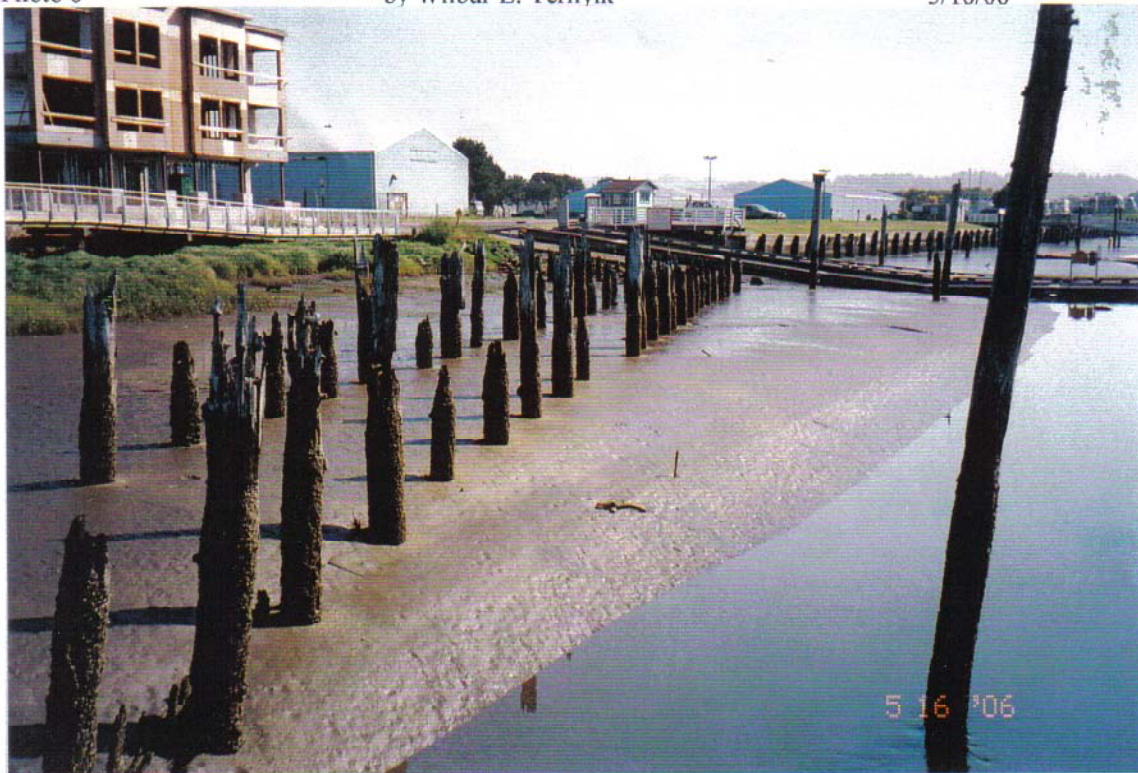
Photo 7 by Wilbur E. Ternyik 5/16/06

Location: Looking over mud flats just east of Port of Siuslaw property. Similar conditions but no Zostora.

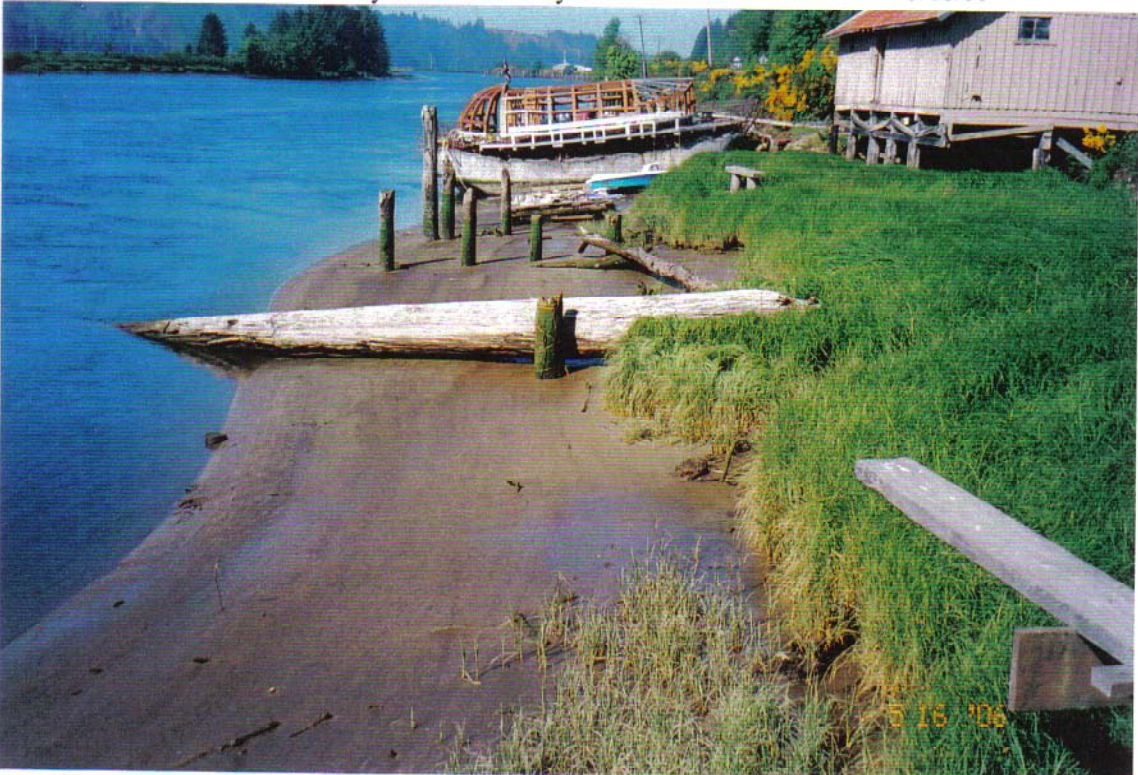
Location: Cushman Store looking downstream. Former Zostora beds now gone .

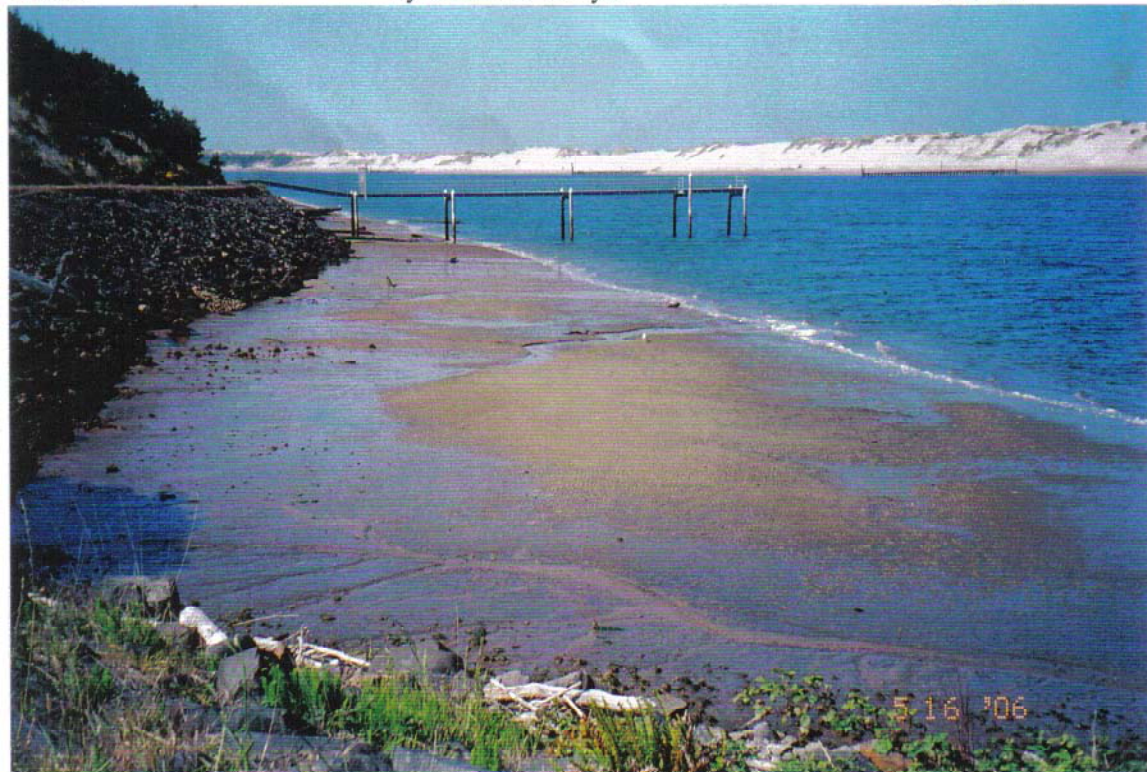
Location: Lower Siuslaw estuary near Wild Winds Subdivision site. Right elevation and salinity but no *Zostora*.

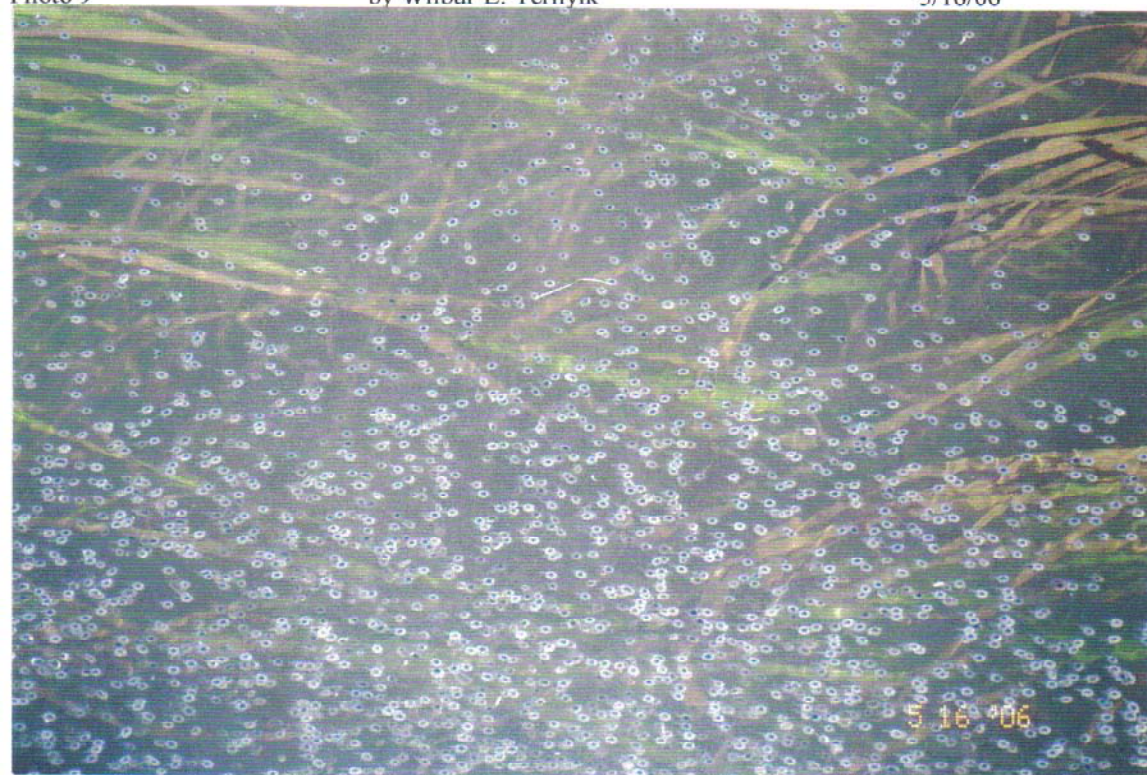
Location: Port of Siuslaw Boardwalk float area. *Zostora* and juvenile ?
