**BANK FAILURE ASSESSMENT
16 Sea Watch Court, Florence, OR**

March 18, 2011

Prepared for:
Patricia and Richard Lukens
16 Sea Watch Court
Florence OR 97439

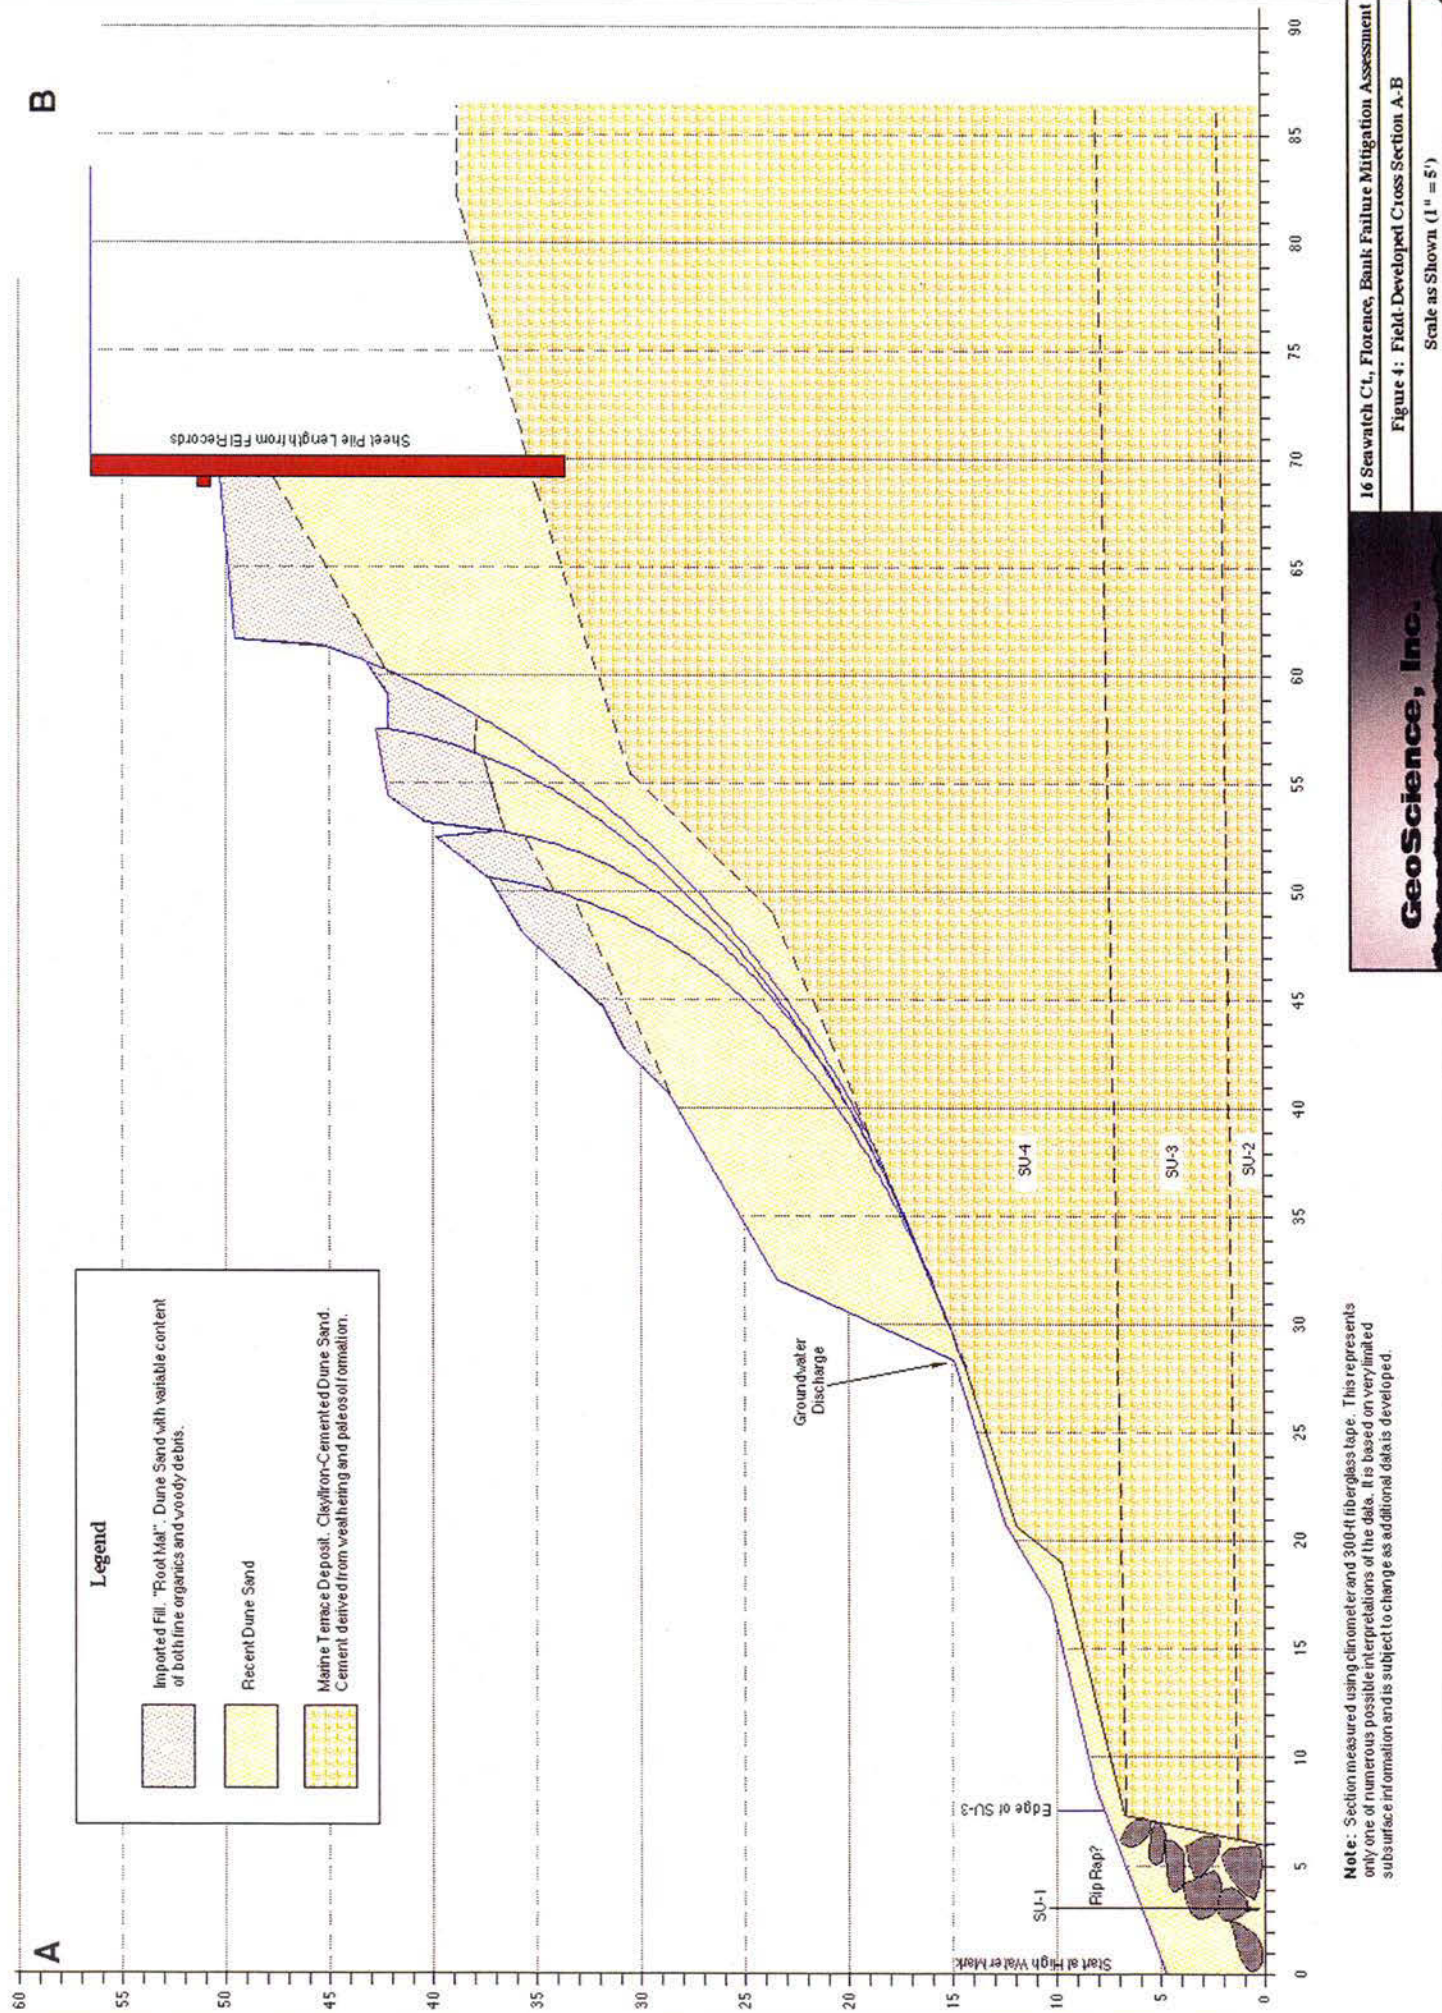
Figure 3: Failure, Field-developed Cross Section and WRDP Locations

The currently active failure is approximately 80 feet wide (Figure 3) and, for the most part, extends from the steel sheetpile sea wall beyond the low water mark of the bank of the Siuslaw River. At the southern end, the failure extends eastward beyond the edge of the sheetpile wall and is encroaching north toward the house behind the seawall (see site photos, Appendix A). Figures 4, 5, and 6 show the three field-developed geologic cross sections measured at the site. The failure area is underlain by imported organic-rich sand ("root mat") overlying native clean, cross-bedded dune sand, which in turn overlies several older dune forms with variably well-developed paleosol horizons. The lowermost two (exposed) paleo-sol appear to be horizontal to very gently sloping. Another, higher paleosol has significant relief, rising towards the east at angles ranging from approximately 10 degrees to 36 degrees. The lower two paleo-sol form both a "ledge" (lowermost paleosol, designated SU-1, and exposed only at low tide) and a "cliff band" (second-lowest exposed paleosol, designated SU-3, mostly exposed even at ordinary high tide) which ranges in height from approximately 4 feet to as much as 8 feet or more south of the immediate failure area. All paleo-sol consist of former dune sand which is cemented by clay, derived from weathering of feldspar sand grains and, in places, by iron hydroxides (rust), derived from weathering of ferro-magnesian sand grains. Even the better-cemented portions of the material can be easily cut and craved with a pocket knife.

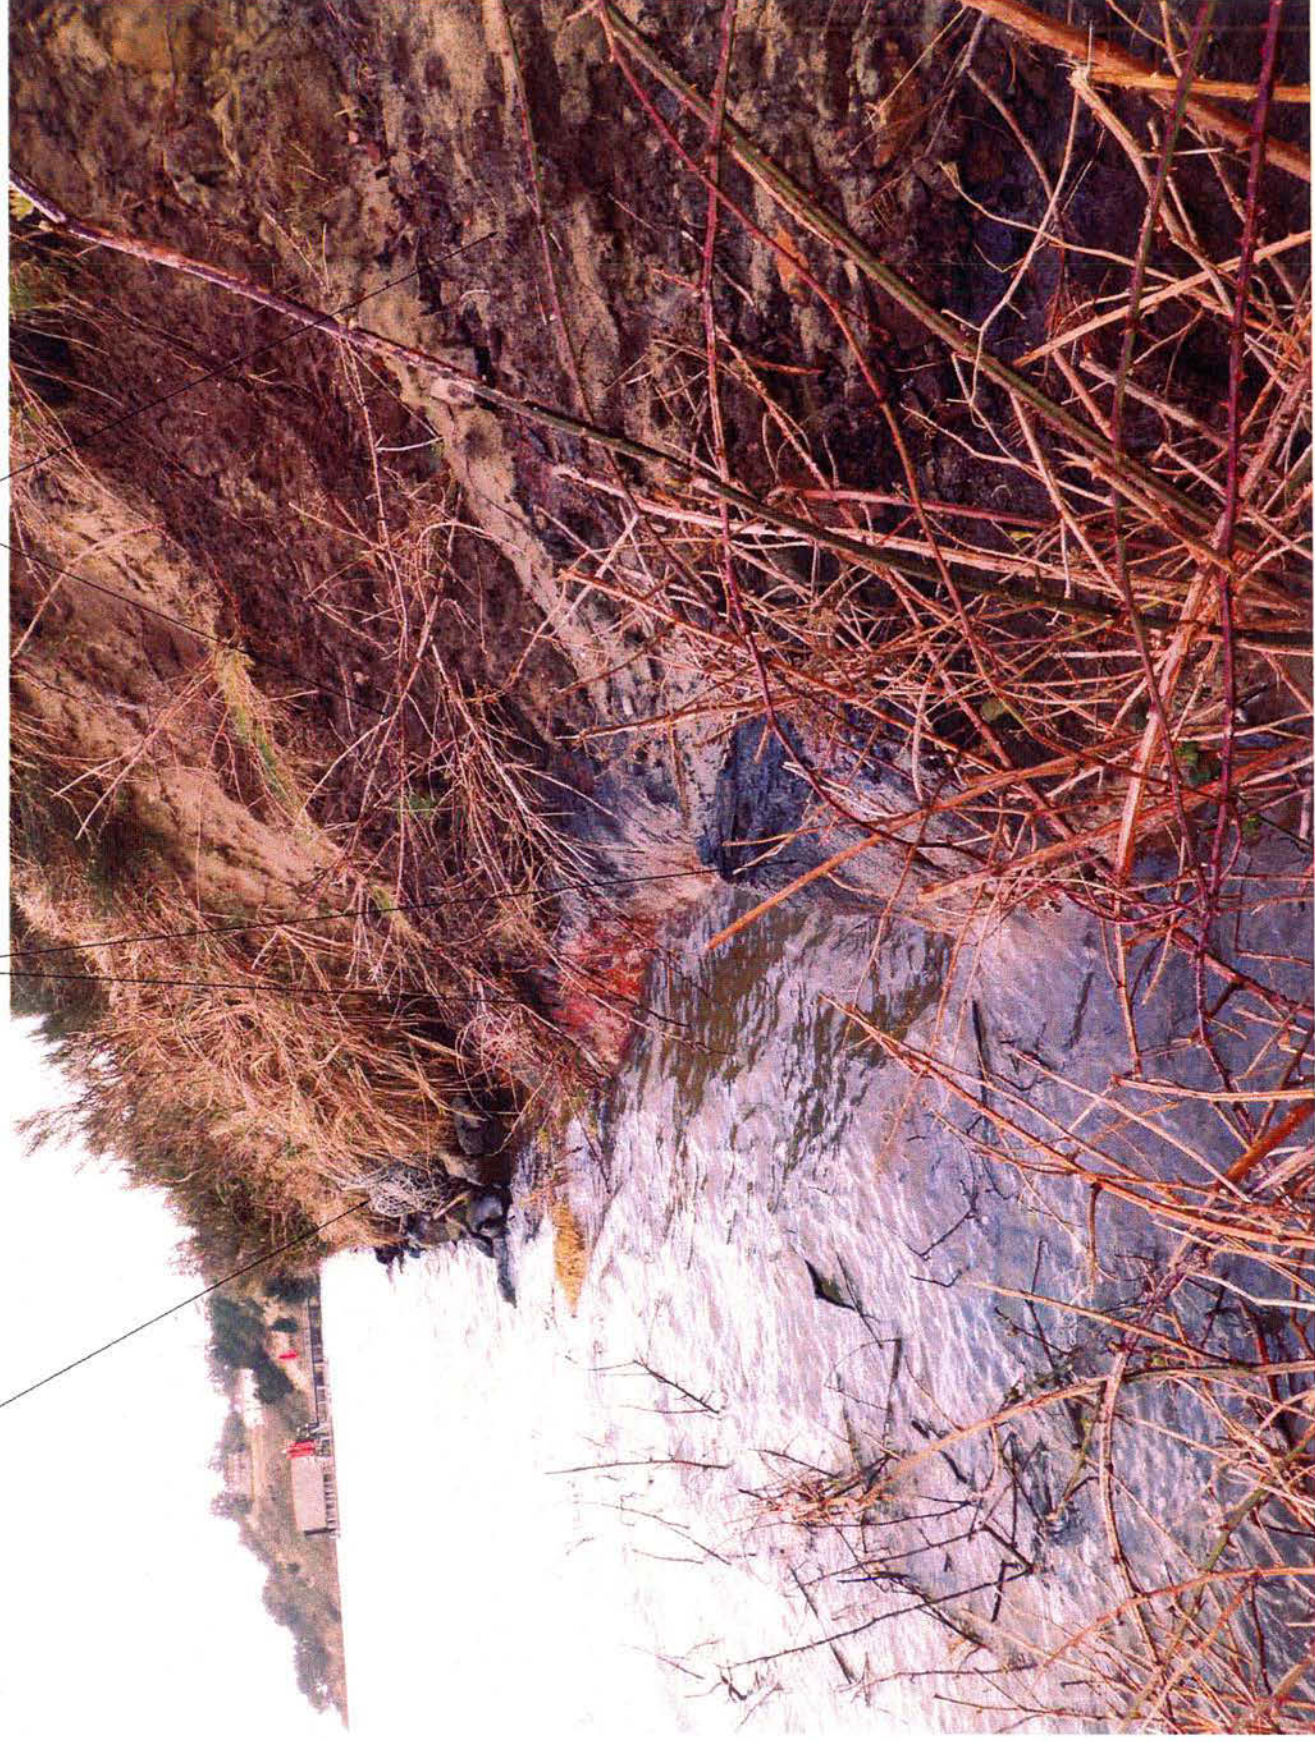
Slope Movement Deposit
