A Resolution Approving the Florence Stormwater Master Plan Update, dated December 2018, including the Capital Improvement Plan in support of the Florence Realization 2020 Comprehensive Plan and Repealing Resolution No. 8, Series 2004.

STORM WATER MASTER PLAN UPDATE

DECEMBER 2018

Civil West

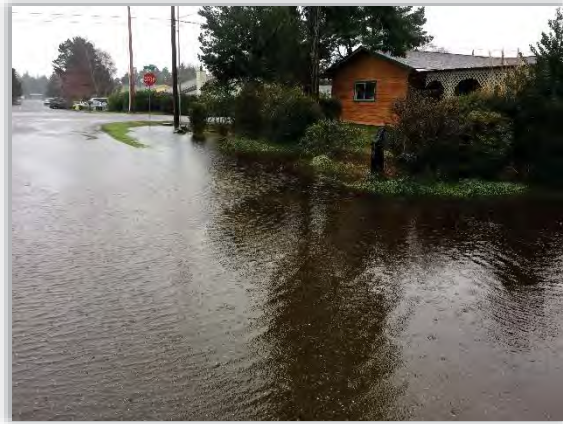
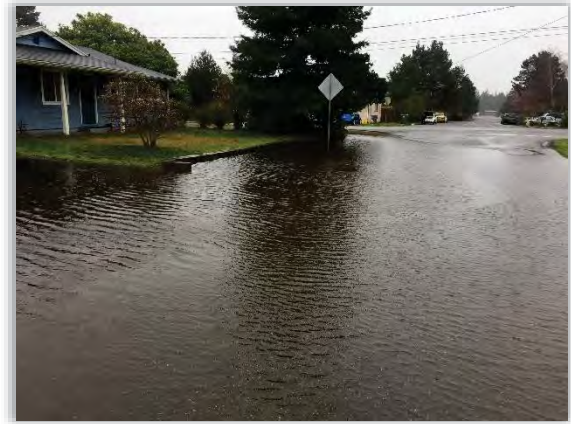
Figure 4-1 - Spruce Street, looking SW

Spruce Street, just north of 42nd Street, was observed to be inundated with storm water during 2016-2017 wet season field inspections. As shown in Figures 4-1 and 4-2, the focal point of the flooding is located approximately 60-70 feet north of the intersection, near the driveways of 4220 and 4211 Spruce Street. The infiltration swales at the road's edge were overflowing, and the water level had risen to the point where the entire roadway was submerged and surface flood waters were approaching the homes on either side of the street.

Figure 4-2 - Spruce Street, looking SE

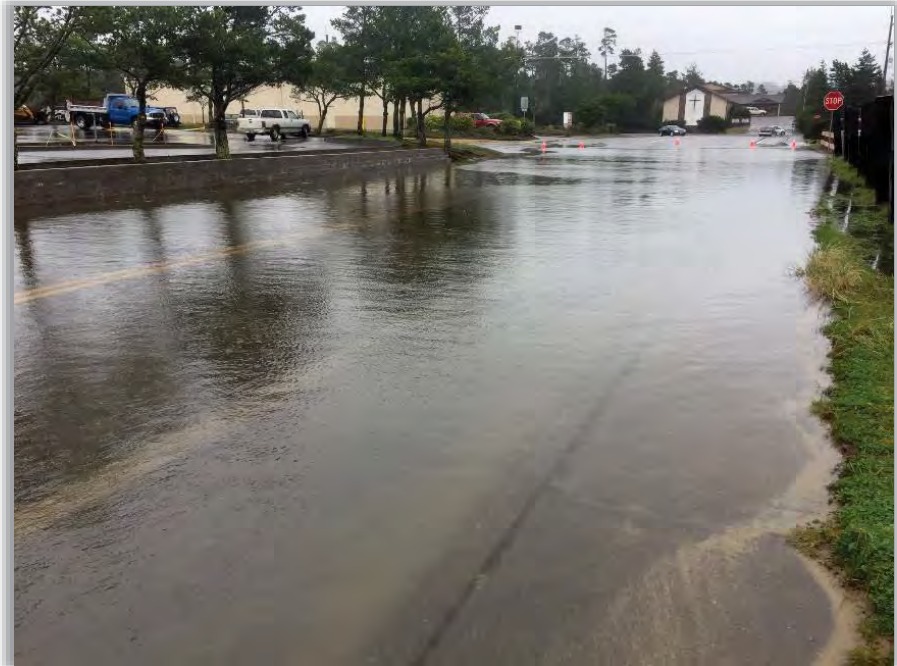
Figure 4-4 - 46th Street, looking East

Wet-season field inspection of this location revealed the shortcomings of the existing drainage system. 46th Street was completely unusable because it was inundated with 8-inches of ground water, as shown in Figure 4-4. Unfortunately, there does not appear to be a “quick fix” solution for these issues. Connecting the existing piping to the highway infrastructure is infeasible because 46th Street piping flows west, in the opposite direction of the highway. There is drainage infrastructure on Oak Street to the west, but it is higher in elevation than 46th Street, which disallows these systems from being connected. Caution should be exercised in any case, because adding flow to either of these systems would increase their demand, possibly exacerbating flooding issues in other parts of the city downstream.

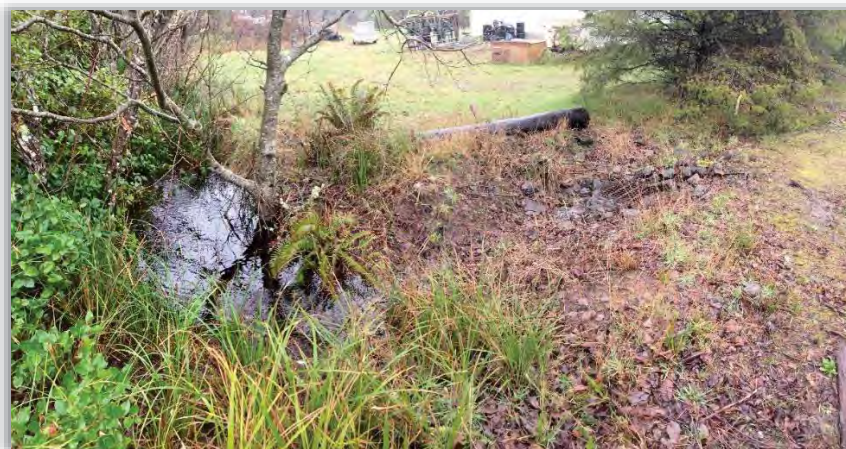
However, the City did install a catch basin at the southeast corner of Tax Lot #300, with an ADS culvert to move *surface* runoff from that parcel to the detention basin on the east side of Spruce Street. The grate elevation of that catch basin is situated well above the hydraulic grade line of the ditch, and during the wet-season of 2016-2017, which saw more rainfall than any other year in the current planning period, water from the Siefert Ditch never rose high enough to crest the grate of the catch basin.

Figure 4-7 - Siefert Ditch with Catch Basin

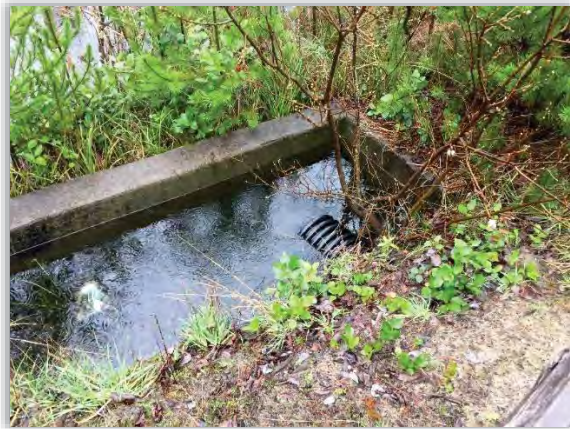
On the east side of Spruce Street, the existing concrete detention basins/ weirs are intended to combine storm water management with road-side aesthetics. These structures have been effective in controlling the flow and improving water quality in the swale toward Munsel Lake Road to the south. In the case of the weir directly east of the Siefert Ditch, City crews have cut a notch in the wall of the weir to lower the discharge elevation of that water quality basin below the grate elevation of the catch basin installed by the City on the southeast corner of Tax Lot #300 (see Figure 4-9).

Figure 4-8 - Detention Ponds/ Weirs

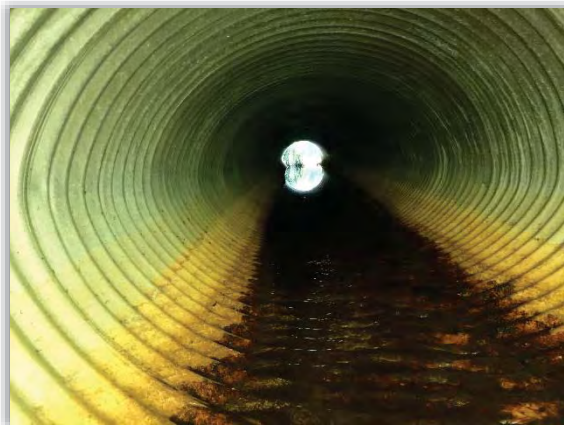
At Munsel Lake Road, storm water splits in two directions. Some flow enters a ditch inlet that conveys water west into the pipe network that travels south along Highway 101. The remainder flows in a ditch east along Munsel Lake Road to a 36-inch CMP culvert which crosses underneath the road. Field inspection of this culvert suggests that it is adequately sized and in reasonably good condition. As shown on the Region 7 Map in the Appendix, after leaving the culvert, this flow travels south, where it splits again. Some of the flow is piped underneath Florentine Estates to Munsel Creek, and the rest of it flows into undeveloped Tax Lot #1812142000700, which contributes to the flooding problems on the east side of Bi-Mart near 42nd Street and Spruce Street (see Section 4.1).

Figure 4-10 - 36" CMP culvert at Munsel Lake Rd.

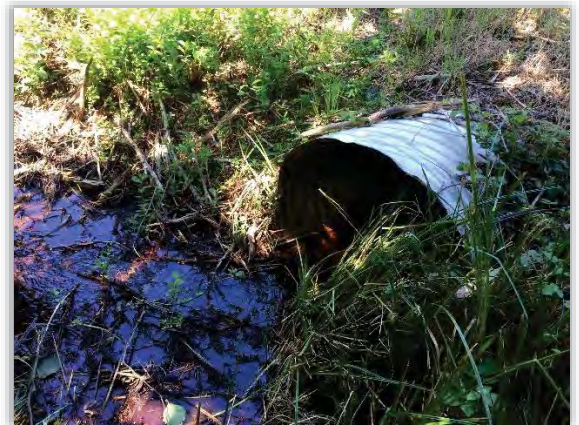
Figure 4-11 - 36" CMP Culvert at Munsel Lake Rd.

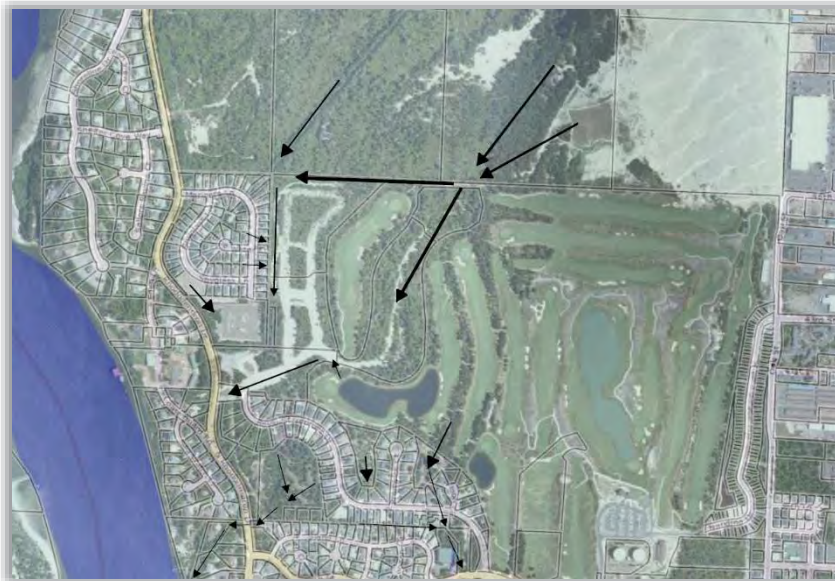
Figure 4-12 - Surface & ground water movement near Mariner's Village

As shown in the figure, storm water flow is concentrated at the northeast corner of the Mariner’s Village subdivision. At that location, the water is collected and piped underneath the development, picking up water from a handful of contributing catch basins along the way. This pipe system then discharges into Tax Lot #4600 (see Lane County Assessor Map #18121532, Appendix B), where it is allowed to pond, forming a natural water body during the wet season. This seasonal wetland is used as a large infiltration basin, until ground water recedes during the summer months.

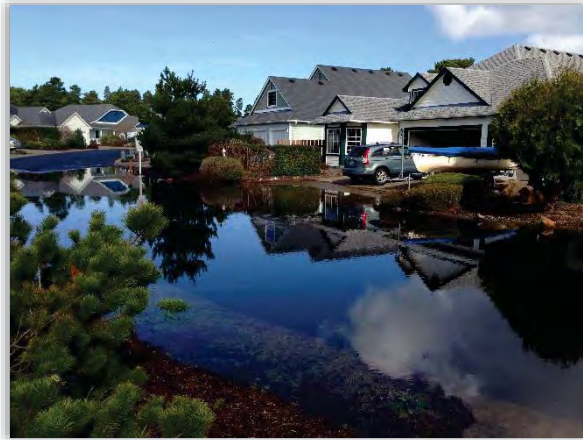
During the wet season of 2016-2017, ground water levels rose to a point where storm water could not be contained within Tax Lot #4600. In fact, flooding spilled out into Tax Lot #126 (labeled “Common Area ‘C’”; see Figure 4-13), which is used as an RV parking lot. Ground water also surcharged back up out of the catch basins throughout the subdivision. Flooding was so excessive that City of Florence Public Works was forced to rent a large pump from Eugene to draw the water down so that flood conditions would not cause damage or loss for nearby residents.

Figure 4-15 - Spyglass Lane flooded after water surcharged out of catch basins

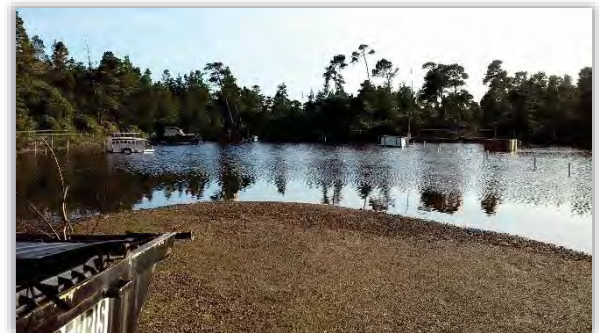
Figure 4-18 - Lot #126 (RV Parking) flooded after #4600 overflowed.

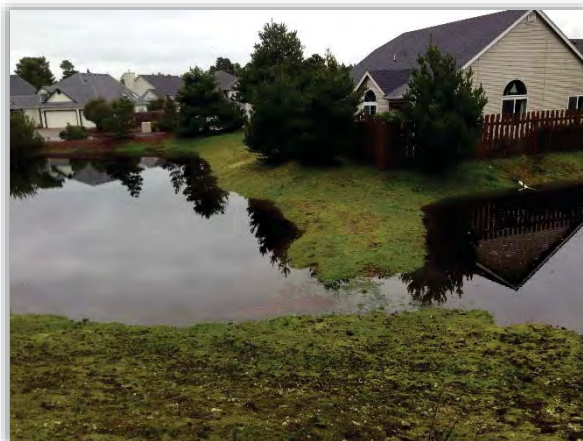
Figure 4-16 - Water overflows from Lot #4600 at this location

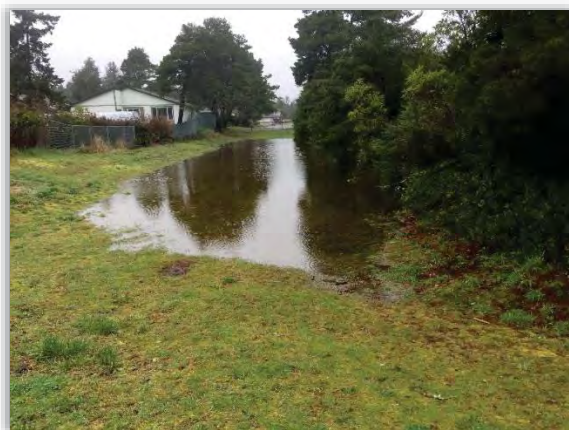
Figure 4-21 - Pine Street, looking north from 28th Street

Figure 4-21 and Figure 4-22 show the flooding that has occurred in this area. Because the undeveloped right of way is topographically lower than the surrounding area, it is possible that high ground water is also contributing to the flooding of the right-of-way. The flooding shown in Figure 4-22 demonstrates that the flooding poses a threat to the businesses there.

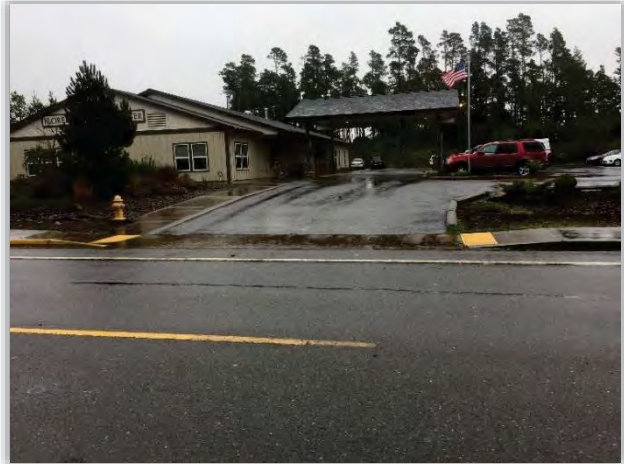
Civil West wet season field inspections of Kingwood Street did not produce any evidence of flooding problems between Airport Way and Airport Road. However, City staff have reported that the driveway entries for the Florence Senior Center (see Figure 4-25) have at times been rendered unusable because flood waters are too deep to allow normal passage.

Figure 4-25 - Florence Senior Center driveway entrance

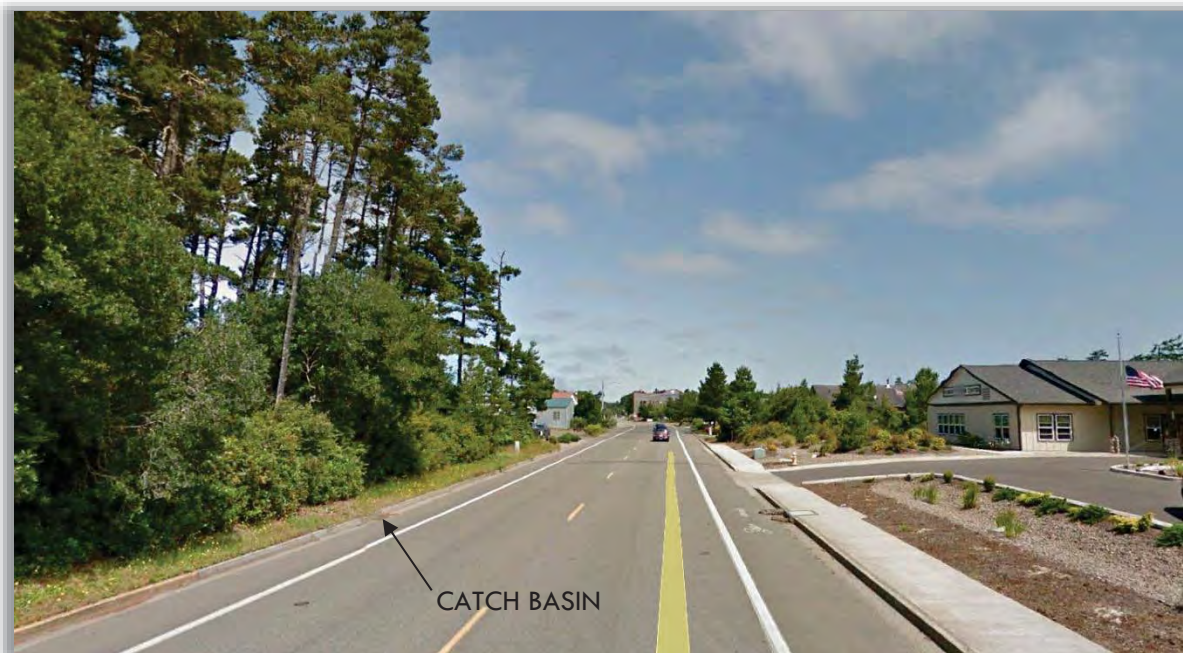
As shown in Figure 4-26, there is a single catch basin on the west side of the street across from the Senior Center, and a curb inlet on the east side next to the driveway. These collection structures fill up with pine needles very quickly, due to the presence of tall coniferous trees lining the west side of the road. The pine needles drop from the trees into the gutter, and are pushed into the catch basin, causing the structure to become clogged, and causing the runoff to be trapped in the driveway area.

Figure 4-26 - Kingwood Street at Florence Senior Center, looking North

It is recommended that the catch basin on the west side of Kingwood, across the street from the Senior Center (shown in Figure 4-26), be removed and replaced with a curb inlet. A curb inlet will be less susceptible to clogging from pine needles, especially if it is constructed with a deep sump. See Figure 6-15 for a potential project layout.

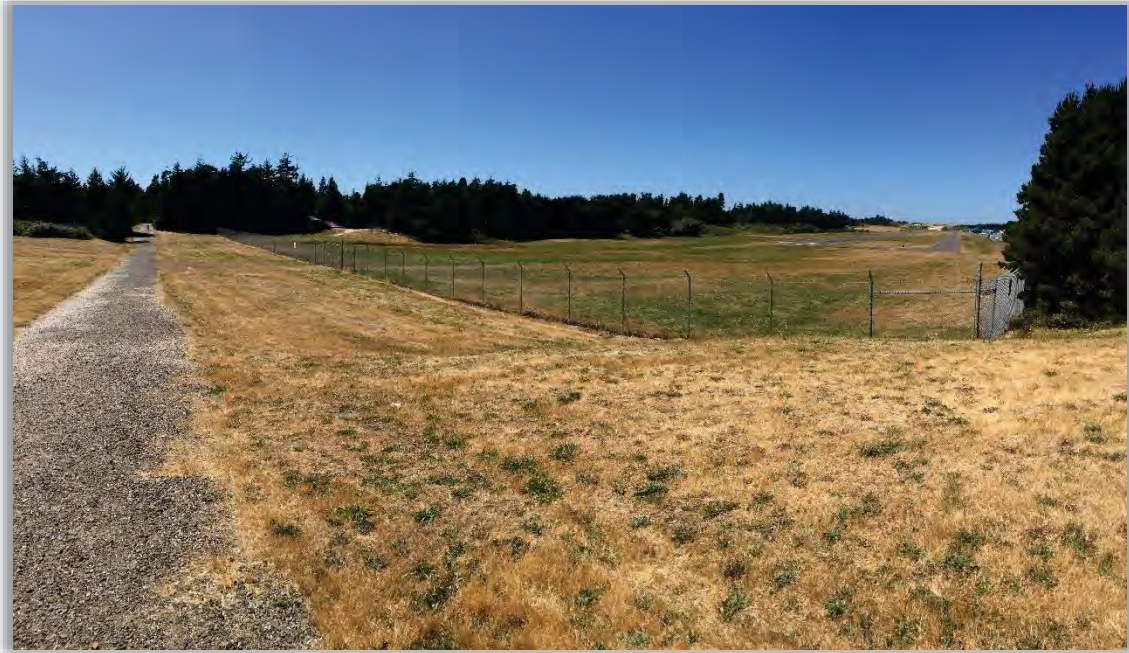
Figure 4-30 - Airport & 12th Street right-of-way, looking NW

Storm water on Kingwood Street, north of Airport Road, is conveyed diagonally across the airport property to the southwest where it crosses underneath the 12th Street right-of-way. Prior to entering the 36-inch CMP inlet, the flow combines with surface runoff that collects at the topographic low point at the south end of the airport runways. As seen on the Region 1 Map in the Appendix, flooding has been reported at this location, and in fact, has been so severe that flood waters have risen high enough to spread out onto the asphalt runway. For this reason, it is possible that the 36-inch culvert is insufficiently sized. As stated, this culvert is CMP on the inlet side, but transitions to ADS before reaching the south side of the right-of-way.

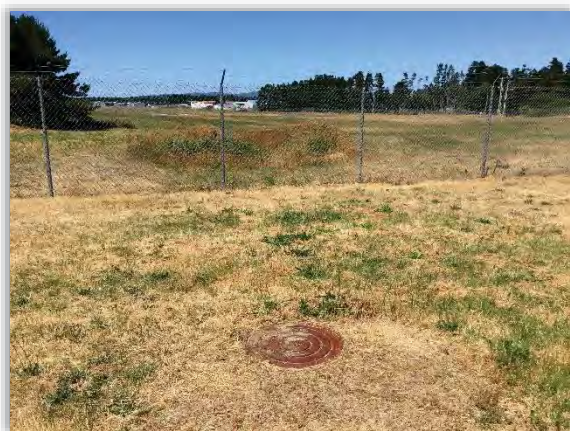
Figure 4-31 - Airport drainage ditch & manhole @ 12th Street R-O-W, SW end of airport property

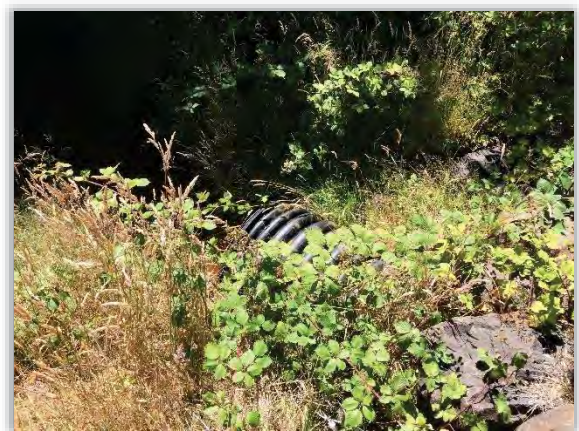
Figure 4-32 - 36" ADS culvert outlet for drainage under 12th Street right-of-way

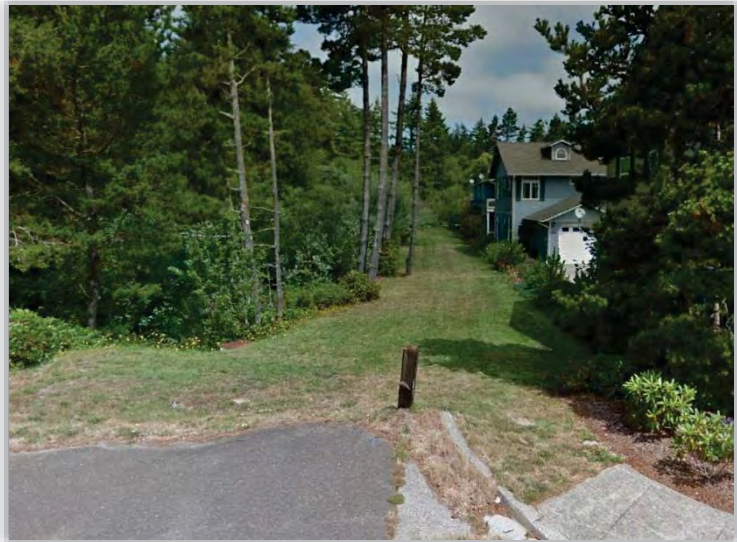
Just prior to reaching the intersection, the ditch runs along the backside of Seabrook Townhomes, whose address is off of Jasper Lane. In 2016, with permission from the City, a resident of the Seabrook Townhomes made considerable efforts to improve the route and cross section of the ditch next to the townhomes, by digging the ditch wider and deeper with a shovel. The motivation for this endeavor was borne by the fact that Seabrook Townhomes were constructed at too low an elevation, and residents there are concerned that high water in the ditch could pose a threat to their townhomes. The modifications to the ditch were done to potentially improve the flow of the ditch, and hopefully relieve/reduce the drainage problems faced by the townhomes.

Figure 4-33 - Seabrook Townhomes & drainage ditch, view from 9th Street, looking North up Ivy Street right-of-way

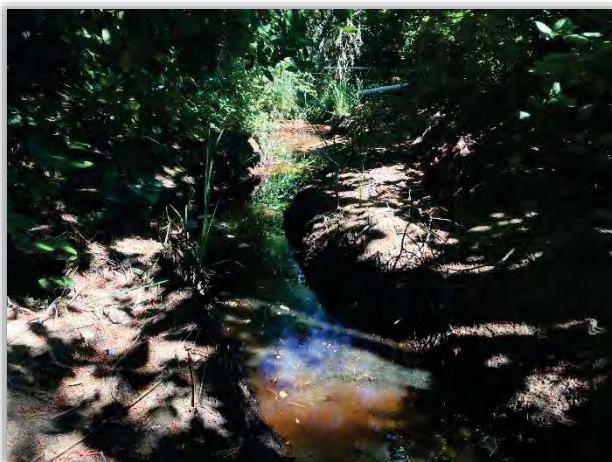
Figure 4-34 - Hand-dug ditch adjacent to Seabrook Townhomes, dry-season field inspection photograph

City Public Works crews have reported that an unforeseen result of hand-digging the ditch is that the sand has been left exposed, subject to erosion. This has caused the culvert and other downstream piping to be significantly silted in, and the City has had to make extra efforts to clean out the piping in this area to maintain capacity. This condition will persist until vegetation grows back in the ditch, but in the meantime, the sedimentation of the system prevents it from flowing at full capacity. This has caused drainage issues everywhere from the Ivy Street ditch to the creek between Elm Street and Fir Street.

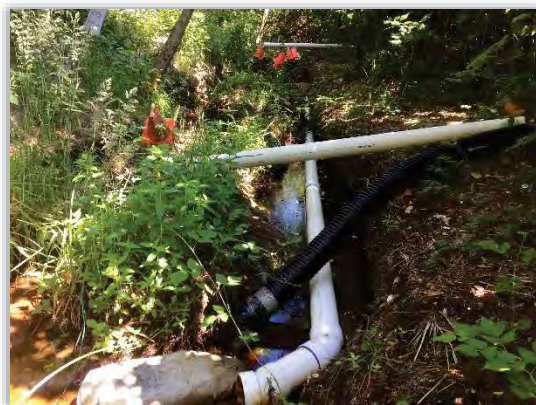
Figure 4-36 - Private drainage piping discharging into ditch. Efforts made by Seabrook Townhomes residents to alleviate flooding

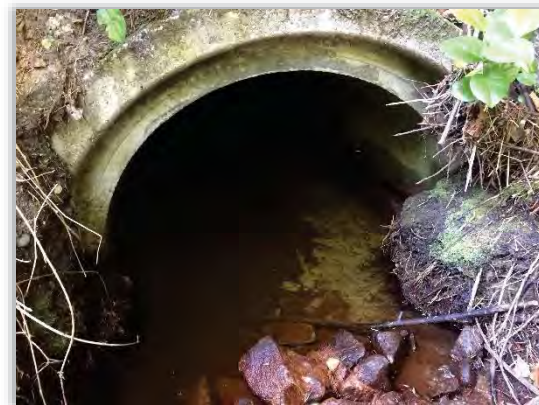
An existing 42-inch concrete culvert conveys water from the ditch into a storm drain manhole located in the intersection of 9th Street and Ivy Street. This manhole channels the flow to the west, where it combines with a few other tributary systems before discharging into a stream at 9th Street between Elm Street and Fir Street. Field inspection of the 42-inch culvert, both in wet-season and dry-season conditions, revealed that the culvert is heavily silted in, which obstructs the flow from the ditch. Figure 4-35 shows the culvert mostly full, and there is evidence that, at times, the water level rises to a point above the crown of

the culvert pipe. This is problematic considering the drainage issues we have just described for the Seabrook Townhomes. Lack of sufficient capacity in the culvert may cause the ditch to backup and overflow on to the property of the townhomes. However, with a thorough cleaning, and control of incoming sediment, it is likely that the culvert will perform as needed.

Figure 4-37 - Dry-season field inspection photograph of 42-inch concrete culvert inlet, silted in

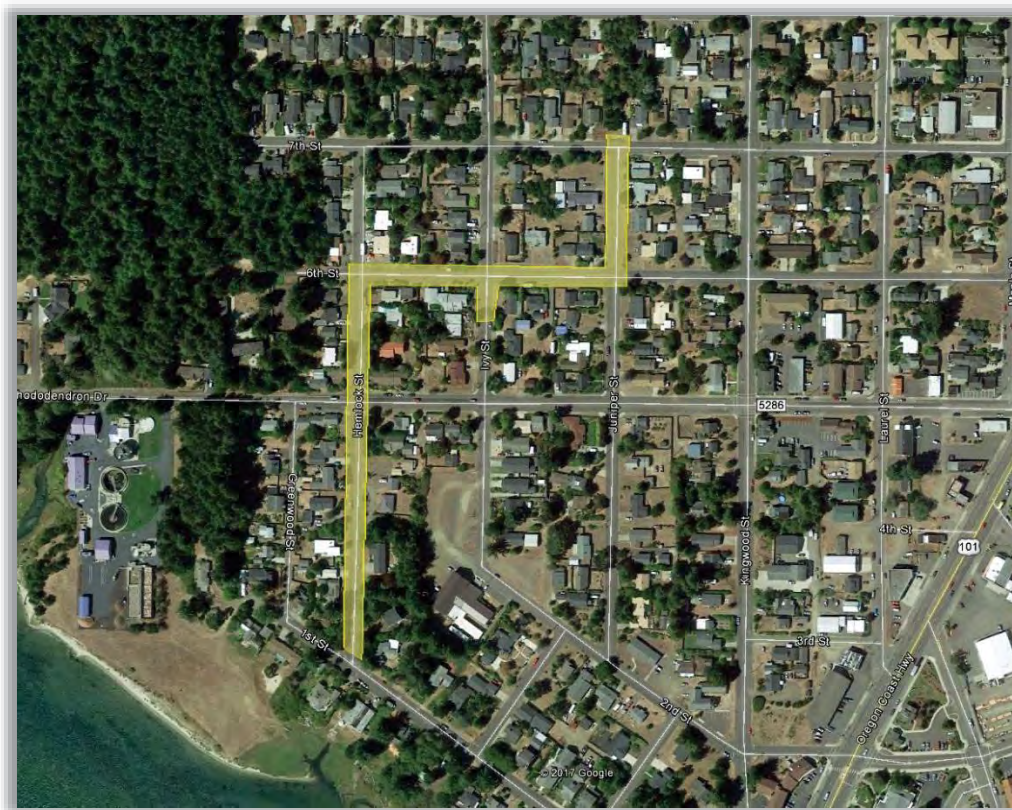
To respond to this issue, the City can do its part by prohibiting street runoff from crossing onto private property. To accomplish this, the City’s storm system must have sufficient capacity to handle the demand of a peak storm event. In this spirit, the City is actively working to up-size storm water piping in these neighborhoods, as shown in Figure 4-39 .

Figure 4-39 - Map of storm water improvements currently under design in the Old Town area.

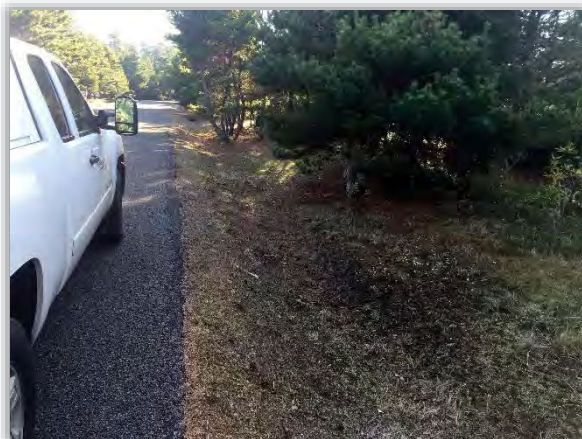
Field inspection of these neighborhoods revealed the presence of roadside ditches and infiltration swales along virtually every street inspected. As shown in Figure 4-41 and Figure 4-42, this infrastructure appeared to be in good condition although it is unclear if the capacity of this system has been sufficient to handle peak flows.

Figure 4-41 - Roadside Ditch (Sandrift Street)

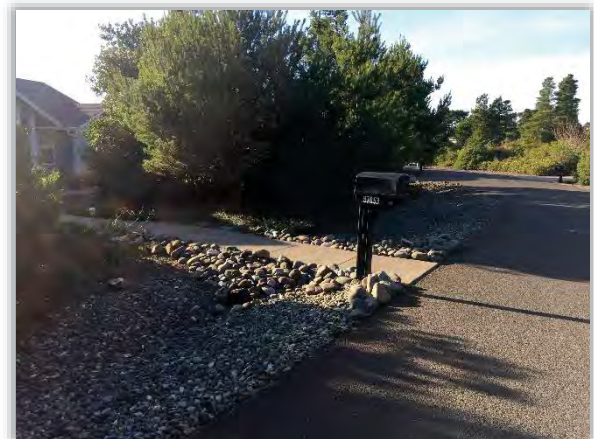
Figure 4-42 - Roadside infiltration swale (Saltaire Street)

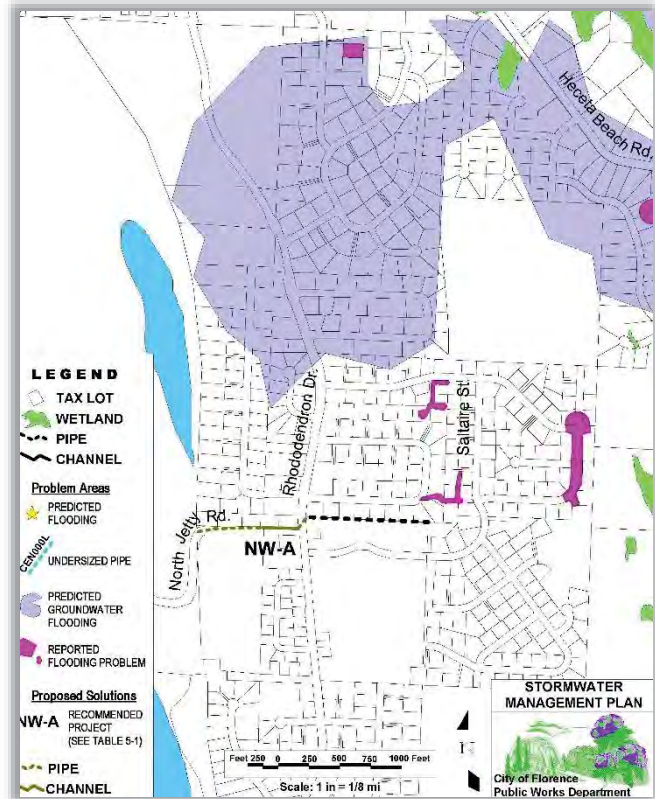
Residents of these neighborhoods have also constructed a small amount of conveyance infrastructure to supplement their roadside ditches and infiltration swales. This infrastructure, which can be seen in Figure 4-43, consists of a concrete-lined channel and 12-inch pipe to move water from the south side of Sea Pines Drive, across Rhododendron Drive to North Jetty Road. (Figure 4-43 is borrowed from SWMP2000.)

Figure 4-43 - Figure 5-1 from SWMP2000, shows existing drainage infrastructure and flooding problems in the neighborhoods northwest of the city boundary

SWMP 2000 recommended the addition of a pumping facility in Gullsettle Court, as well as replacement of the 12-inch culvert which passes underneath Rhododendron Drive. At the time of SWMP2000 the ditch along North Jetty Road was in poor condition and the 18-inch culvert at its west end did not exist. It was recommended that the 18-inch culvert be installed with large riprap at the bottom of the bluffs to dissipate energy at the base of the slope and prevent erosion. It has not been verified whether this recommendation was heeded.

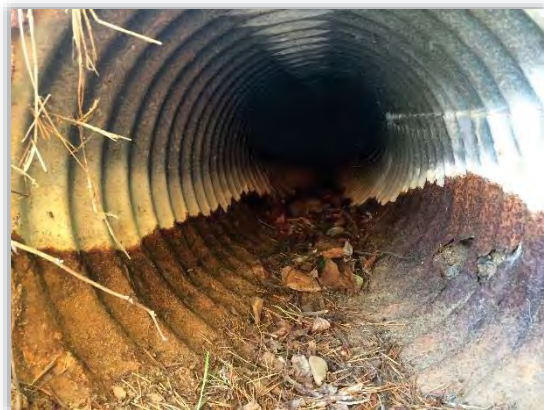
From there, a ditch conveys water to the west along the north edge of North Jetty Road, until it reaches an 18" CMP culvert, which carries water over the edge of the steep bank, and down toward the North Jetty Recreation Area. This culvert, shown in Figure 4-44, has experienced extensive corrosion, and needs to be replaced. It is unclear where this pipe eventually discharges, as its terminus could not be located during field inspection.

Figure 4-44 - 18-inch CMP culvert at top of bluffs on North Jetty Road

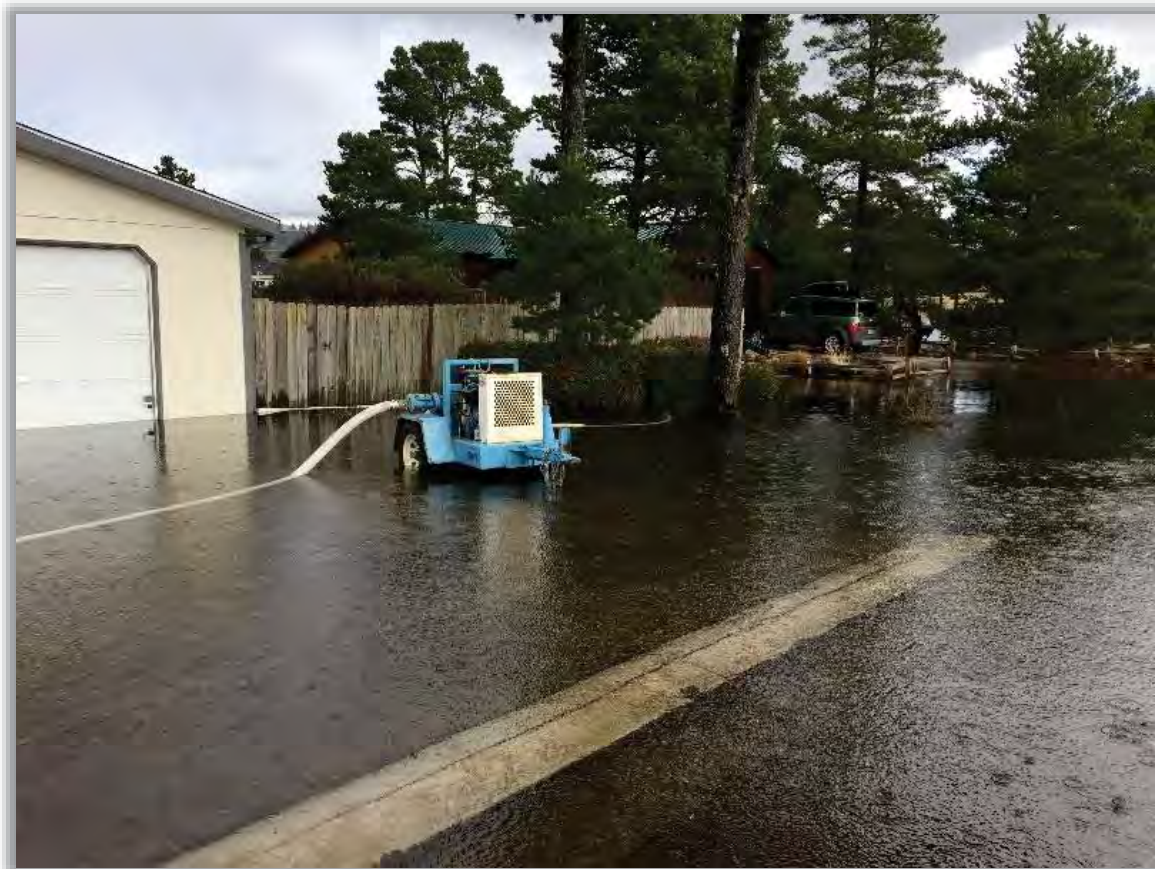
The development's proximity to this seasonal wetland has been problematic during times of high rainfall because the wetland does not have a discharge point. Instead, when the water table rises in the wetland, ground water surcharges back on to city streets, and remains until the water table recedes once again, or as in the winter of 2017, it is pumped out at the City's expense.

Figure 4-45 - Driveway of 1720 Pine Court, pumping flood waters west across Willow Loop into Munsel Creek

The City of Florence has already engaged in planning efforts to correct these issues. This summary has been provided, simply to collect and summarize all the City's major drainage issues in the same document. See Pine Court Storm Drainage System Improvements – Evaluation of Alternatives (2017) for more information.

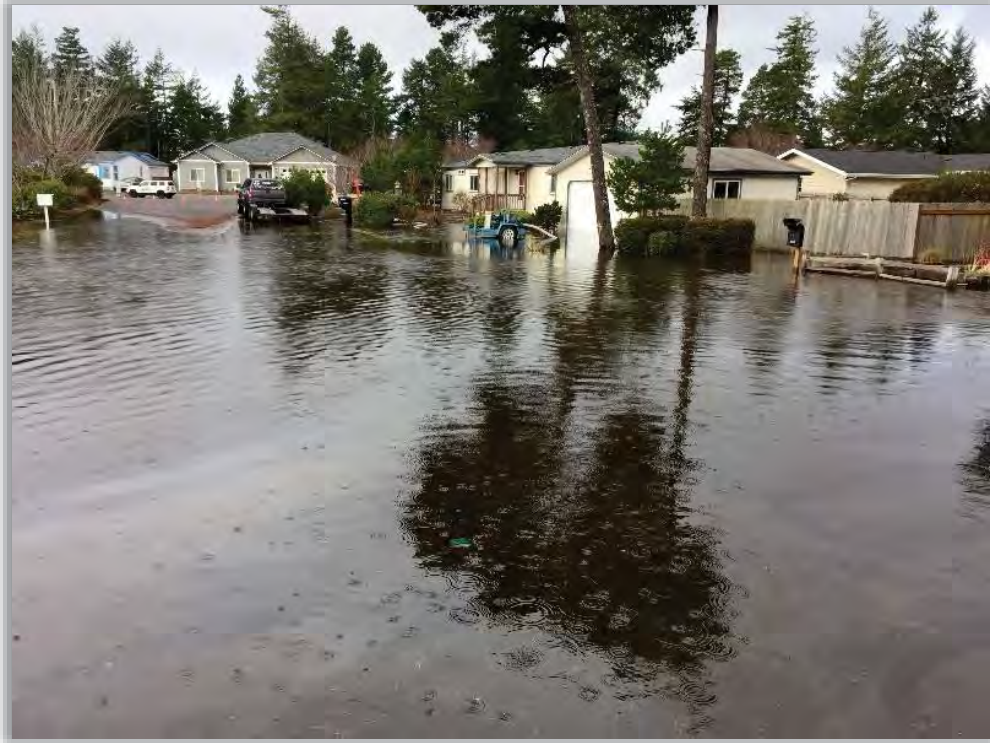
Figure 4-46 - Pine Court, flooded with more than 12-inches of ground water

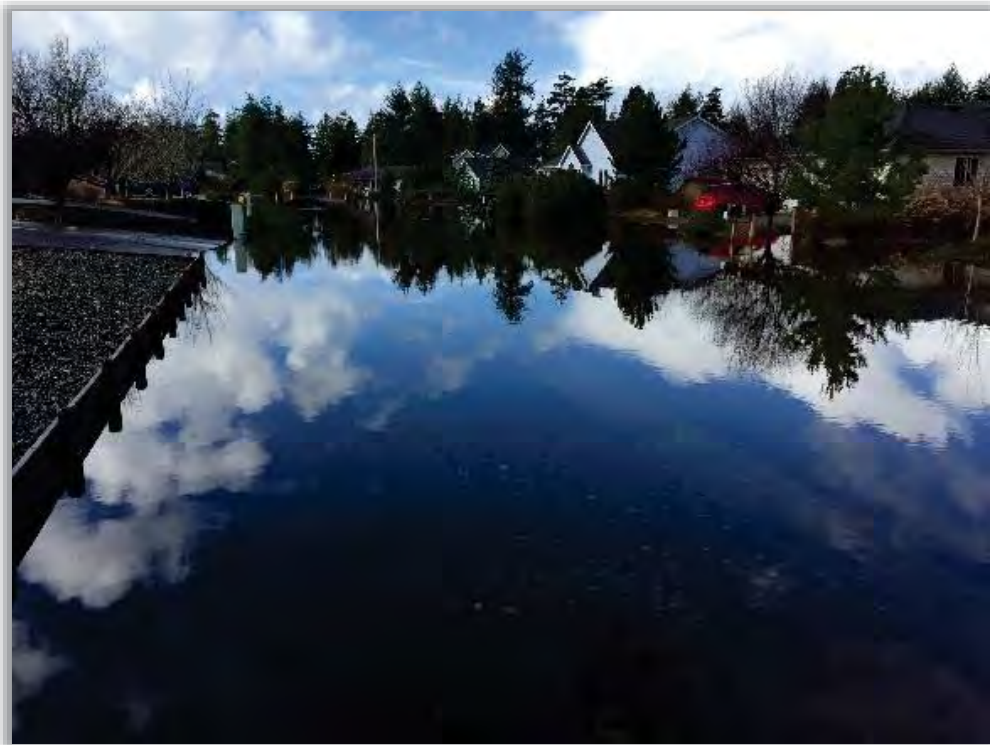
Figure 4-47 - 16th Street, flooded with more than 12-inches of ground water

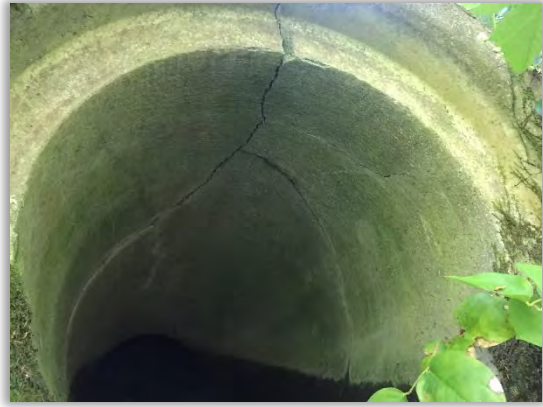
There is a separate outfall pipe approximately 15 to 20 feet south of this 84-inch CMP culvert. It is a 24-inch concrete outfall pipe for the 12th Street underground drainage infrastructure. Field inspection of this outfall revealed that the concrete is cracked along the crown of the pipe (Figure 5-5), and the pipe is heavily silted in (Figure 5-6). The sedimentation of this pipe is a result of its slope, which goes uphill in the direction of drainage. In this way, the pipe acts as a filtration weir. After the water crests the discharge invert elevation, the water flows down a concrete chute into Munsel Creek (see Figure 5-7).

Figure 5-5 - 24-inch concrete outfall, cracking in the pipe crown

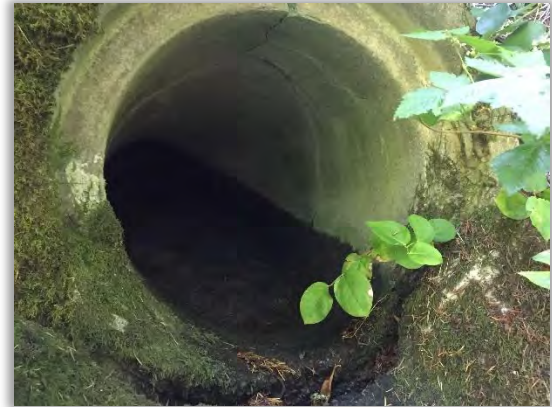
Figure 5-6 - Outfall pipe is sloped uphill in the direction of flow, causing sedimentation

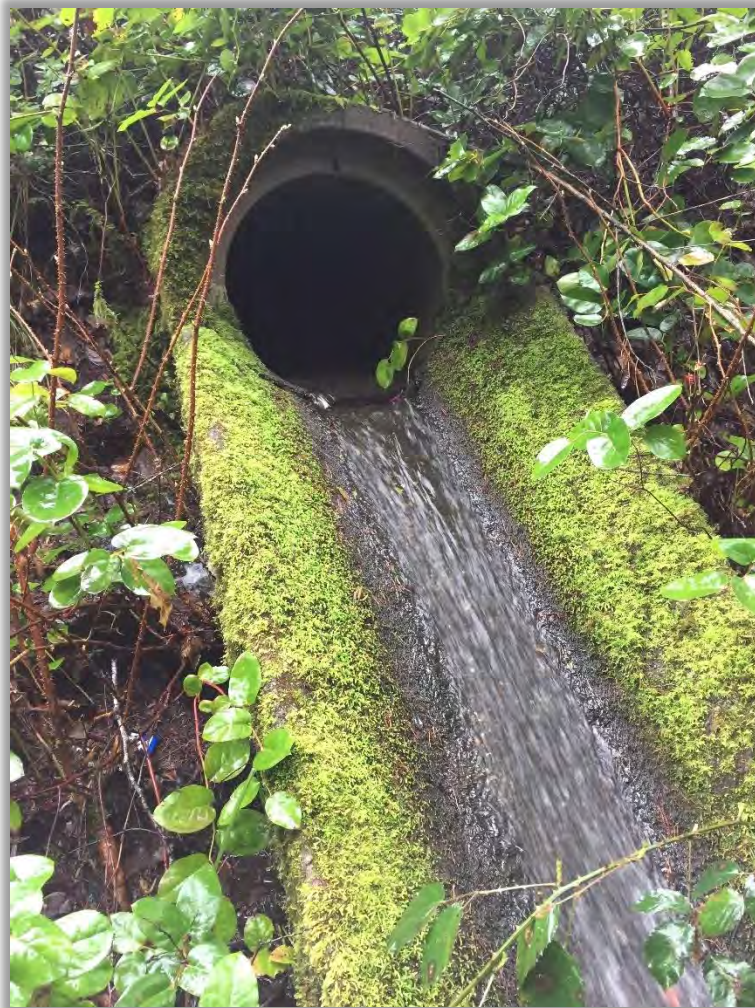
Figure 5-7 - Concrete chute channeling flow down into Munsel Creek

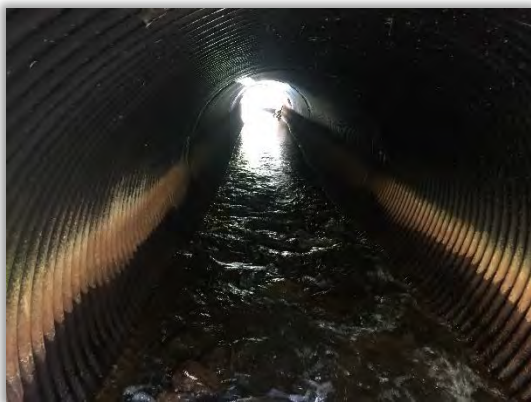
Field inspection of the inside of the culvert indicates that the pipe has sufficient capacity to handle the peak flows experienced at this location, and no reports have been filed by the City or the Public regarding flooding in this area. For a view of the inside of this culvert, see Figure 5-10.

Figure 5-10 - Inside of 72-inch culvert, level of water stains suggests sufficient capacity

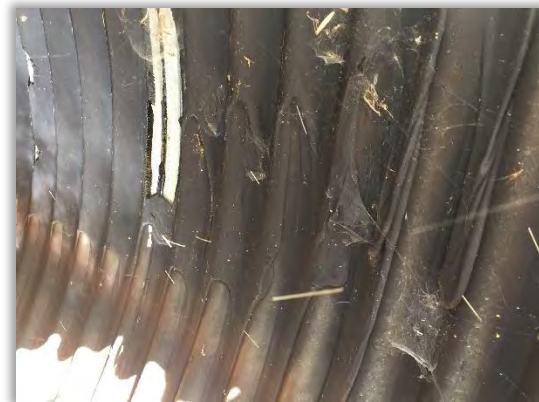
In addition to the CLSM cap, City crews have coated the inside of this culvert with an old coal-tar epoxy, which is common for increasing the longevity of corrugated metal pipe. In many places, the epoxy coating was observed to be peeling away, leaving the bare steel exposed, and increasing its susceptibility to future corrosion.

Figure 5-11 - Coal-tar epoxy present on pipe wall

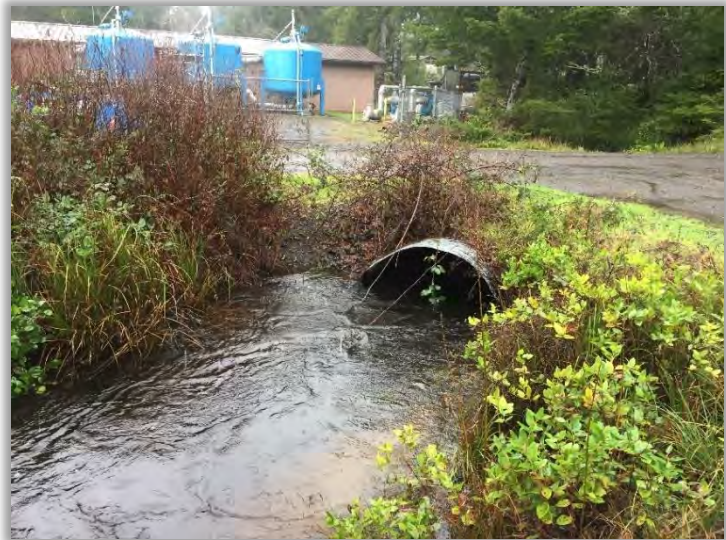
Munsel Creek crosses underneath Willow Street on the northeast side of the Florence Water Treatment Plant via a single 60-inch CMP culvert. This culvert is in relatively good condition in comparison with other CMP culverts in the city. Field inspection revealed no dislocations, and only minimal amounts of corrosion were observed in the pipe wall.

The pipe cross section is slightly deformed but does not appear to have caused any significant impact to the road above. This road, “Willow”, is a gravel access road used only for Treatment Plant operations and presently does not experience heavy traffic loads. The culvert has somewhat less-than-average bury depth (between 12” and 18”), but this appears to be holding up well.

Figure 5-14 - 60-inch CMP culvert at WTP

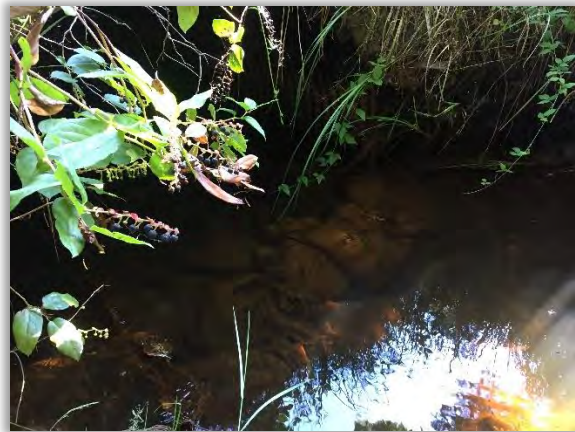
Field inspection indicates that this culvert appears to have adequate capacity, flowing at 50% to two-thirds capacity during peak flow conditions. There have been no reports of overflow or flooding at this location. As shown in Figure 5-15, sand bags were discovered on the inlet side of the culvert. These sand bags were not installed as a flood-prevention or sedimentation averting mechanism. City staff indicated that the sand bags were installed as part of the Salmon Trout Enhancement Program (STEP), to slow flow at this location, and make a settling pond of sorts, just prior to entering the culvert. Dry season inspection revealed that the sand bags do not appear to have impeded the flow through the culvert.

Figure 5-15 - Sand bags installed as part of STEP

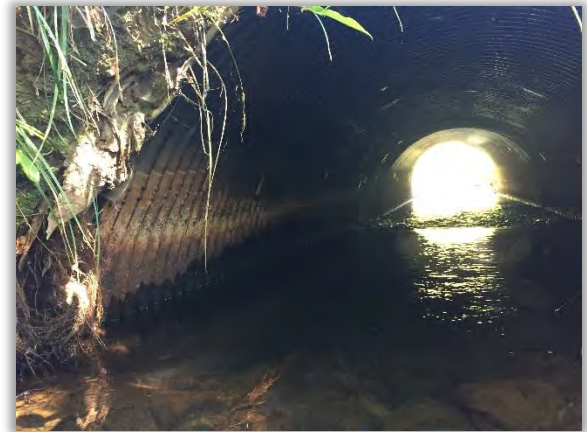
Figure 5-16 - Inside of WTP culvert

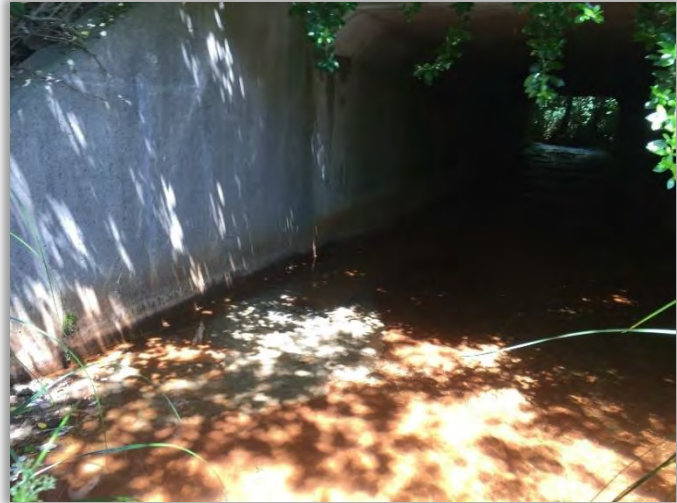
Ultimately, this stream crosses underneath Rhododendron Drive via a 10-foot wide by 8-foot tall box culvert, which is notably one of the largest storm water conveyance structures in Florence. However, once the water exits the box culvert on the west side, it is not permitted to maintain the same volume of space because the stream comes to a tee in the middle of the Marine Manor PUD where housing and landscaping have been constructed. There is a small berm on the outlet side of the culvert, and a stilling basin to dissipate the water's energy before it is channeled into a single 36-inch corrugated metal pipe which conveys water across the Marine Manor properties and discharges into the Siuslaw River through a sea wall discharge. Somewhere prior to reaching the sea wall, the CMP culvert transitions to 36-inch ADS pipe.

Figure 5-17 - 10' x 8' box culvert crossing Rhododendron Drive

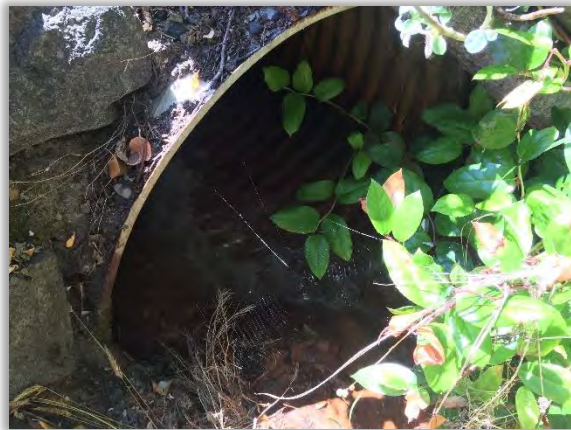
This dramatic reduction in cross-sectional area is not necessarily problematic, as long as the 36-inch culvert is adequately sized to convey storm water during peak flow conditions. During dry-season field inspections, a resident of the PUD expressed concern over the substantial amounts of flow that culminate at this location, but no other reports have been logged by Civil West engineers or the City.

Figure 5-18 - 36-inch CMP pipe from box culvert to river

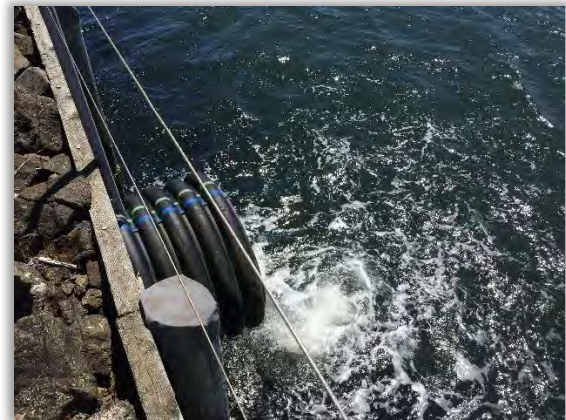
Figure 5-19 - 36-inch outfall constructed of ADS
