APPENDIX A:

SITE PHOTOS

16 Sea Watch Estates, Florence, Bank Failure Assessment/Mitigation
Site on January 17, 2011. View of Failure from N End. View E and S.
Panorama Generated from GeoScience Site Photos 1/17/2011

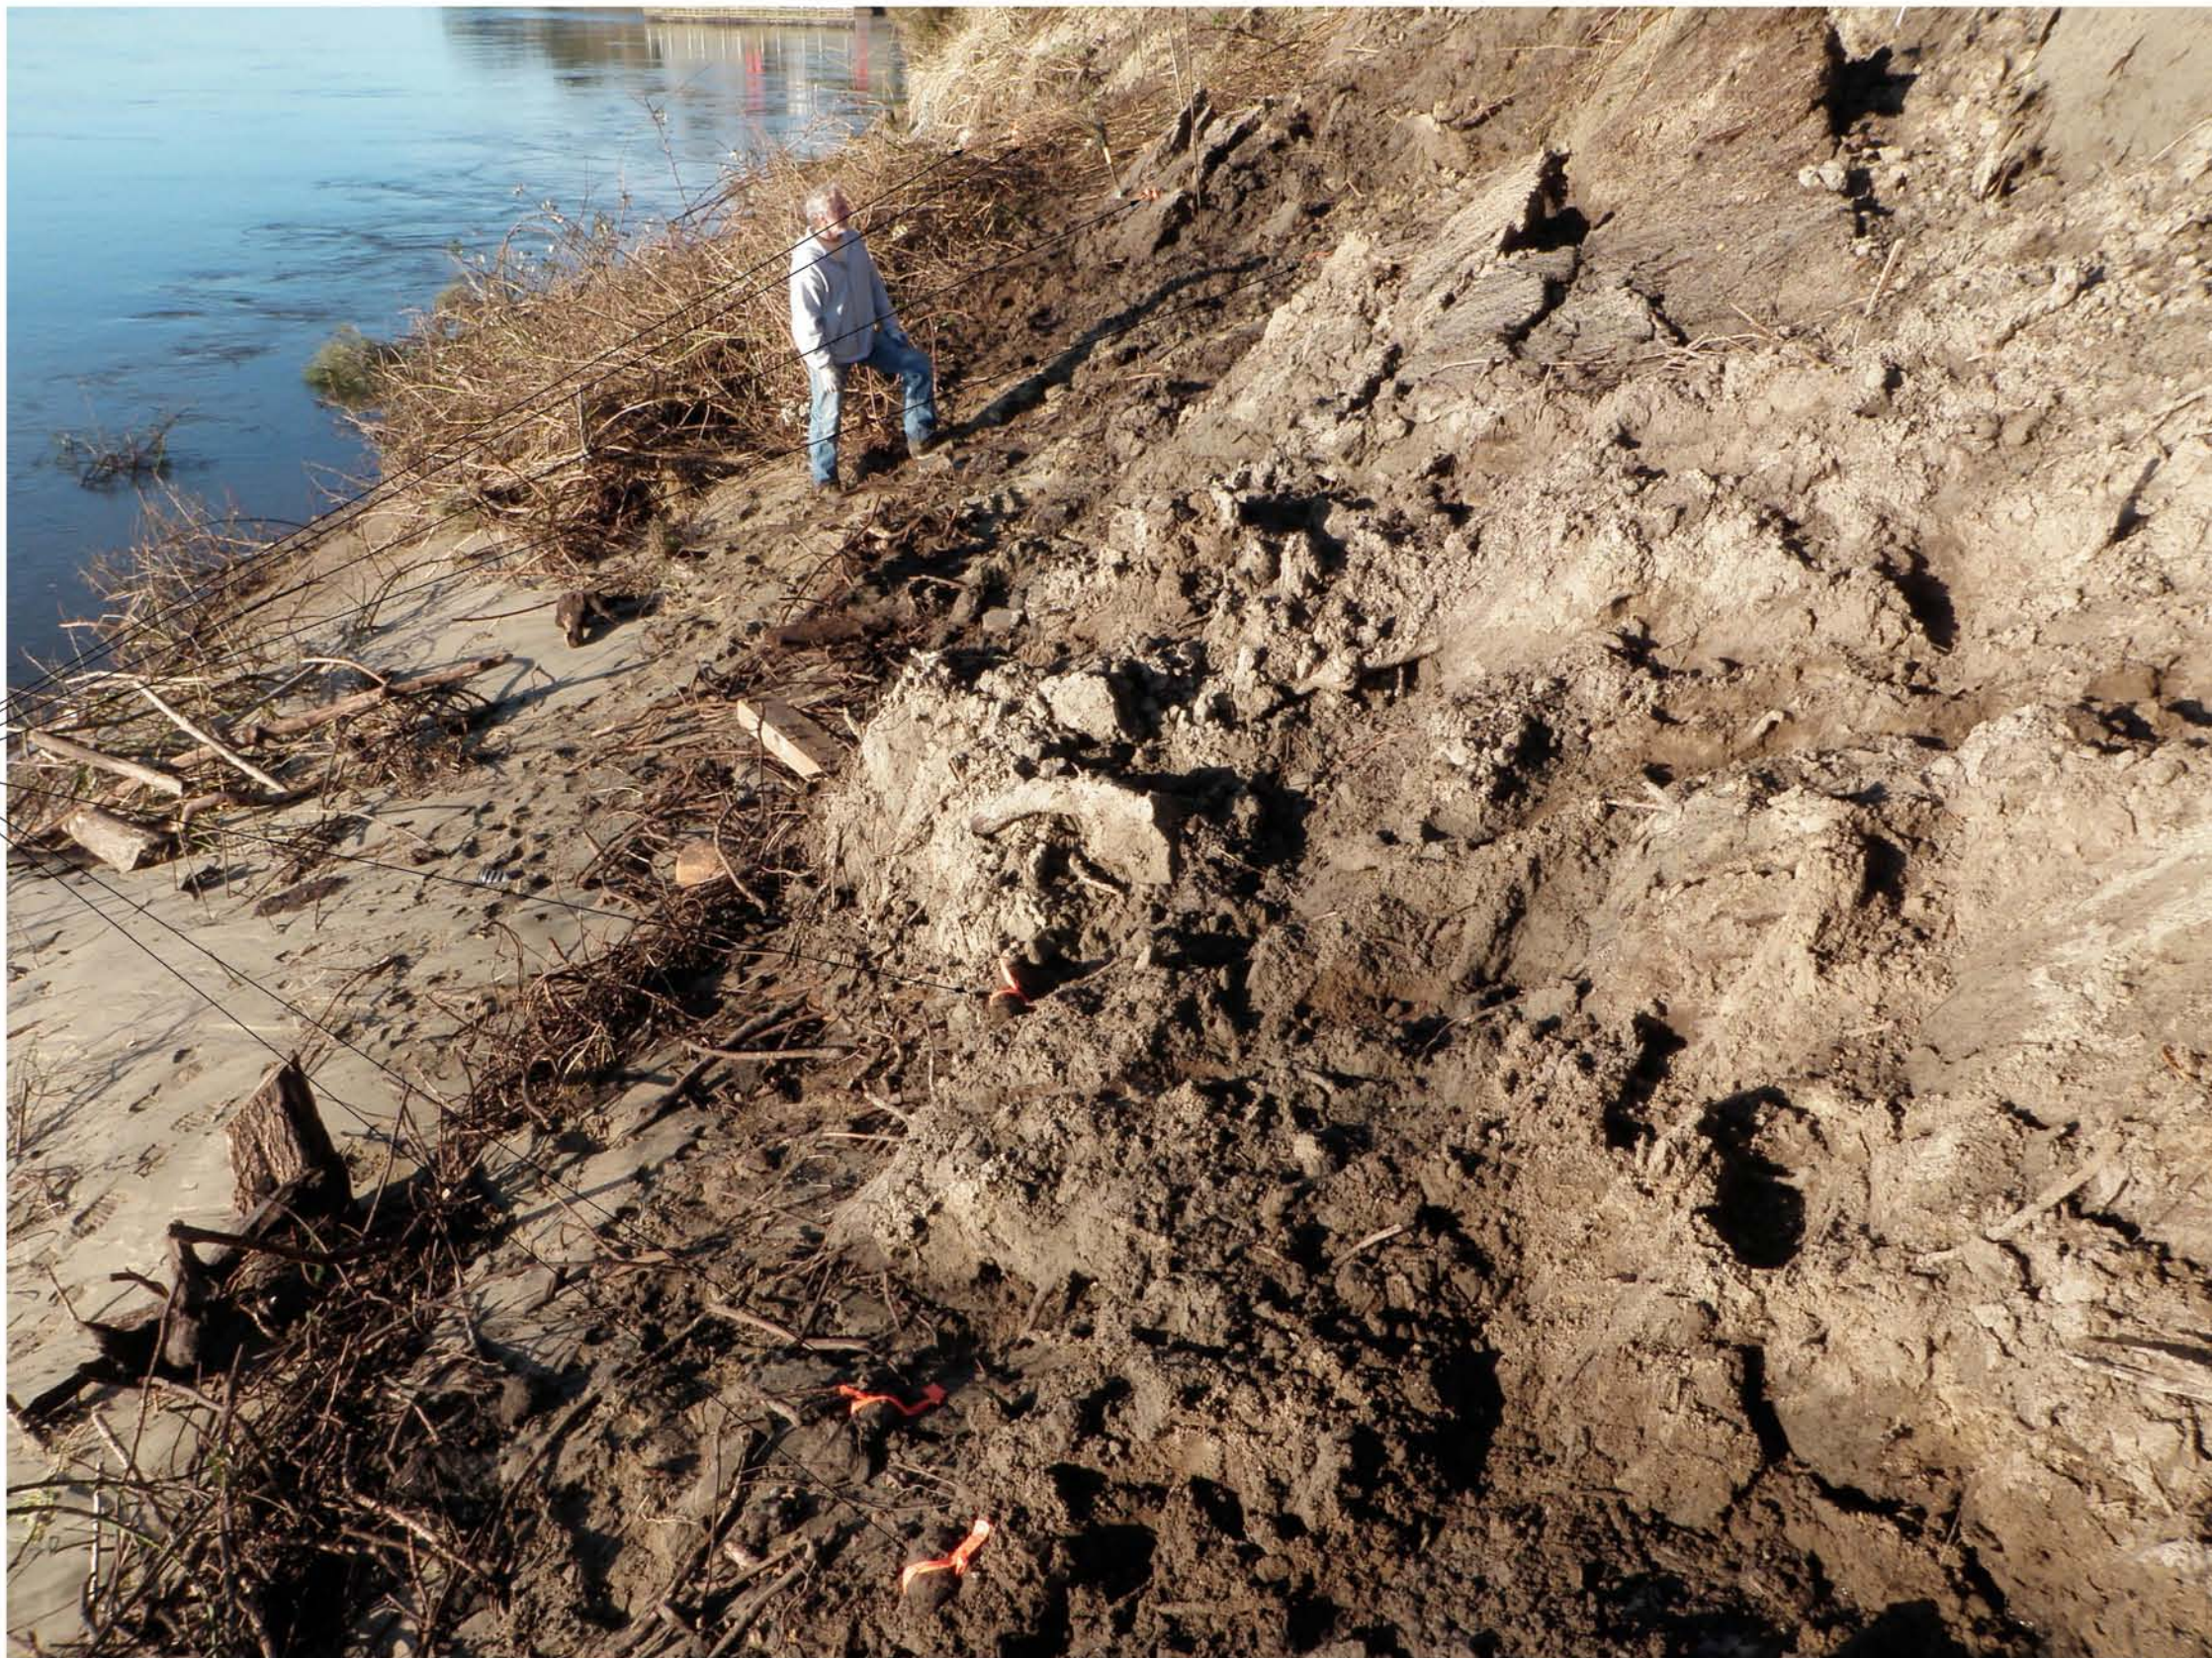
16 Sea Watch Estates, Florence, Bank Failure Assessment/Mitigation
January 17, 2011. View S Along Cliff-forming SU-3
GeoScience Site Photos 1/17/2011

Buried Upper Edge of SU-3 Marked

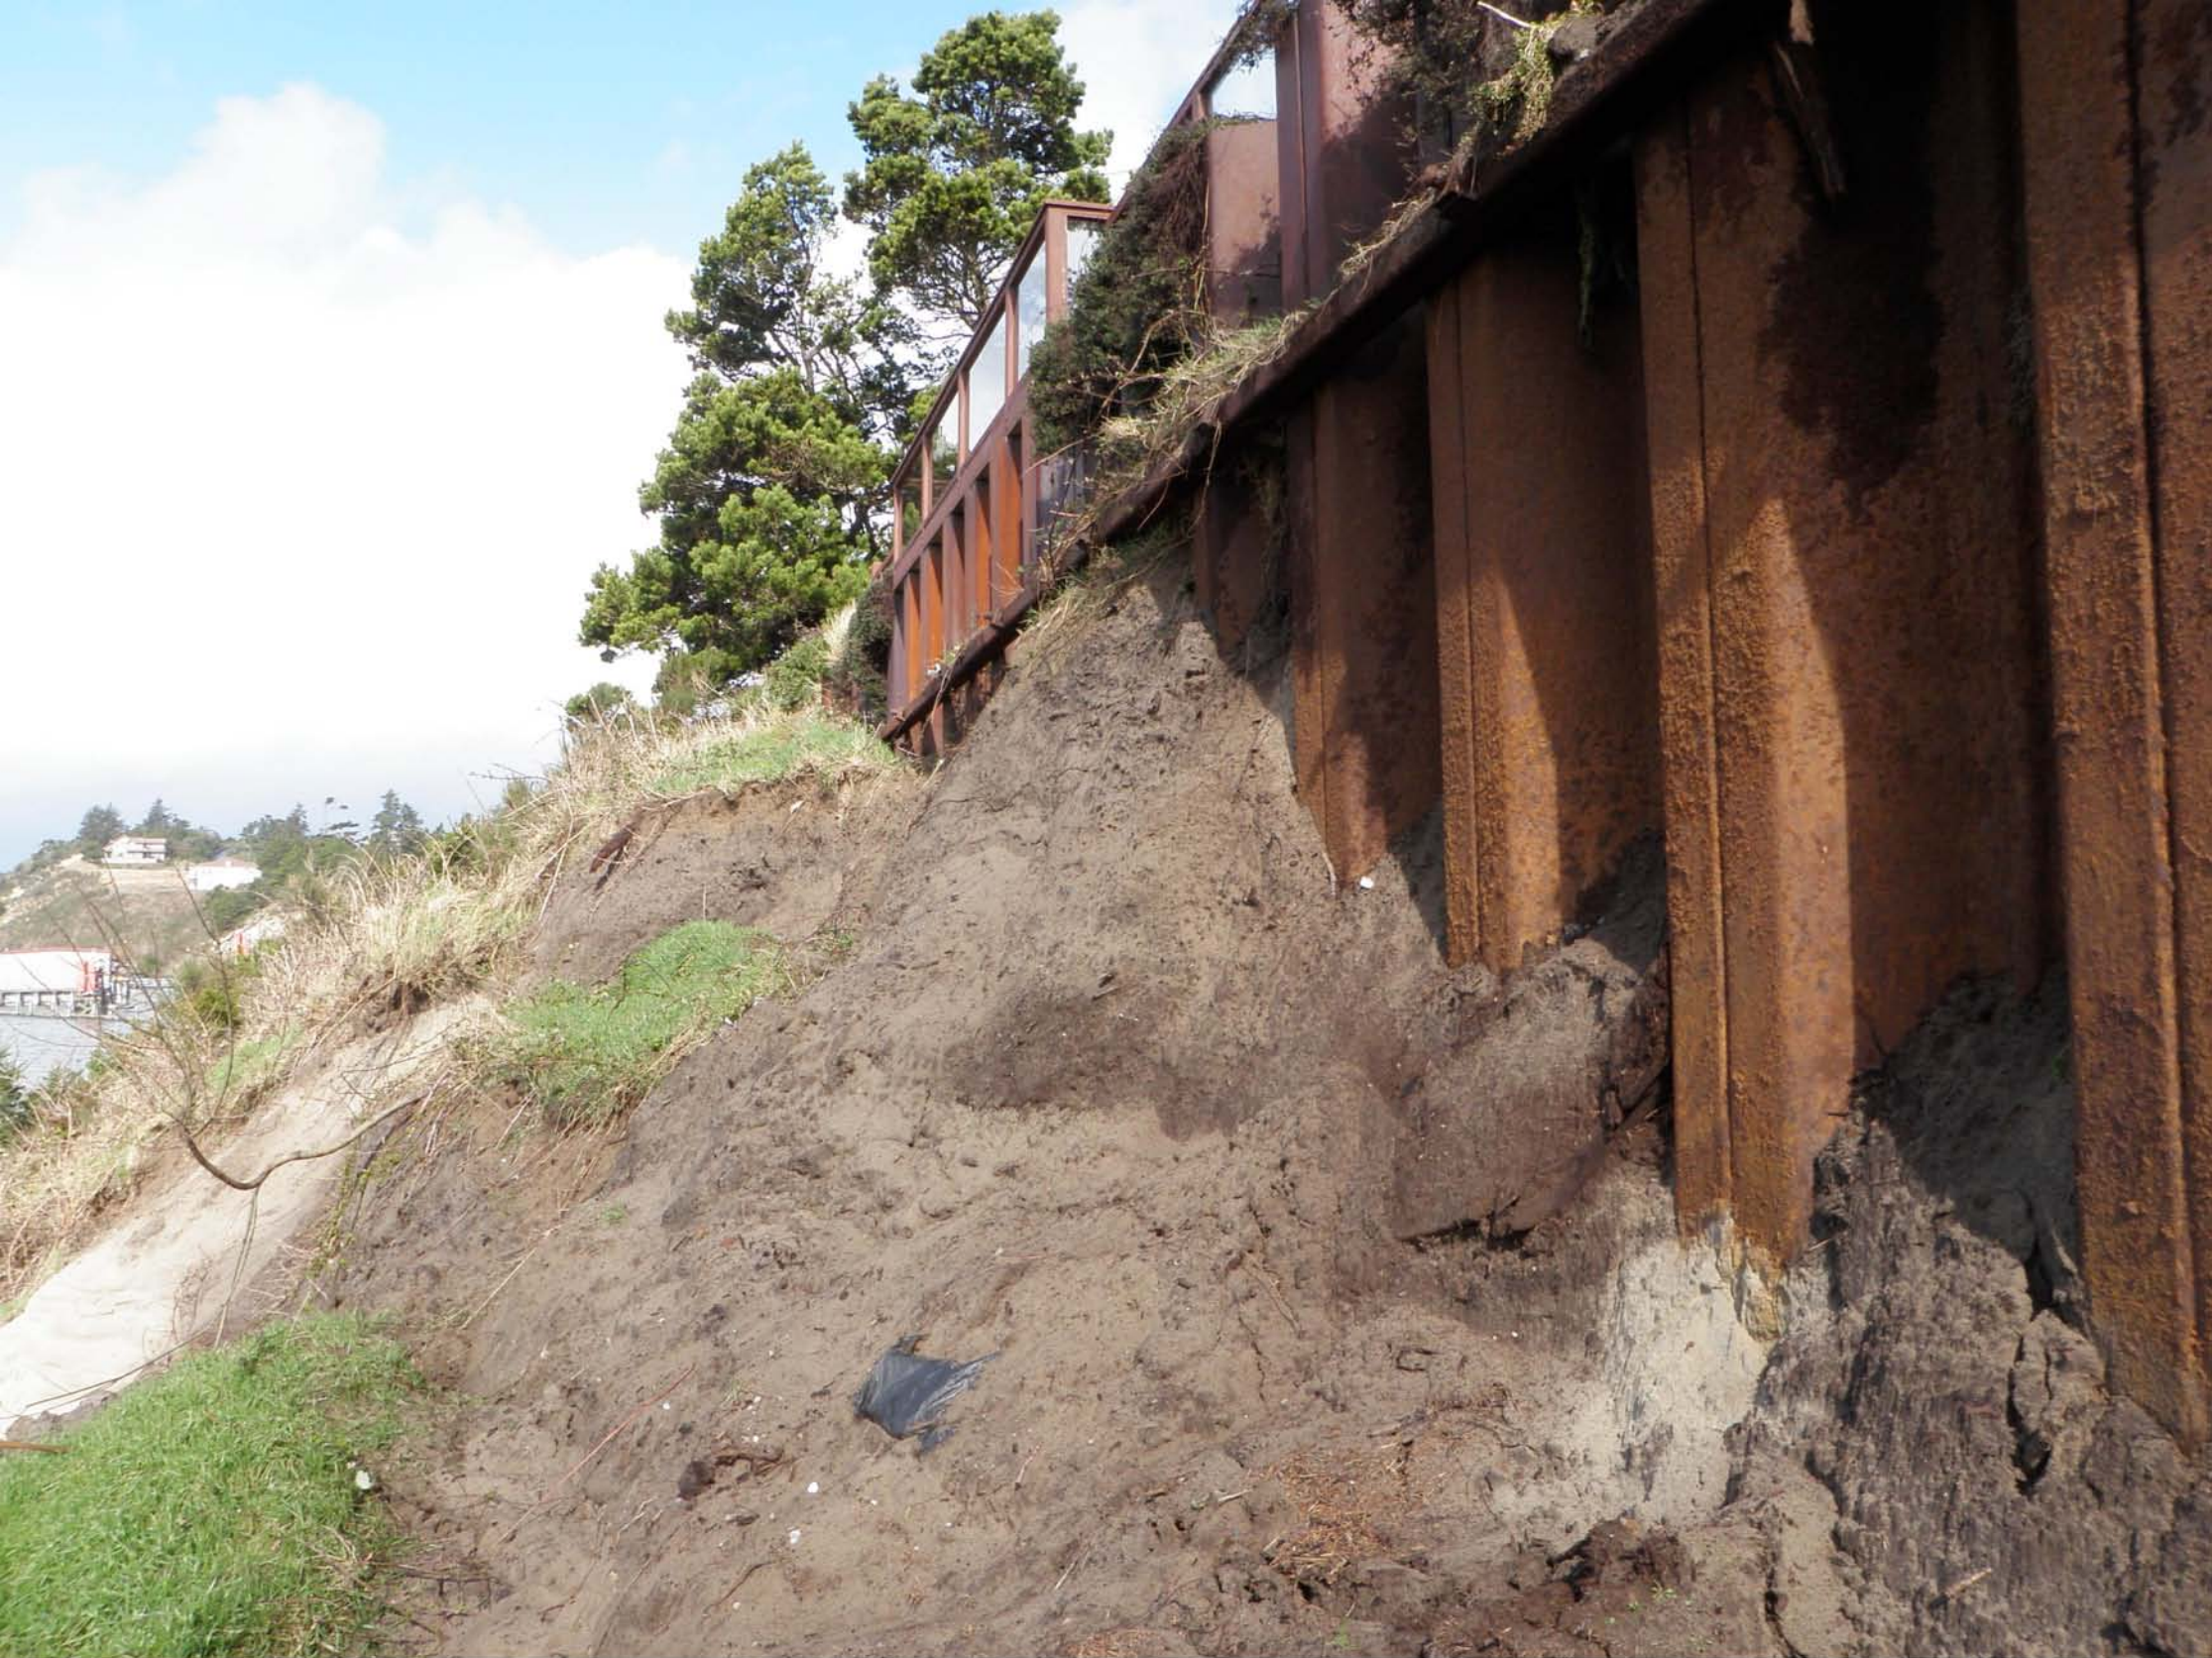
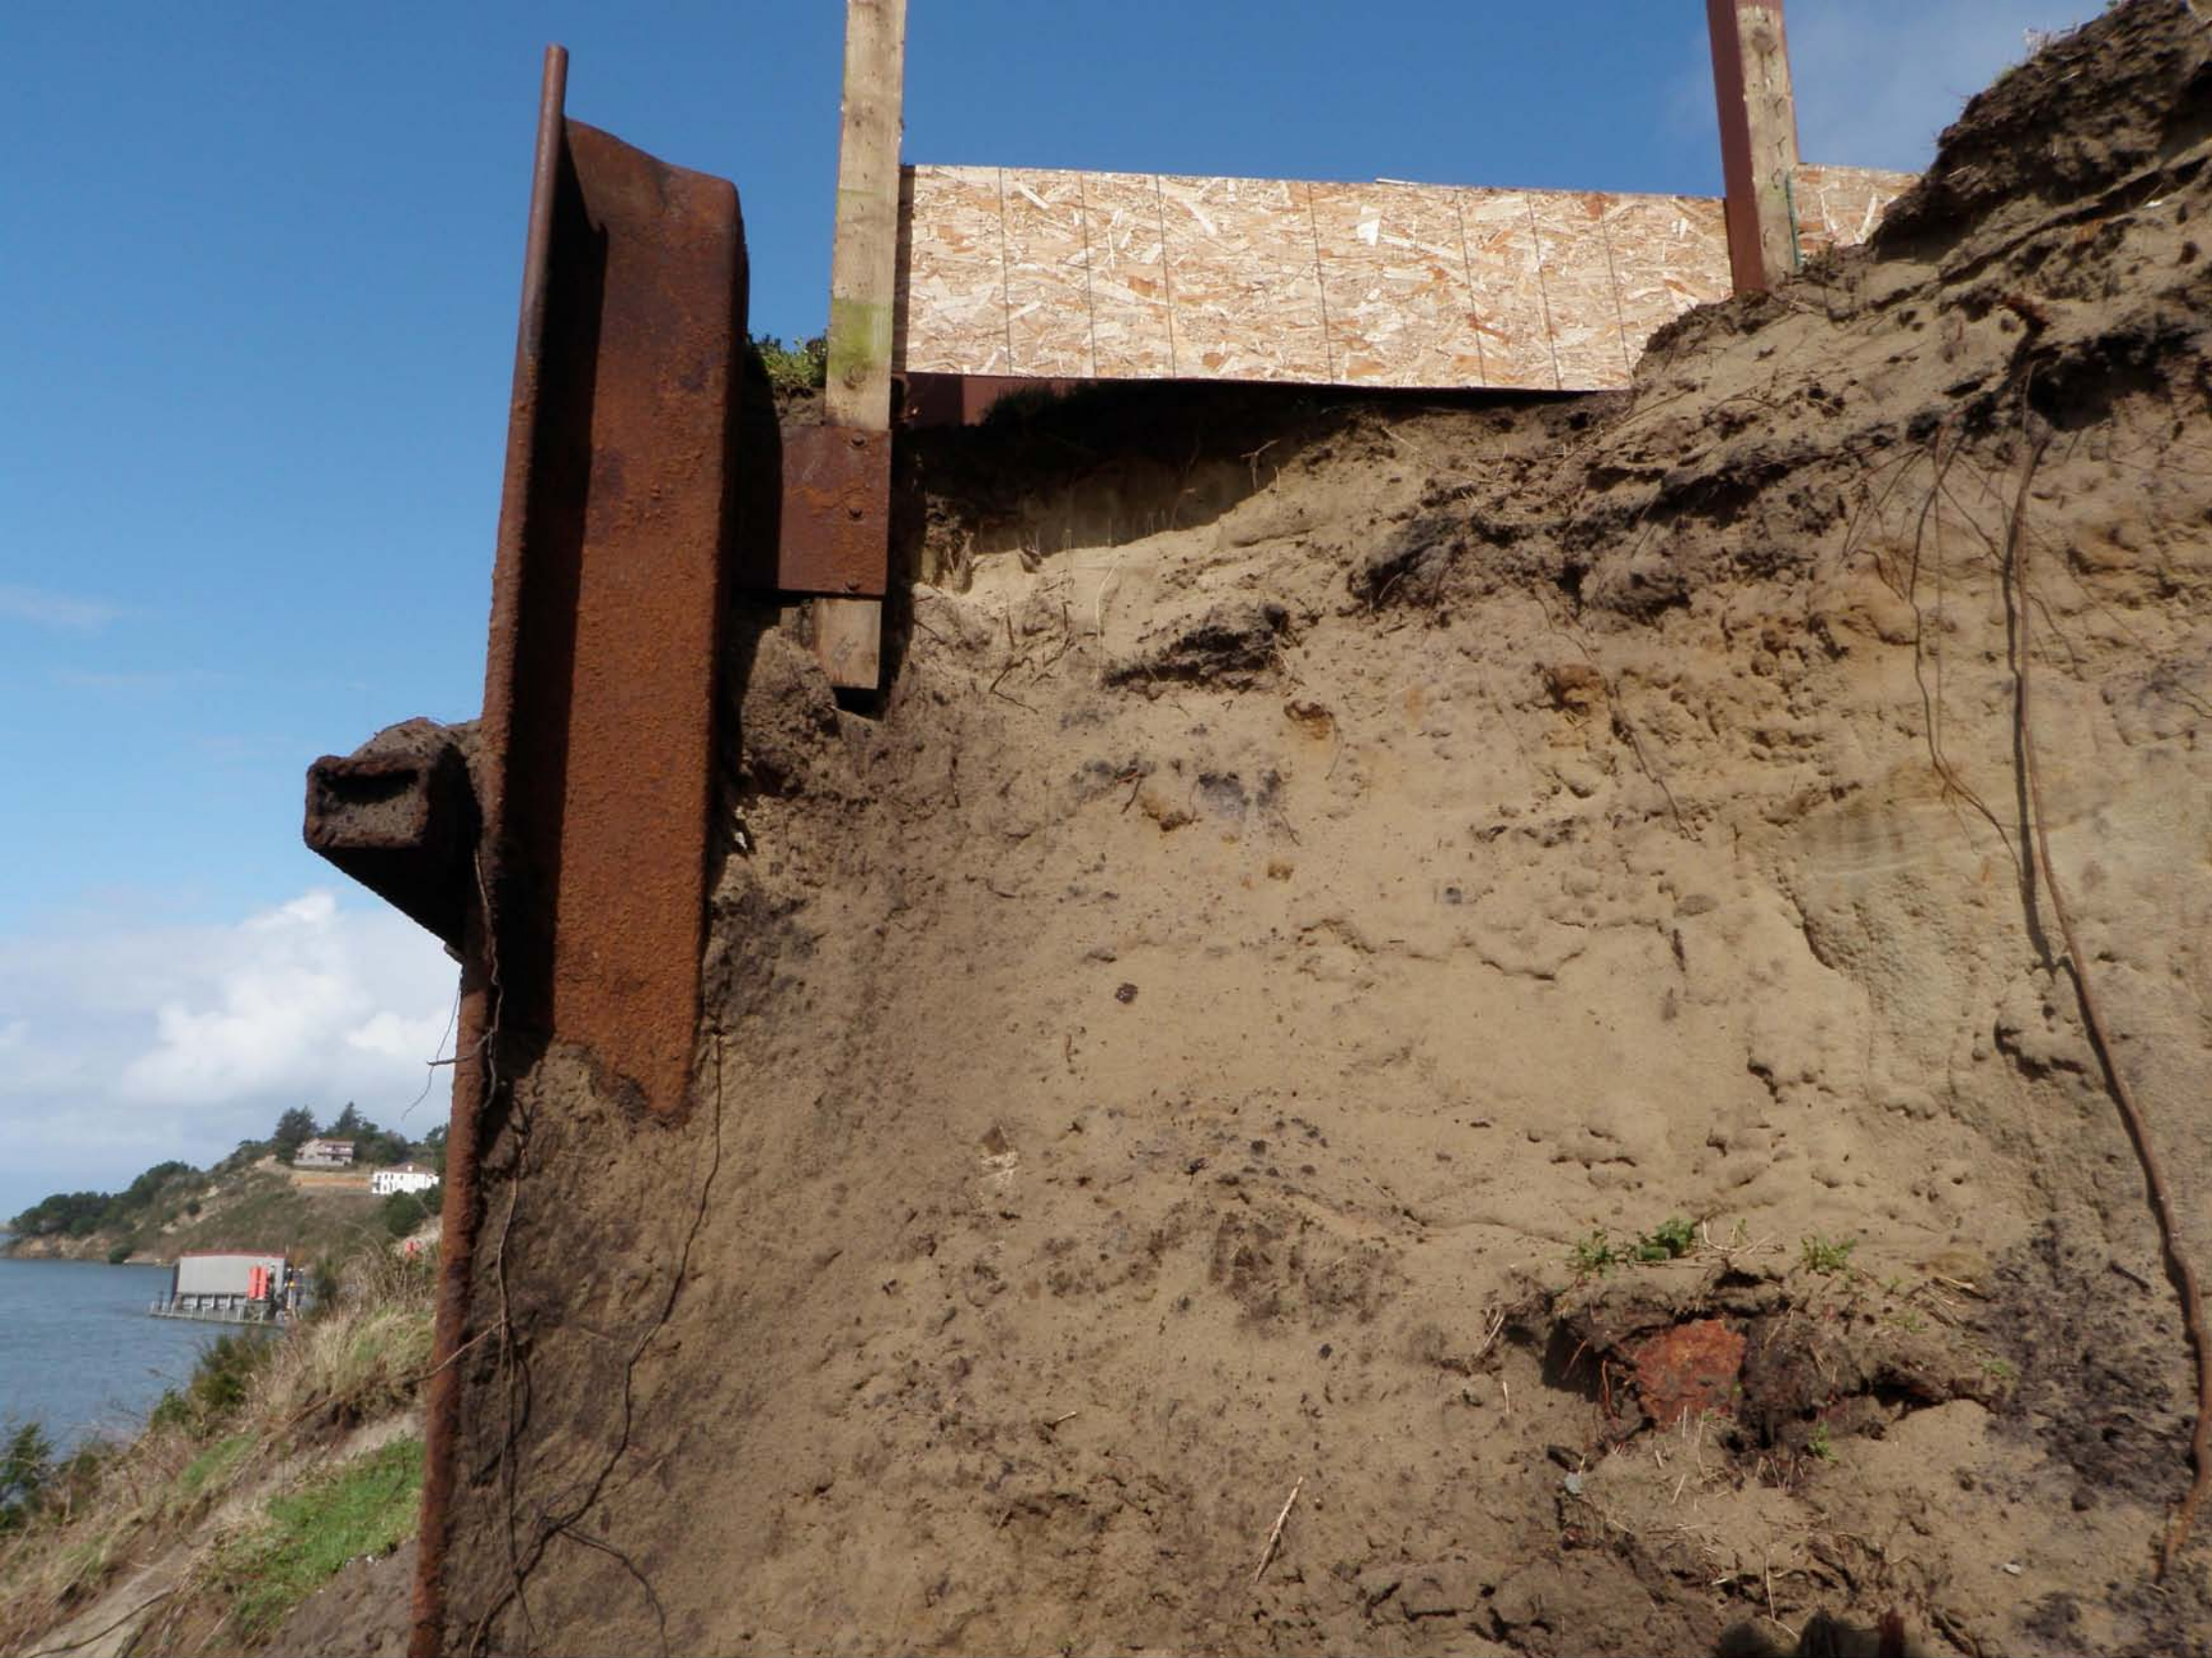
Exposure of MTDs (SU-3) in North Portion of Failure Area. View N
