City of Florence, Oregon

# STORM WATER MASTER PLAN UPDATE

DECEMBER 2018

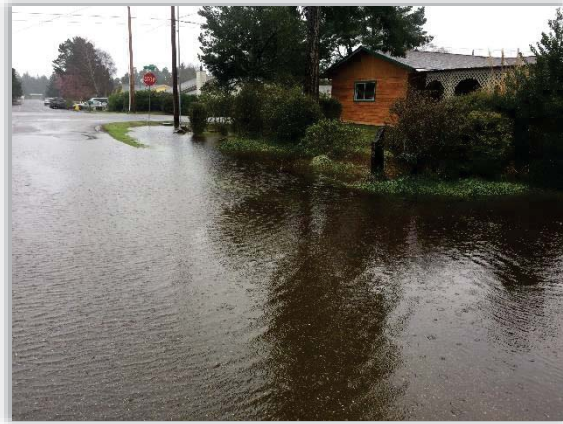
Figure 4-1 - Spruce Street, looking SW

Spruce Street, just north of 42<sup>nd</sup> Street, was observed to be inundated with storm water during 2016-2017 wet season field inspections. As shown in Figures 4-1 and 4-2, the focal point of the flooding is located approximately 60-70 feet north of the intersection, near the driveways of 4220 and 4211 Spruce Street. The infiltration swales at the road's edge were overflowing, and the water level had risen to the point where the entire roadway was submerged and surface flood waters were approaching the homes on either side of the street.

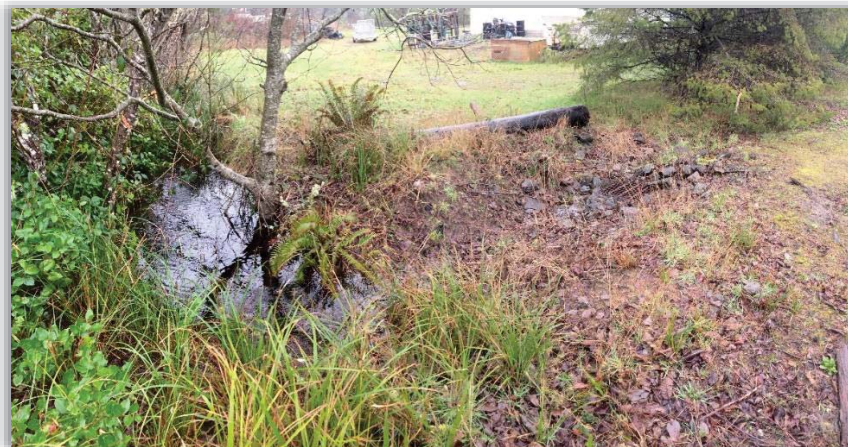
Figure 4-7 - Siefert Ditch with Catch Basin

However, the City did install a catch basin at the southeast corner of Tax Lot #300, with an ADS culvert to move *surface* runoff from that parcel to the detention basin on the east side of Spruce Street. The grate elevation of that catch basin is situated well above the hydraulic grade line of the ditch, and during the wet-season of 2016-2017, which saw more rainfall than any other year in the current planning period, water from the Siefert Ditch never rose high enough to crest the grate of the catch basin.

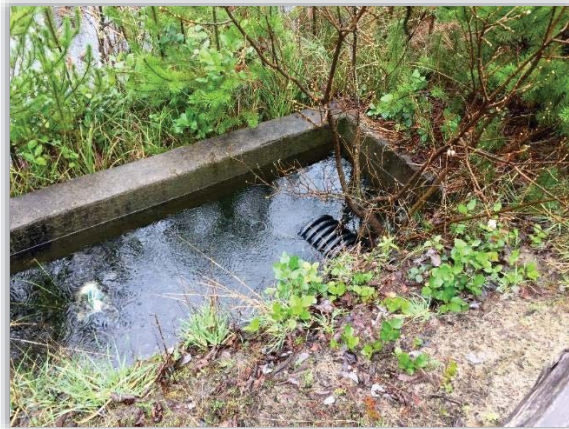
*Figure 4-8 - Detention Ponds/ Weirs*

On the east side of Spruce Street, the existing concrete detention basins/ weirs are intended to combine storm water management with road-side aesthetics. These structures have been effective in controlling the flow and improving water quality in the swale toward Munsel Lake Road to the south. In the case of the weir directly east of the Siefert Ditch, City crews have cut a notch in the wall of the weir to lower the discharge elevation of that water quality basin below the grate elevation of the catch basin installed by the City on the southeast corner of Tax Lot #300 (see Figure 4-9).

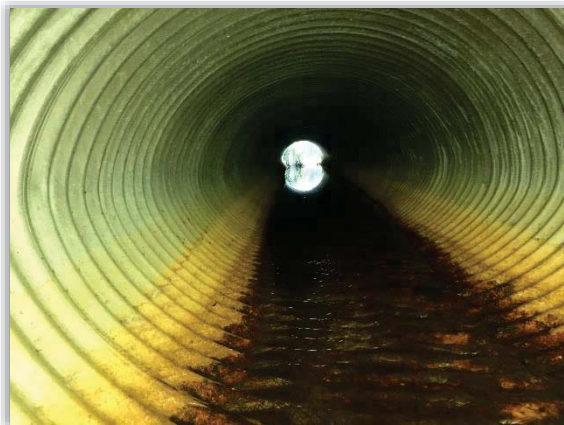
*Figure 4-10 - 36" CMP culvert at Munsel Lake Rd.*

At Munsel Lake Road, storm water splits in two directions. Some flow enters a ditch inlet that conveys water west into the pipe network that travels south along Highway 101. The remainder flows in a ditch east along Munsel Lake Road to a 36-inch CMP culvert which crosses underneath the road. Field inspection of this culvert suggests that it is adequately sized and in reasonably good condition. As shown on the Region 7 Map in the Appendix, after leaving the culvert, this flow travels south, where it splits again. Some of the flow is piped underneath Florentine Estates to Munsel Creek, and the rest of it flows into undeveloped Tax Lot #1812142000700, which contributes to the flooding problems on the east side of Bi-Mart near 42<sup>nd</sup> Street and Spruce Street (see Section 4.1).

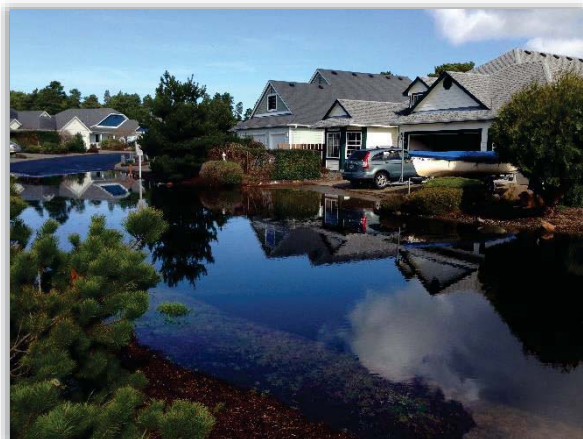
During the wet season of 2016-2017, ground water levels rose to a point where storm water could not be contained within Tax Lot #4600. In fact, flooding spilled out into Tax Lot #126 (labeled “Common Area ‘C’”; see Figure 4-13), which is used as an RV parking lot. Ground water also surcharged back up out of the catch basins throughout the subdivision. Flooding was so excessive that City of Florence Public Works was forced to rent a large pump from Eugene to draw the water down so that flood conditions would not cause damage or loss for nearby residents.

*Figure 4-15 - Spyglass Lane flooded after water surcharged out of catch basins*

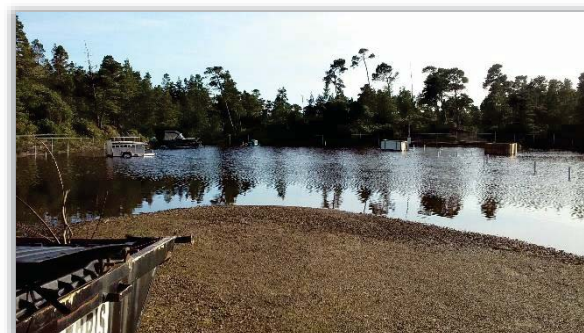
*Figure 4-18 - Lot #126 (RV Parking) flooded after #4600 overflowed.*

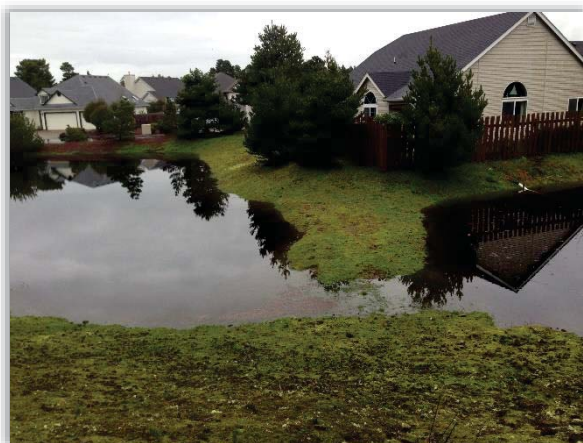
*Figure 4-16 - Water overflows from Lot #4600 at this location*

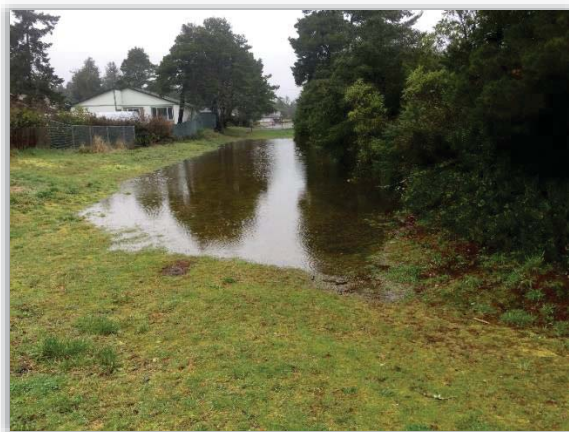
*Figure 4-21 - Pine Street, looking north from 28<sup>th</sup> Street*

Figure 4-21 and Figure 4-22 show the flooding that has occurred in this area. Because the undeveloped right of way is topographically lower than the surrounding area, it is possible that high ground water is also contributing to the flooding of the right-of-way. The flooding shown in Figure 4-22 demonstrates that the flooding poses a threat to the businesses there.

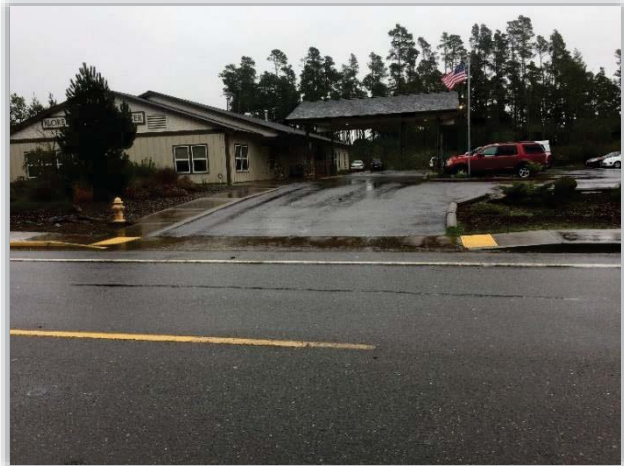
Figure 4-25 - Florence Senior Center driveway entrance

Civil West wet season field inspections of Kingwood Street did not produce any evidence of flooding problems between Airport Way and Airport Road. However, City staff have reported that the driveway entries for the Florence Senior Center (see Figure 4-25) have at times been rendered unusable because flood waters are too deep to allow normal passage.

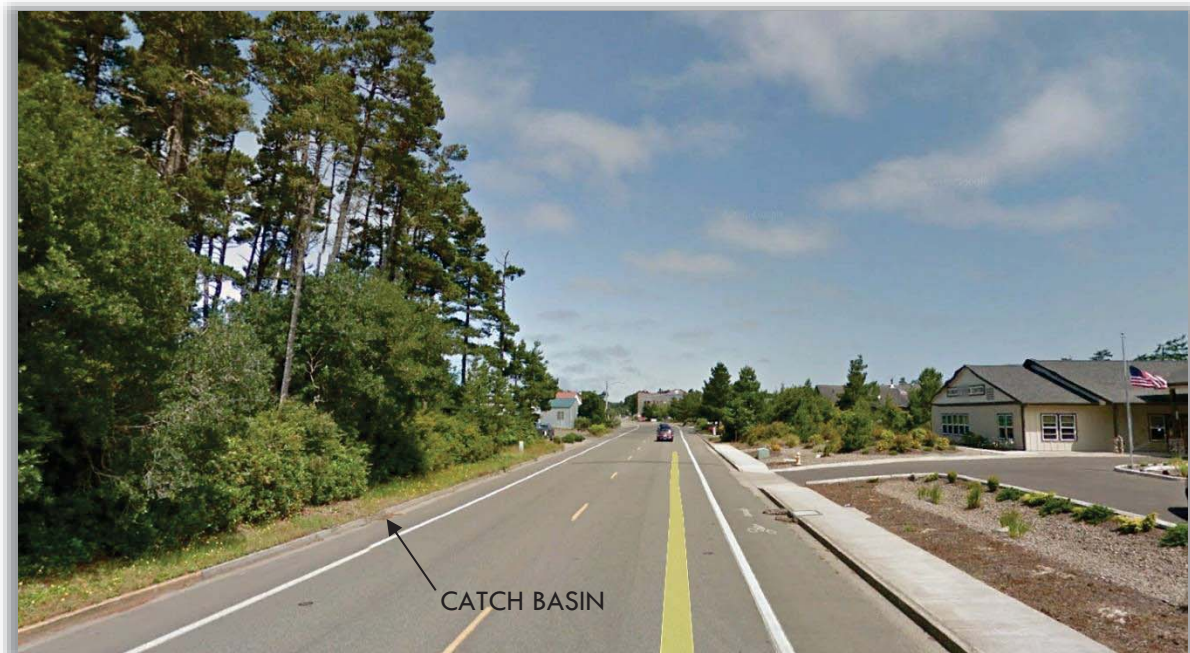
Figure 4-26 - Kingwood Street at Florence Senior Center, looking North

As shown in Figure 4-26, there is a single catch basin on the west side of the street across from the Senior Center, and a curb inlet on the east side next to the driveway. These collection structures fill up with pine needles very quickly, due to the presence of tall coniferous trees lining the west side of the road. The pine needles drop from the trees into the gutter, and are pushed into the catch basin, causing the structure to become clogged, and causing the runoff to be trapped in the driveway area.

It is recommended that the catch basin on the west side of Kingwood, across the street from the Senior Center (shown in Figure 4-26), be removed and replaced with a curb inlet. A curb inlet will be less susceptible to clogging from pine needles, especially if it is constructed with a deep sump. See Figure 6-15 for a potential project layout.

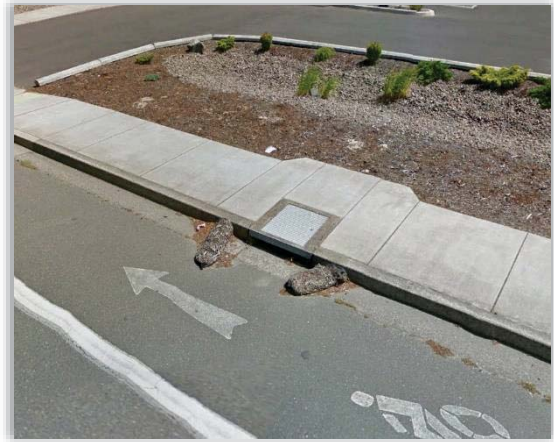
Figure 4-27 also shows that biorolls have been placed in the gutter surrounding the curb inlet. This is an erosion control measure that the City has used to slow the collection of pine needles in the curb inlet, but this solution has been shown to be temporary in nature and is insufficient, particularly during peak flow conditions.

*Figure 4-27 - Biorolls placed by curb inlet*

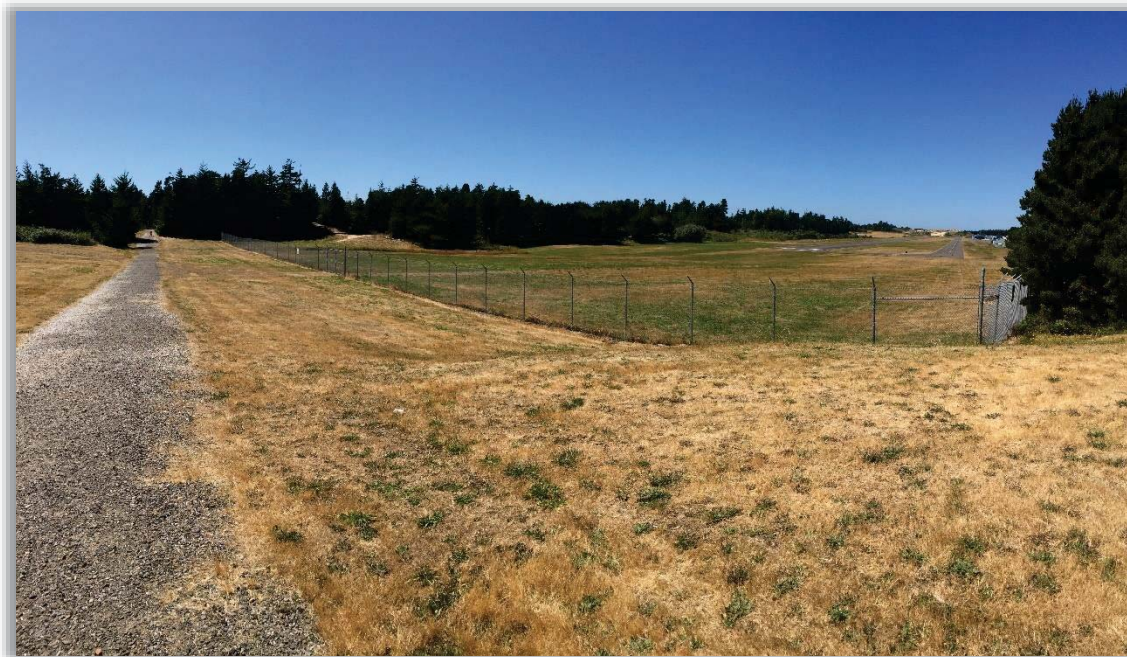
*Figure 4-30 - Airport & 12th Street right-of-way, looking NW*

Storm water on Kingwood Street, north of Airport Road, is conveyed diagonally across the airport property to the southwest where it crosses underneath the 12<sup>th</sup> Street right-of-way. Prior to entering the 36-inch CMP inlet, the flow combines with surface runoff that collects at the topographic low point at the south end of the airport runways. As seen on the Region 1 Map in the Appendix, flooding has been reported at this location, and in fact, has been so severe that flood waters have risen high enough to spread out onto the asphalt runway. For this reason, it is possible that the 36-inch culvert is insufficiently sized. As stated, this culvert is CMP on the inlet side, but transitions to ADS before reaching the south side of the right-of-way.

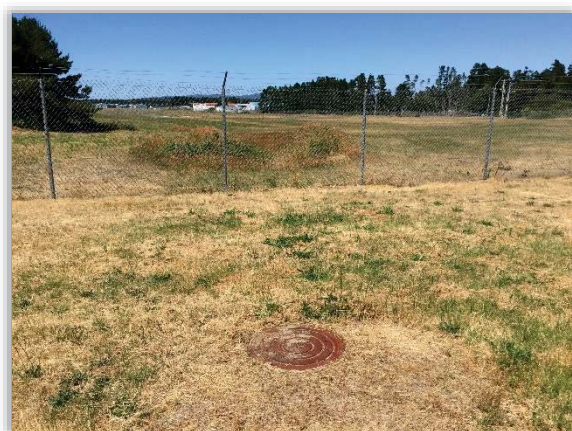
*Figure 4-31 - Airport drainage ditch & manhole @ 12th Street R-O-W, SW end of airport property*

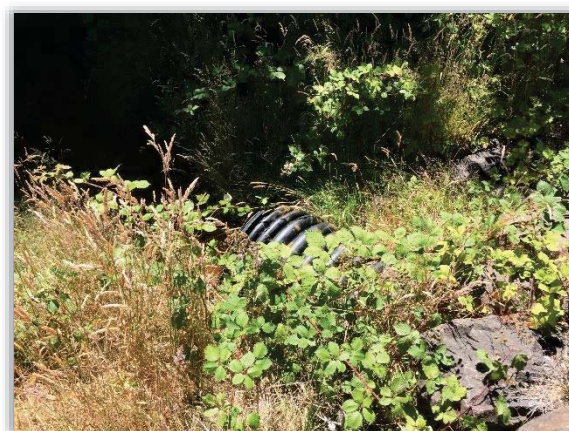
*Figure 4-32 - 36" ADS culvert outlet for drainage under 12th Street right-of-way*

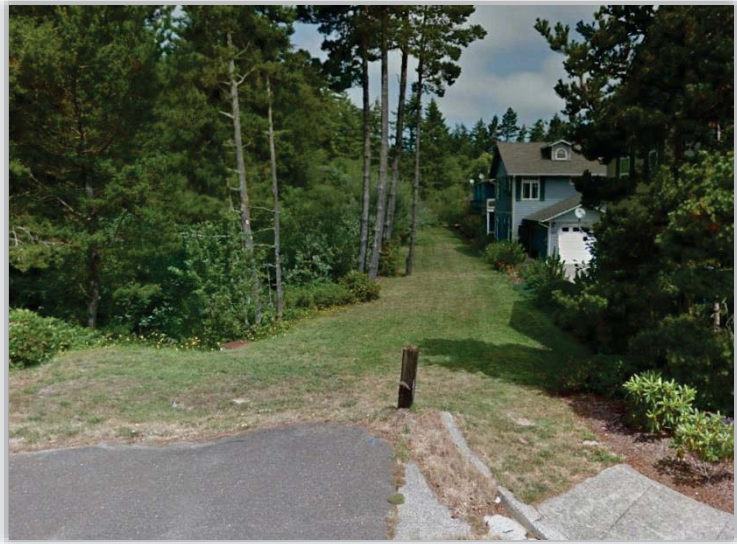
Just prior to reaching the intersection, the ditch runs along the backside of Seabrook Townhomes, whose address is off of Jasper Lane. In 2016, with permission from the City, a resident of the Seabrook Townhomes made considerable efforts to improve the route and cross section of the ditch next to the townhomes, by digging the ditch wider and deeper with a shovel. The motivation for this endeavor was borne by the fact that Seabrook Townhomes were constructed at too low an elevation, and residents there are concerned that high water in the ditch could pose a threat to their townhomes. The modifications to the ditch were done to potentially improve the flow of the ditch, and hopefully relieve/reduce the drainage problems faced by the townhomes.

*Figure 4-33 - Seabrook Townhomes & drainage ditch, view from 9th Street, looking North up Ivy Street right-of-way*

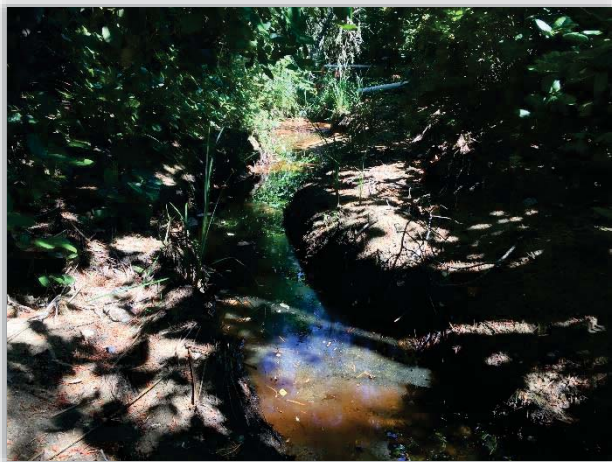
*Figure 4-34 - Hand-dug ditch adjacent to Seabrook Townhomes, dry-season field inspection photograph*

It appears that storm water in the ditch is only a threat to these townhomes if it runs too high and floods on to the townhomes' property. The more imminent drainage threat for these citizens though, is that this area, like many others in Florence, is prone to extremely high ground water levels. With the finished floor elevation of the townhomes set as they are, high ground water could potentially surcharge and flood the units. While improving flow in the drainage ditch will help to confine those waters, it will not eliminate the threat that ground water poses to Seabrook Townhomes.

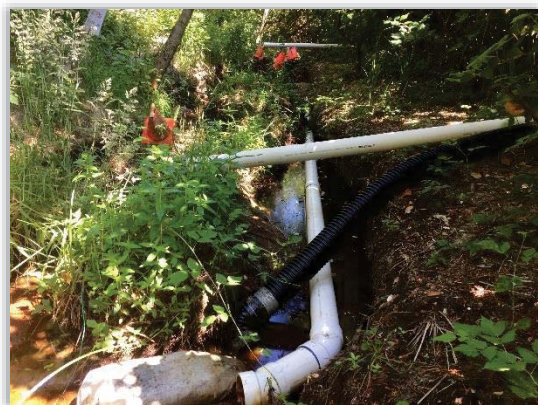
*Figure 4-36 - Private drainage piping discharging into ditch. Efforts made by Seabrook Townhomes residents to alleviate flooding*

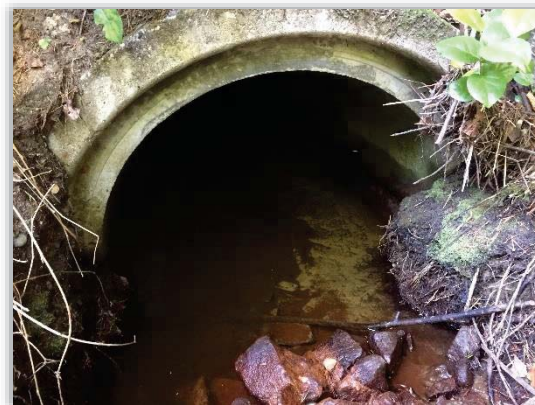
City Public Works crews have reported that an unforeseen result of hand-digging the ditch is that the sand has been left exposed, subject to erosion. This has caused the culvert and other downstream piping to be significantly silted in, and the City has had to make extra efforts to clean out the piping in this area to maintain capacity. This condition will persist until vegetation grows back in the ditch, but in the meantime, the sedimentation of the system prevents it from flowing at full capacity. This has caused drainage issues everywhere from the Ivy Street ditch to the creek between Elm Street and Fir Street.

*Figure 4-37 - Dry-season field inspection photograph of 42-inch concrete culvert inlet, silted in*

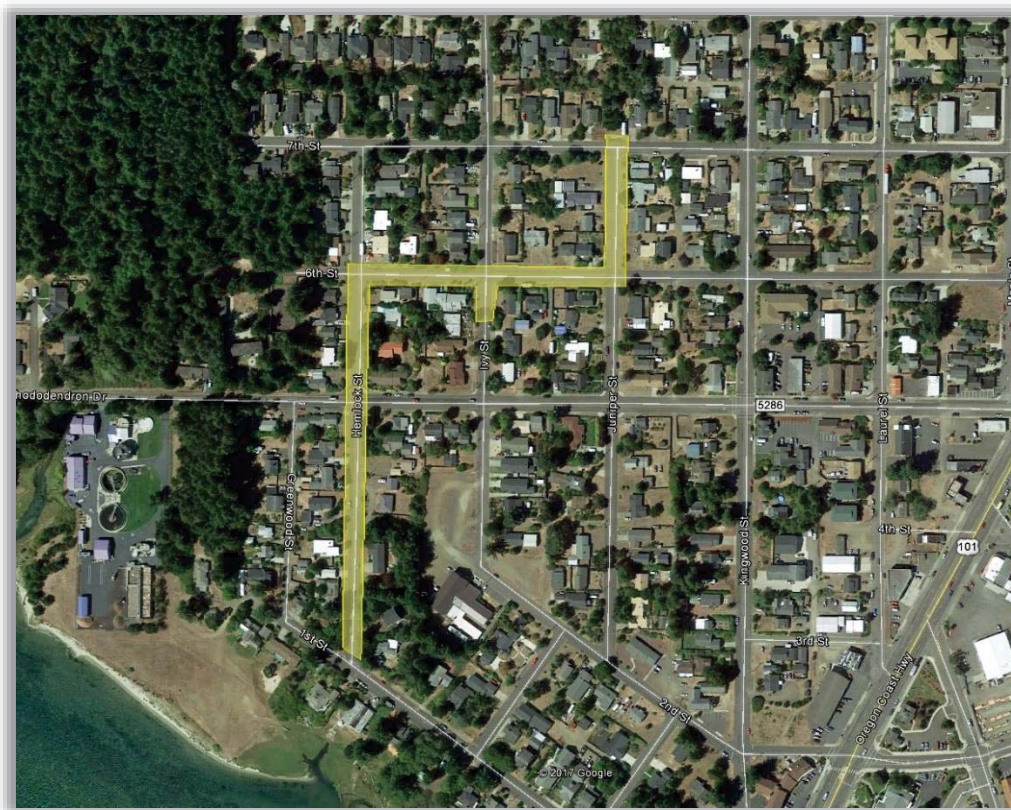
*Figure 4-39 - Map of storm water improvements currently under design in the Old Town area.*

To respond to this issue, the City can do its part by prohibiting street runoff from crossing onto private property. To accomplish this, the City’s storm system must have sufficient capacity to handle the demand of a peak storm event. In this spirit, the City is actively working to up-size storm water piping in these neighborhoods, as shown in Figure 4-39 .

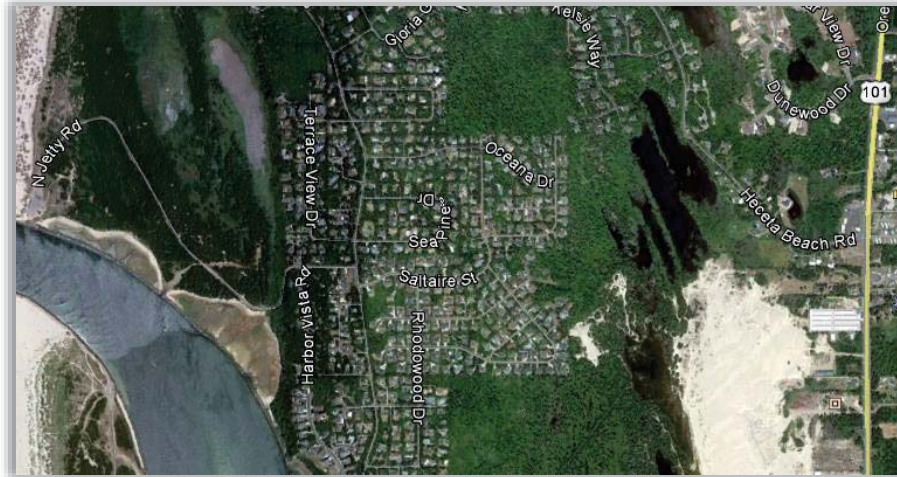
*Figure 4-40 - Aerial view of neighborhoods outside of City boundary*

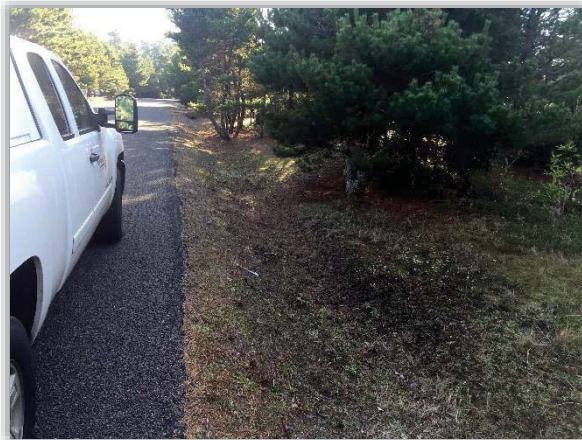
Field inspection of these neighborhoods revealed the presence of roadside ditches and infiltration swales along virtually every street inspected. As shown in Figure 4-41 and Figure 4-42, this infrastructure appeared to be in good condition although it is unclear if the capacity of this system has been sufficient to handle peak flows.

*Figure 4-41 - Roadside Ditch (Sandrift Street)*

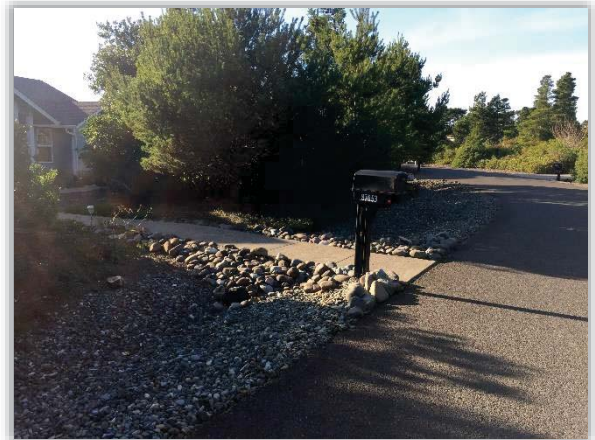
*Figure 4-42 - Roadside infiltration swale (Saltire Street)*

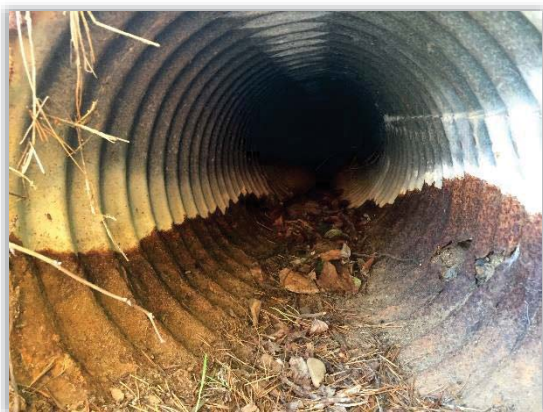
From there, a ditch conveys water to the west along the north edge of North Jetty Road, until it reaches an 18" CMP culvert, which carries water over the edge of the steep bank, and down toward the North Jetty Recreation Area. This culvert, shown in Figure 4-44, has experienced extensive corrosion, and needs to be replaced. It is unclear where this pipe eventually discharges, as its terminus could not be located during field inspection.

Figure 4-44 - 18-inch CMP culvert at top of bluffs on North Jetty Road

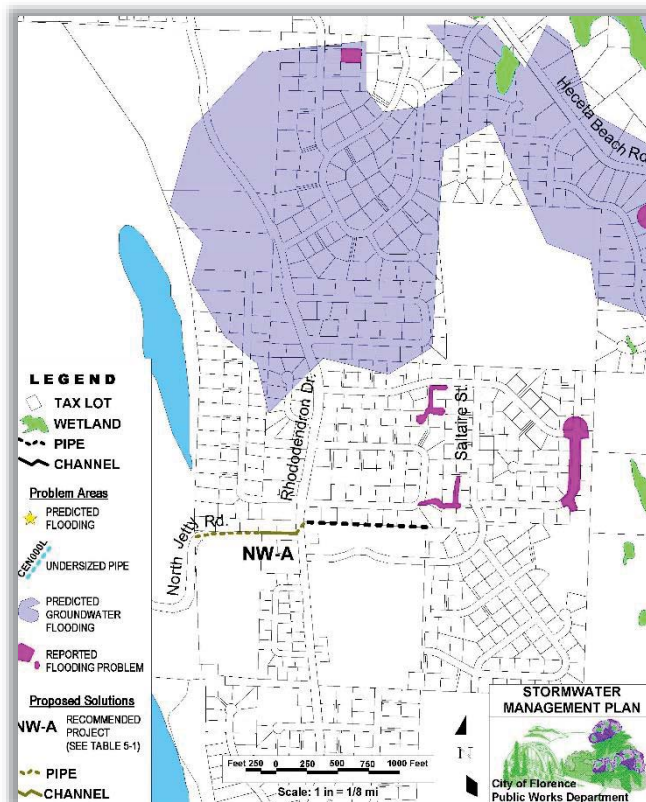
Residents of these neighborhoods have also constructed a small amount of conveyance infrastructure to supplement their roadside ditches and infiltration swales. This infrastructure, which can be seen in Figure 4-43, consists of a concrete-lined channel and 12-inch pipe to move water from the south side of Sea Pines Drive, across Rhododendron Drive to North Jetty Road. (Figure 4-43 is borrowed from SWMP2000.)

Figure 4-43 - Figure 5-1 from SWMP2000, shows existing drainage infrastructure and flooding problems in the neighborhoods northwest of the city boundary

SWMP 2000 recommended the addition of a pumping facility in Gullett Court, as well as replacement of the 12-inch culvert which passes underneath Rhododendron Drive. At the time of SWMP2000 the ditch along North Jetty Road was in poor condition and the 18-inch culvert at its west end did not exist. It was recommended that the 18-inch culvert be installed with large riprap at the bottom of the bluffs to dissipate energy at the base of the slope and prevent erosion. It has not been verified whether this recommendation was heeded.

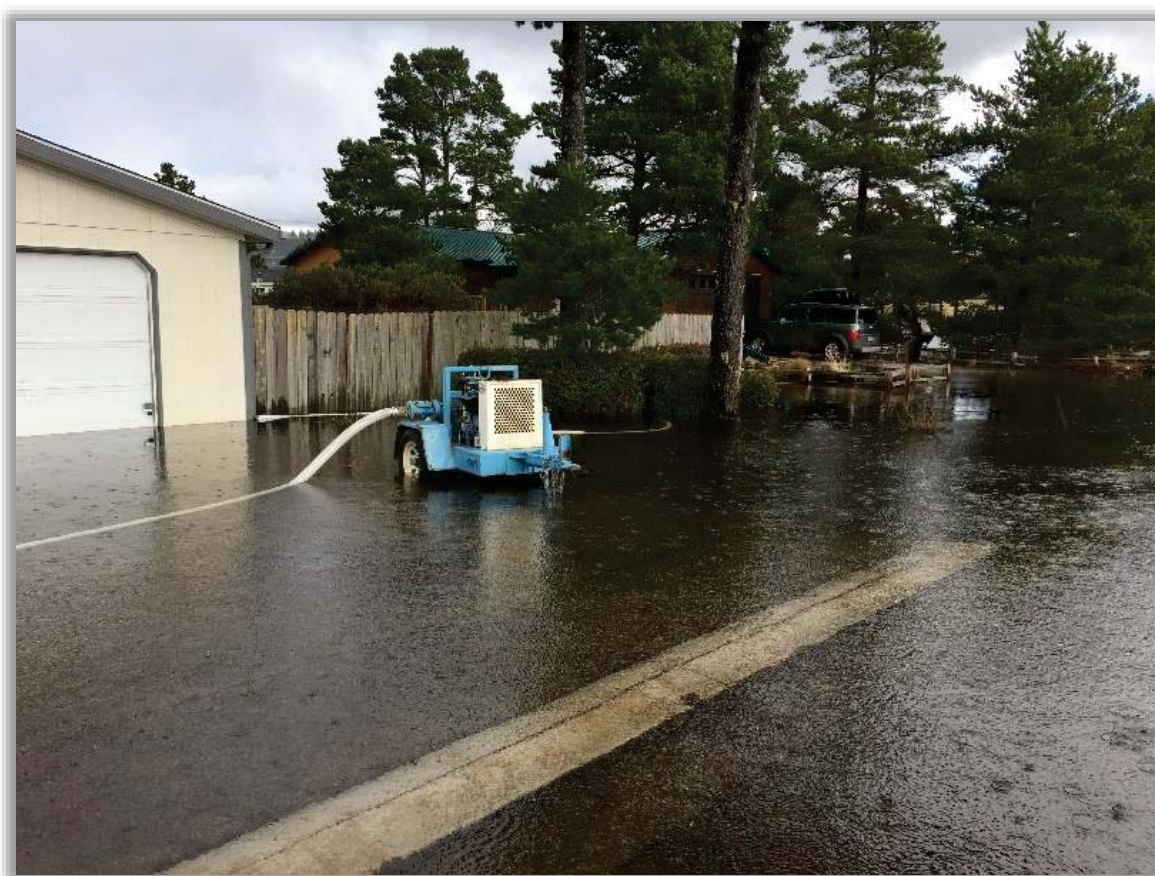
The development's proximity to this seasonal wetland has been problematic during times of high rainfall because the wetland does not have a discharge point. Instead, when the water table rises in the wetland, ground water surcharges back on to city streets, and remains until the water table recedes once again, or as in the winter of 2017, it is pumped out at the City's expense.

*Figure 4-45 - Driveway of 1720 Pine Court, pumping flood waters west across Willow Loop into Munsel Creek*

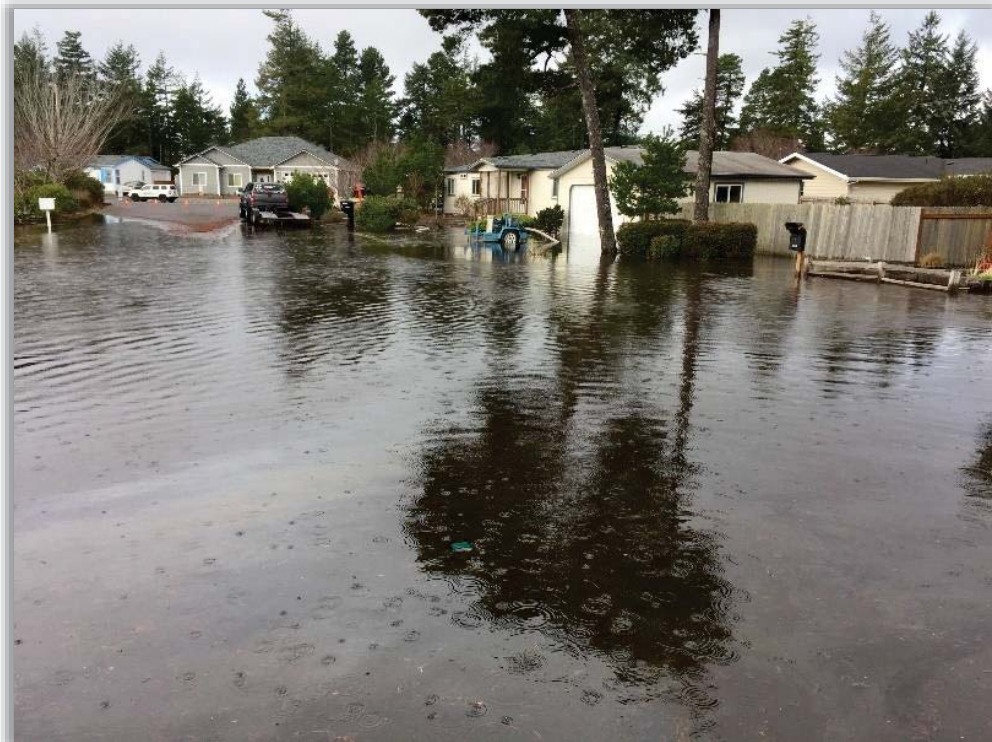
*Figure 4-46 - Pine Court, flooded with more than 12-inches of ground water*

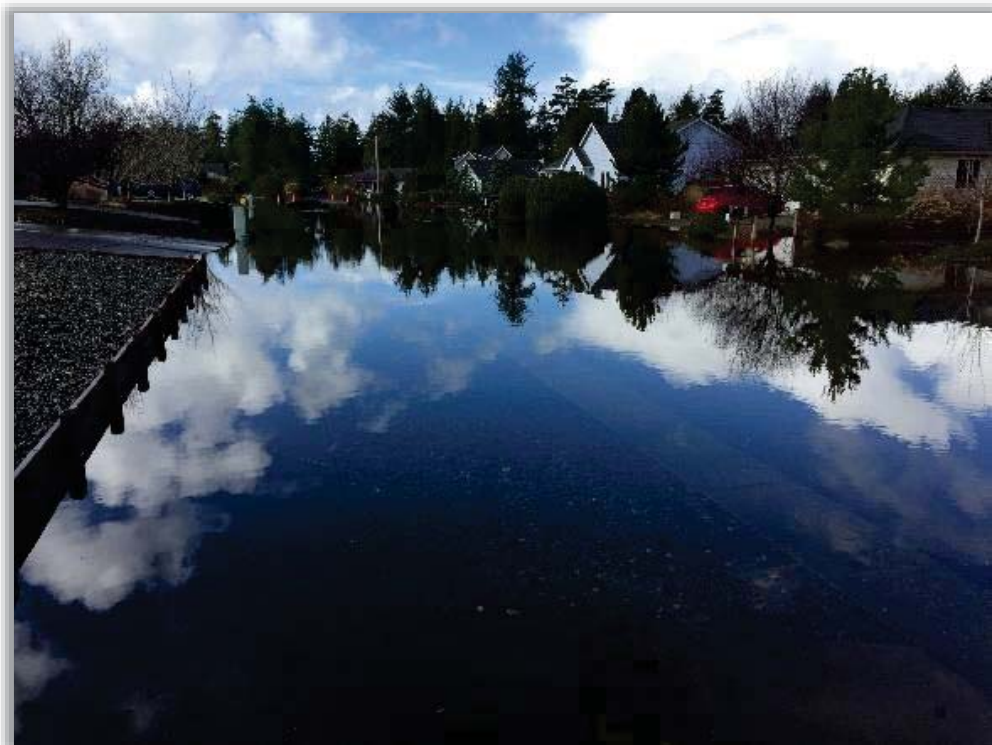
*Figure 4-47 - 16th Street, flooded with more than 12-inches of ground water*

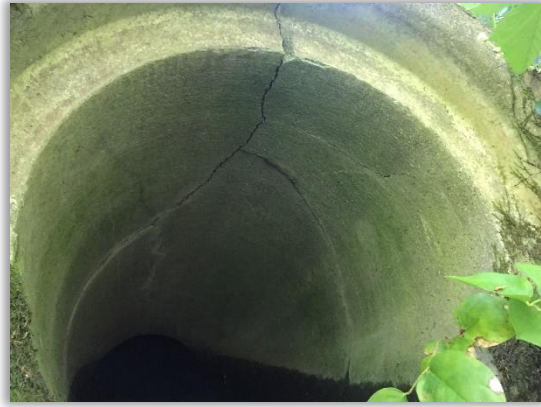
There is a separate outfall pipe approximately 15 to 20 feet south of this 84-inch CMP culvert. It is a 24-inch concrete outfall pipe for the 12<sup>th</sup> Street underground drainage infrastructure. Field inspection of this outfall revealed that the concrete is cracked along the crown of the pipe (Figure 5-5), and the pipe is heavily silted in (Figure 5-6). The sedimentation of this pipe is a result of its slope, which goes uphill in the direction of drainage. In this way, the pipe acts as a filtration weir. After the water crests the discharge invert elevation, the water flows down a concrete chute into Munsel Creek (see Figure 5-7).

*Figure 5-5 - 24-inch concrete outfall, cracking in the pipe crown*

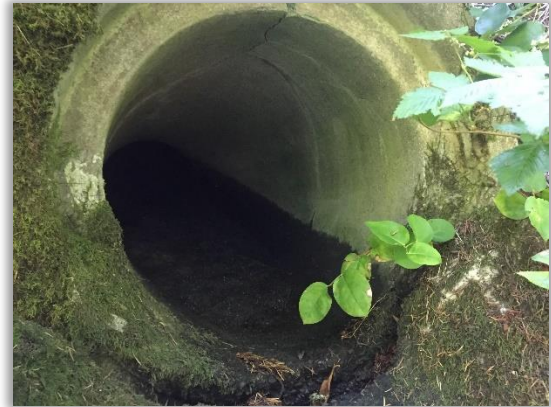
*Figure 5-6 - Outfall pipe is sloped uphill in the direction of flow, causing sedimentation*

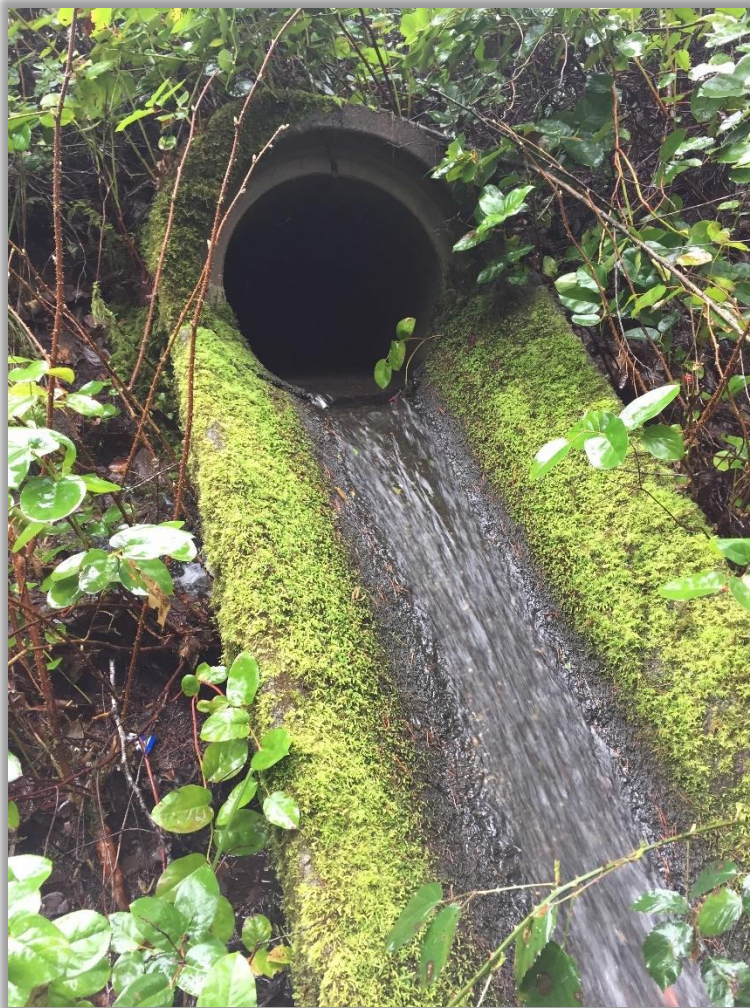
*Figure 5-7 - Concrete chute channeling flow down into Munsel Creek*

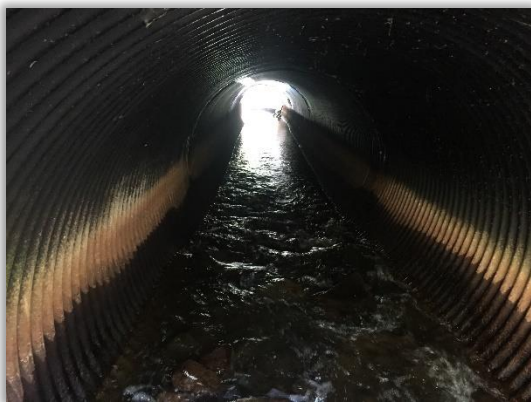
Field inspection of the inside of the culvert indicates that the pipe has sufficient capacity to handle the peak flows experienced at this location, and no reports have been filed by the City or the Public regarding flooding in this area. For a view of the inside of this culvert, see Figure 5-10.

*Figure 5-10 - Inside of 72-inch culvert, level of water stains suggests sufficient capacity*

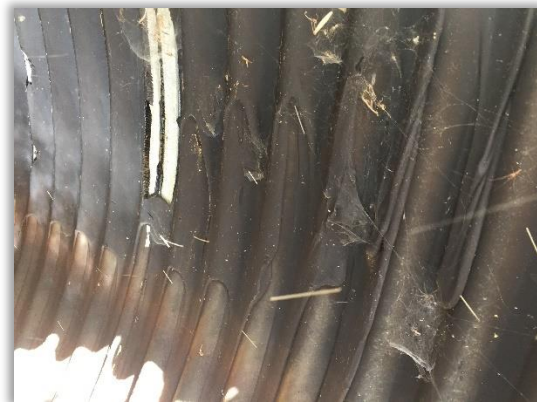
In addition to the CLSM cap, City crews have coated the inside of this culvert with an old coal-tar epoxy, which is common for increasing the longevity of corrugated metal pipe. In many places, the epoxy coating was observed to be peeling away, leaving the bare steel exposed, and increasing its susceptibility to future corrosion.

*Figure 5-11 - Coal-tar epoxy present on pipe wall*

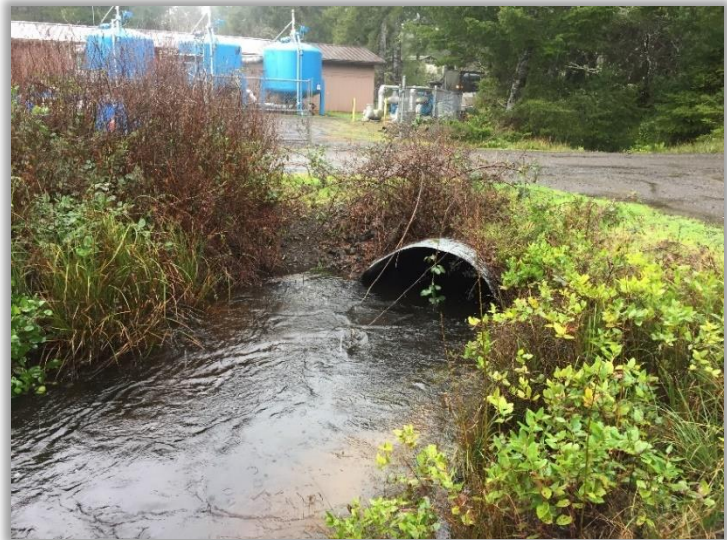
Munsel Creek crosses underneath Willow Street on the northeast side of the Florence Water Treatment Plant via a single 60-inch CMP culvert. This culvert is in relatively good condition in comparison with other CMP culverts in the city. Field inspection revealed no dislocations, and only minimal amounts of corrosion were observed in the pipe wall.

The pipe cross section is slightly deformed but does not appear to have caused any significant impact to the road above. This road, “Willow”, is a gravel access road used only for Treatment Plant operations and presently does not experience heavy traffic loads. The culvert has somewhat less-than-average bury depth (between 12” and 18”), but this appears to be holding up well.

*Figure 5-14 - 60-inch CMP culvert at WTP*

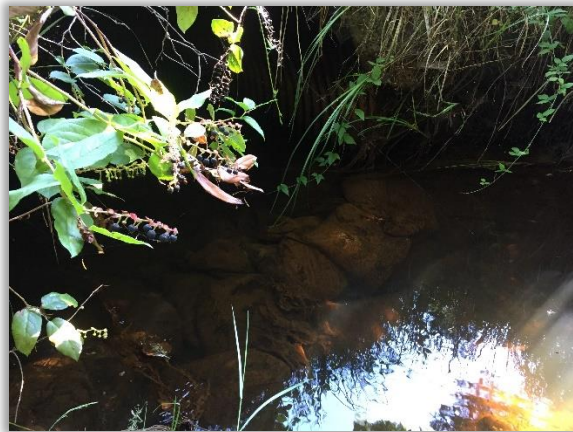
Field inspection indicates that this culvert appears to have adequate capacity, flowing at 50% to two-thirds capacity during peak flow conditions. There have been no reports of overflow or flooding at this location. As shown in Figure 5-15, sand bags were discovered on the inlet side of the culvert. These sand bags were not installed as a flood-prevention or sedimentation averting mechanism. City staff indicated that the sand bags were installed as part of the Salmon Trout Enhancement Program (STEP), to slow flow at this location, and make a settling pond of sorts, just prior to entering the culvert. Dry season inspection revealed that the sand bags do not appear to have impeded the flow through the culvert.

*Figure 5-15 - Sand bags installed as part of STEP*

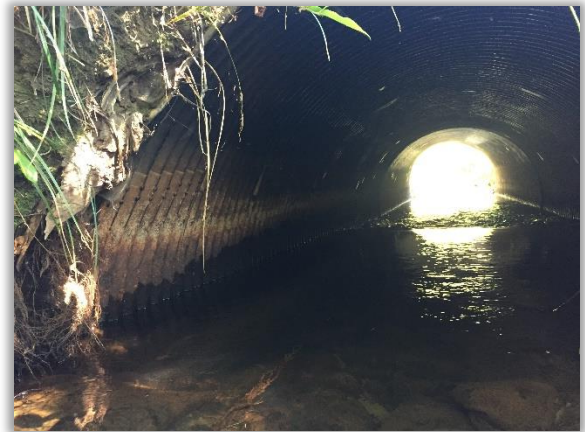
*Figure 5-16 - Inside of WTP culvert*

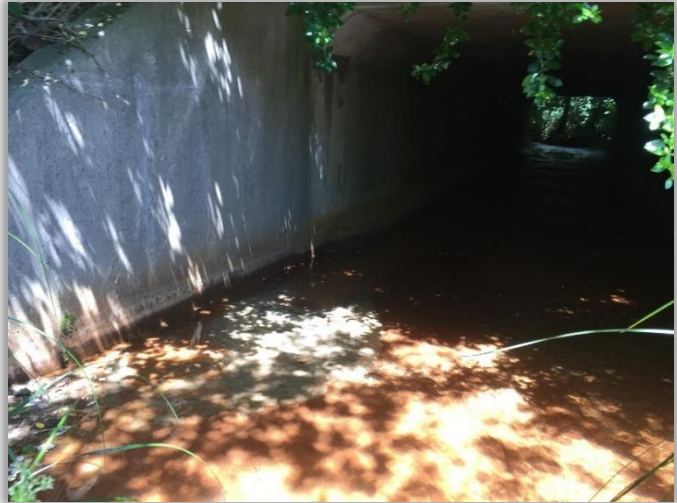
Ultimately, this stream crosses underneath Rhododendron Drive via a 10-foot wide by 8-foot tall box culvert, which is notably one of the largest storm water conveyance structures in Florence. However, once the water exits the box culvert on the west side, it is not permitted to maintain the same volume of space because the stream comes to a tee in the middle of the Marine Manor PUD where housing and landscaping have been constructed. There is a small berm on the outlet side of the culvert, and a stilling basin to dissipate the water's energy before it is channeled into a single 36-inch corrugated metal pipe which conveys water across the Marine Manor properties and discharges into the Siuslaw River through a sea wall discharge. Somewhere prior to reaching the sea wall, the CMP culvert transitions to 36-inch ADS pipe.

*Figure 5-17 - 10' x 8' box culvert crossing Rhododendron Drive*

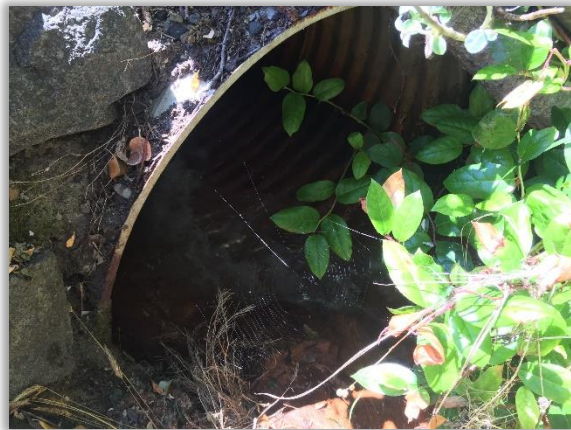
This dramatic reduction in cross-sectional area is not necessarily problematic, as long as the 36-inch culvert is adequately sized to convey storm water during peak flow conditions. During dry-season field inspections, a resident of the PUD expressed concern over the substantial amounts of flow that culminate at this location, but no other reports have been logged by Civil West engineers or the City.

*Figure 5-18 - 36-inch CMP pipe from box culvert to river*

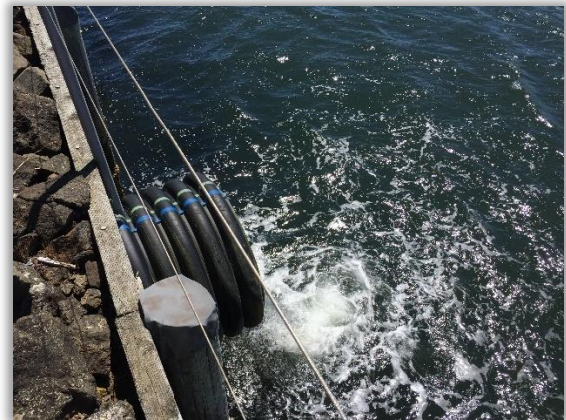
*Figure 5-19 - 36-inch outfall constructed of ADS*

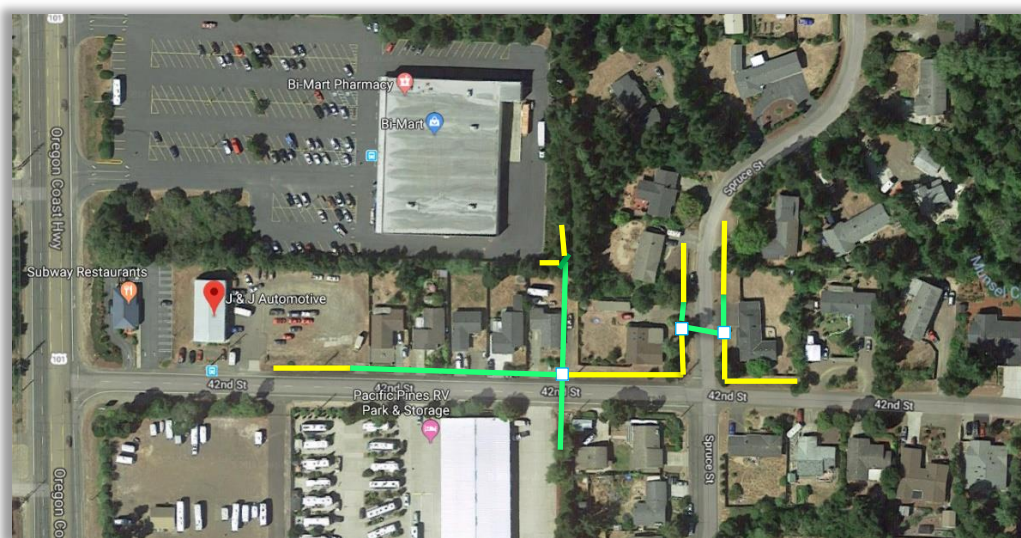
Figure 6-1 – CI Project Diagram (Spruce & 42<sup>nd</sup>)

As stated in Section 4.1, streets in the vicinity of Spruce Street and 42<sup>nd</sup> Street are not presently equipped with storm water management infrastructure. The proposed improvements at this location would include the installation of underground piping, catch basins, and ditches to collect storm water from the intersection of Spruce and 42<sup>nd</sup> and from the southeast corner of Bi-Mart, and convey those waters into the existing ditch which flows south along the eastern property boundary of the Pacific Pines RV park. See Figure 6-1 for a schematic diagram of these improvements.

The existing 18-inch culvert which currently collects water from the southeast corner of Bi-Mart lacks capacity, so this pipe would need to be removed and replaced with a larger diameter pipe. Additionally, since water flows to this location from two separate directions (from the west and from the north), it will be important to construct and orient the new culvert inlet in such a way that water enters the new pipe from both ditches without scouring or eroding away the adjacent private properties. To accomplish this, a concrete headwall structure is recommended at this location.

This system would alleviate flooding in the intersection, and it would also create a path for water in the ditch behind Bi-Mart to discharge, thus helping to alleviate the flooding in that location as well.

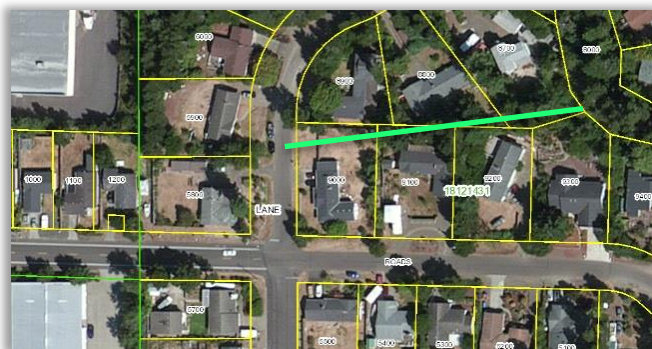
*Figure 6-2 - Tax lots near 42nd and Spruce. Direct discharge into Munsel Creek would require easements*

As an alternative to this design, the City could elect to install underground piping to transmit water directly into Munsel Creek. As shown in Figure 6-2, such a design would require the City to obtain multiple easements, and it would likely be more expensive, and more difficult to maintain than the ditch solution described above. This approach is not recommended.

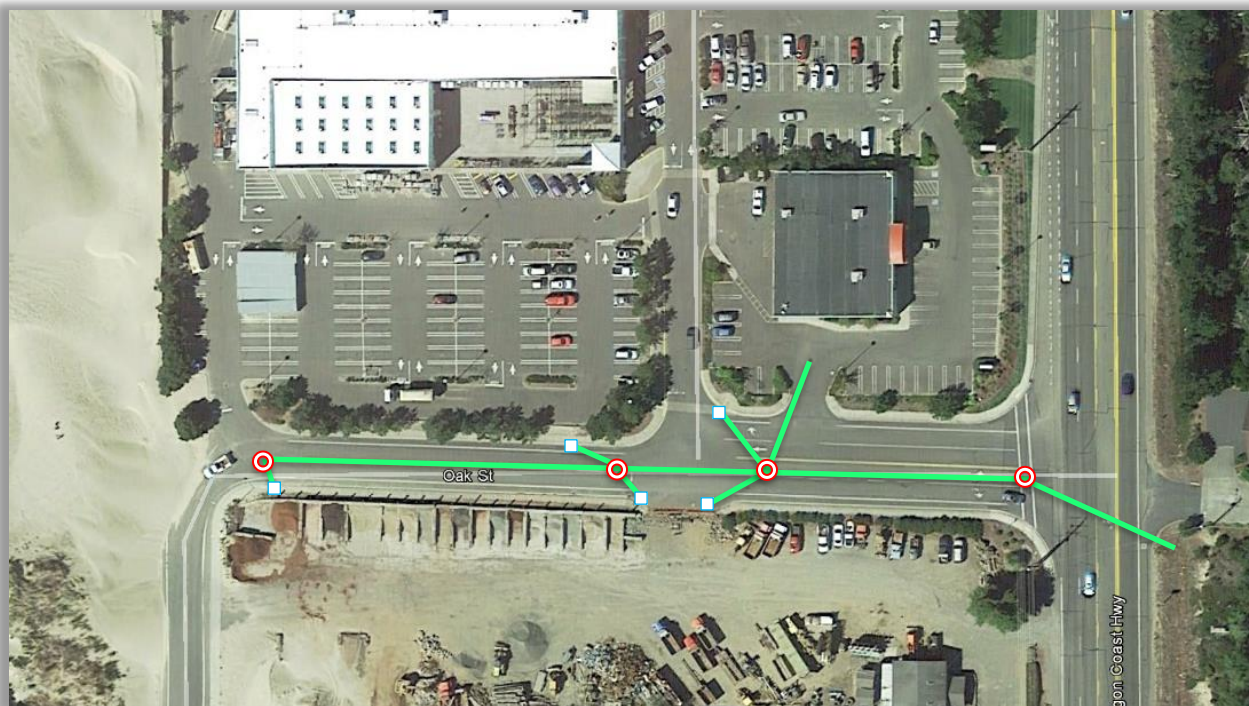
Figure 6-3 - CI Project Diagram (46<sup>th</sup> by Fred Meyer)

Drainage issues for 46<sup>th</sup> Street on the south side of Fred Meyer are described in Section 4.2. As stated there, the direction of flow in the existing underground storm piping on 46<sup>th</sup> street is to the west. In order to provide a point of discharge for this network, it will be necessary to reverse the direction of flow by removing and replacing the existing pipe network such that storm water can be conveyed east toward the highway via gravity flow. The new system may be connected to either the City-owned 42-inch pipe on the east side of the highway, or to the State system which runs south along the west side of Highway 101. See Figure 6-3 for a potential project layout.

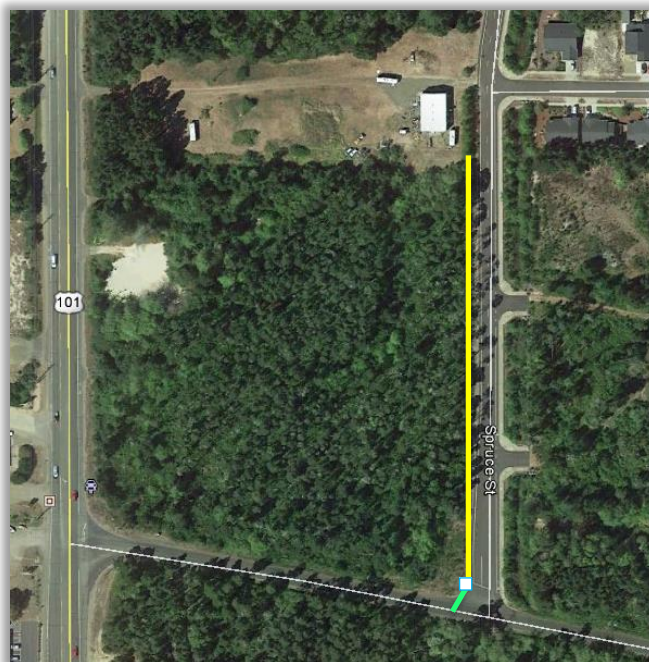
Figure 6-4 - CI Project Diagram (Spruce near 52<sup>nd</sup>)

As described in Section 4.3, the Siefert Ditch is currently being used as an infiltration swale. During development of Spruce Street, the Army Corps of Engineers prohibited water in the ditch from crossing Spruce Street, due to water quality concerns related to the historic use of Tax Lot #300 as a wrecking yard. The Army Corps wishes to protect the wetland mitigation efforts on the east side of Spruce from being contaminated by ground water from Tax Lot #300. As a consequence, water in the ditch may get backed up during wet-weather months, spilling over into adjacent properties. To correct this issue, it is recommended that the City restore the Siefert Ditch as a conveyance channel, and further, extend the ditch to the south along the western edge of the Spruce Street right-of-way, and tie it in to the pipe network on Munsel Lake Road.

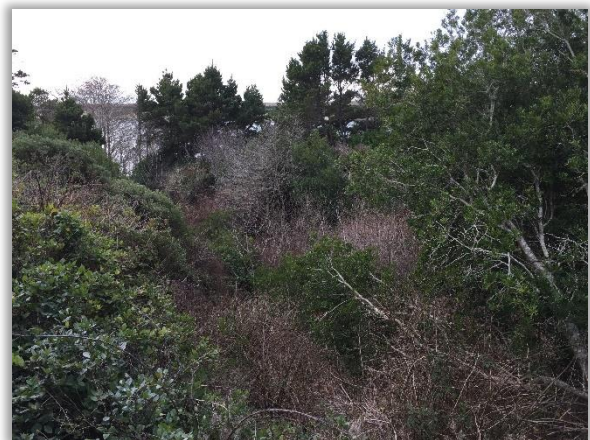
This recommendation was made long before the 2016 installation of the 42-inch culvert at Rhododendron Drive and 35<sup>th</sup> Street, which itself enables water from Tax Lot #3800 (and beyond) to enter Bud’s Ravine. However, no erosion control measures or scour-prevention improvements have since been implemented. Bud’s Ravine has not been piped, but it has been subjected to increased flows. Visual inspection of Bud’s Ravine revealed that the ravine is so densely vegetated that it is mostly unnavigable by foot. Plants and trees in this area are very well established, and their presence provides natural slope stabilization and scour prevention.

Figure 6-6 - Dense vegetation in Bud's Ravine
