City of Florence, Oregon

# STORM WATER MASTER PLAN UPDATE

DECEMBER 2018

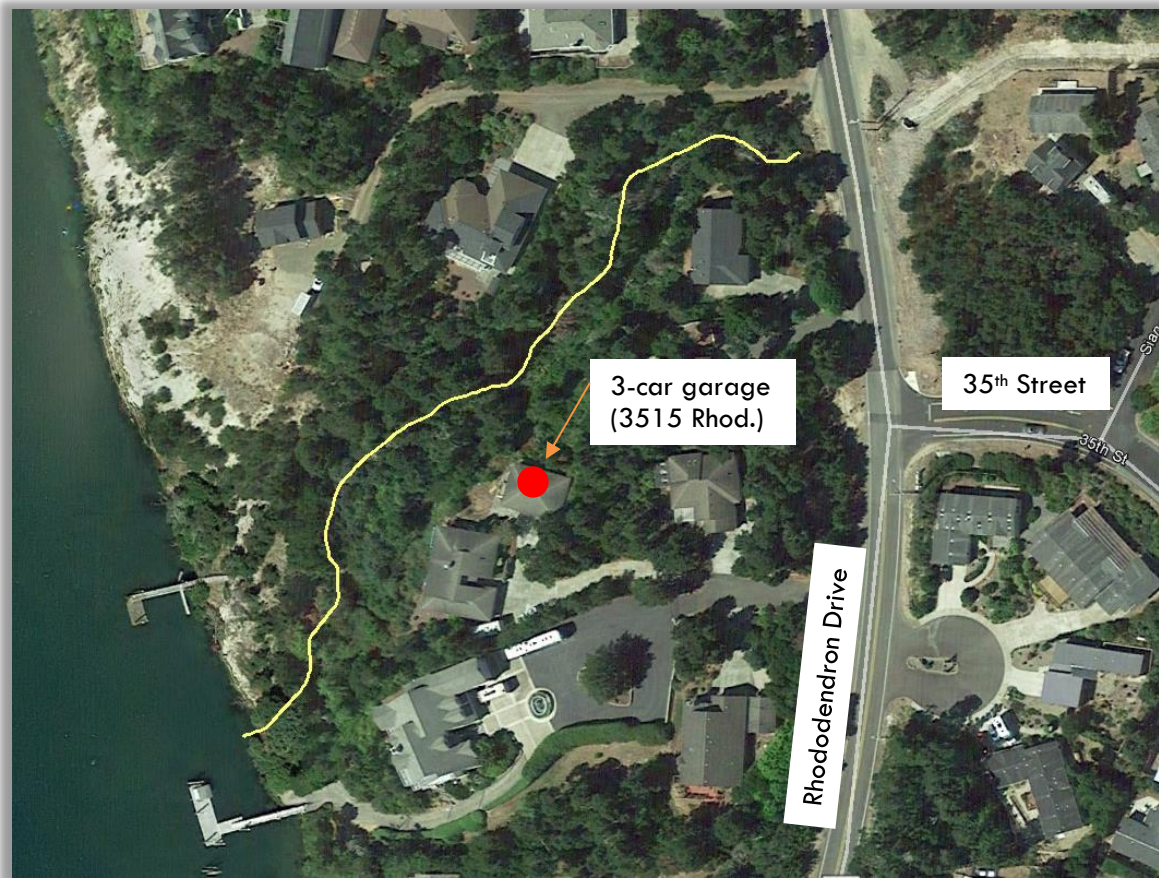
*Figure 6-7 - Approximate path of Bud's Ravine*

The approximate path of Bud's Ravine is shown in Figure 6-7. As seen in the Figure, there are a handful of homes which are situated along the banks of the ravine. One of these homes, 3515 Rhododendron Drive has a detached 3-car garage/shop which is located in close proximity to the top of the sloped bank. As shown in Figure 6-8, the foundation of this shop has been completely exposed at its northwest corner due to unconfined, loose sand eroding away from the building's perimeter. The previous owners of this home had argued that this erosion was caused by increased flows in Bud's Ravine, introduced by the 42-inch culvert, but this claim is likely incorrect. The erosion seen here appears to be a localized issue, likely caused by rain, wind, lack of stabilizing vegetation at the top of the slope, and therefore appears to be unrelated to the stormwater flows in the ravine.

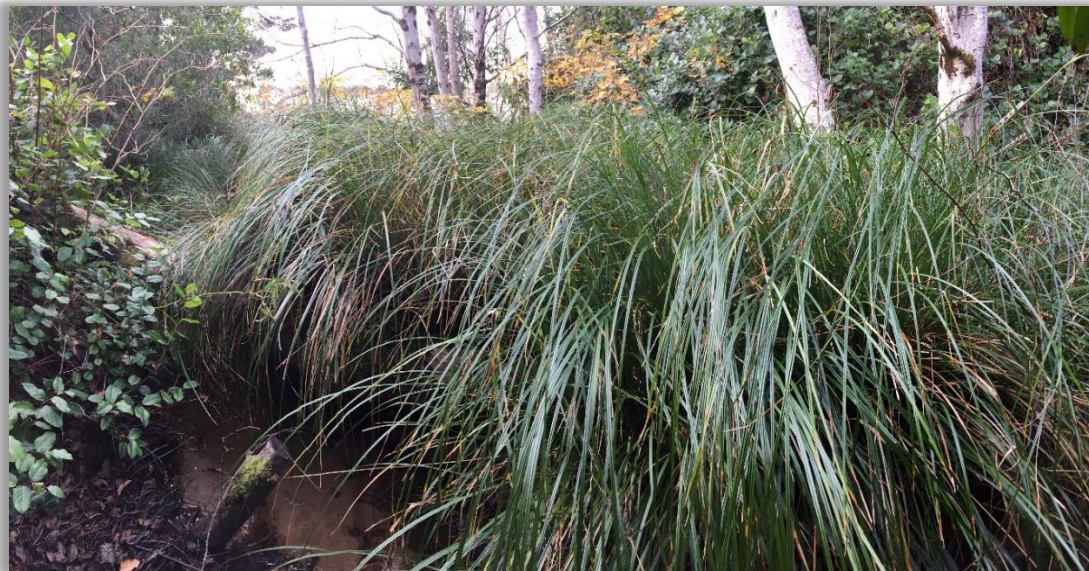
*Figure 6-10 - Bud's Ravine flowline (approx. 80 ft from outfall)*

If this solution is selected and no piping occurs within Bud’s Ravine, a maintenance and inspection plan should be implemented. This plan would call for routine inspection and re-evaluation of the stability of this ravine. If conditions change, and erosion or scour is observed, it may become necessary for the City to alter its approach and implement improvements to stabilize the banks. At the time of this report, such work appears to be unnecessary, but no guarantee is made that it will not become necessary in the future, with changing climatic conditions and/or alterations to the City’s drainage network.

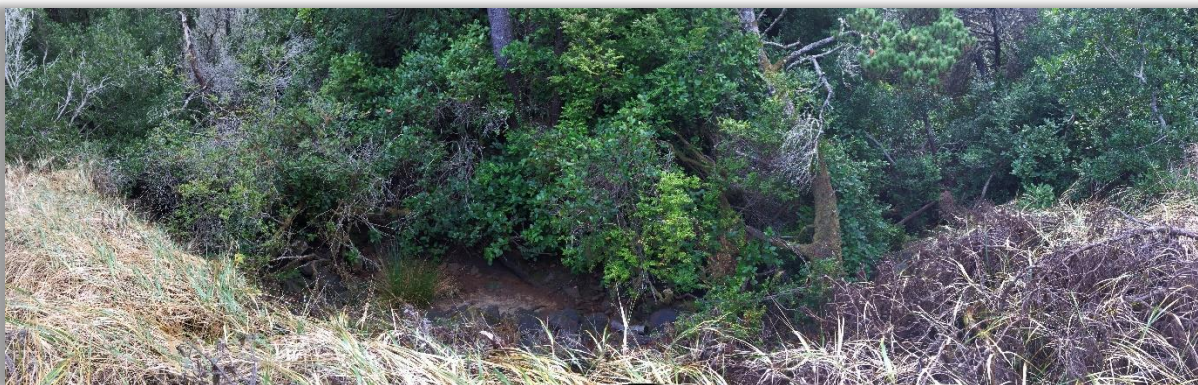
*Figure 6-11 - Bud's Ravine flowline (approx. 250 ft downstream from Rhododendron crossing)*

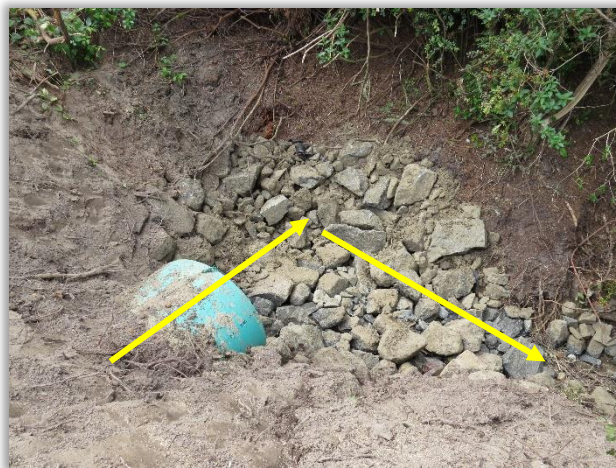
Figure 6-12 - Inlet into Bud's Ravine (90-deg angle turn)

Second, with the addition of flows from Mariner's Village and Fairway Estates to the 42-inch crossing at Rhododendron Drive, it is recommended to install additional armoring to the outfall on the west side of the street. That location, shown in Figure 6-12, requires water to make a 90-degree angle turn immediately after exiting the pipe. Energy dissipating rip rap is already in place but may need to be enhanced to prevent scour of the bank with the additional flow to the network.

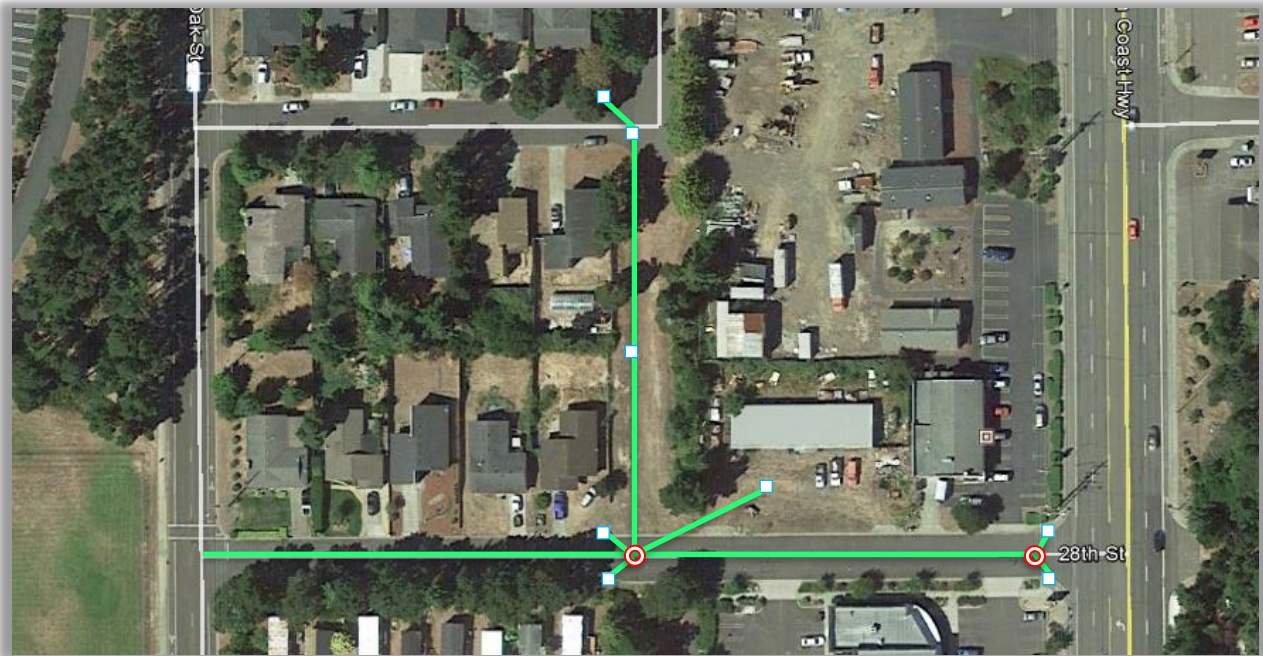
Figure 6-13 – CI Project Diagram (28<sup>th</sup> Street & Pine)

Drainage issues for Pine Street from 29<sup>th</sup> Street to 28<sup>th</sup> and Highway 101 are described in Section 4.5. As stated there, the undeveloped right-of-way is currently being used to infiltrate overflowing water from the pipe system, which has no discharge. This has caused flooding at nearby businesses.

In order to provide a point of discharge for this network, eliminate flooding, and restore the utility of the right-of-way, it is recommended to remove and replace the existing pipe network in the region, and connect new piping to the existing drainage infrastructure on Oak Street to the west. This project will provide the City with an opportunity to complete street improvements on 28<sup>th</sup> Street at the same time. See Figure 6-3 for a potential project layout.

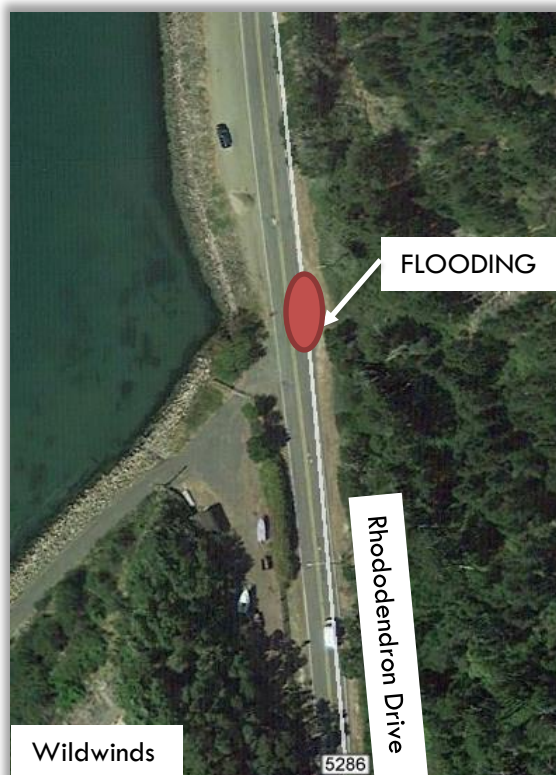
Figure 6-14 - CI Project Diagram (Rhododendron Drive, north of Wildwinds)

As described in Section 4.6, flooding has been observed on the east side of Rhododendron Drive north of Wildwinds Street. It would seem that this issue could be easily resolved by simply installing a culvert to pass water underneath the roadway to discharge into the Siuslaw River. But, as has been described previously, it will be difficult for the City to obtain permission from the Army Corps of Engineers to construct an additional outfall on the river. City staff has indicated that there may be an existing storm water inlet on the west side of the street. If such a structure exists, the City could explore that as a discharge opportunity for a culvert across Rhododendron.

In the case that such an inlet is not available, it is recommended that the City install a catch basin with piping to convey water to the southeast, and discharge onto Tax Lot #702. This tax lot, which is the former site of a landfill, is owned by Lane County, so its use would require the City to come to an agreement with County officials. It is also recommended to install energy dissipating rip-rap at the discharge point, to prevent erosion of the embankment.

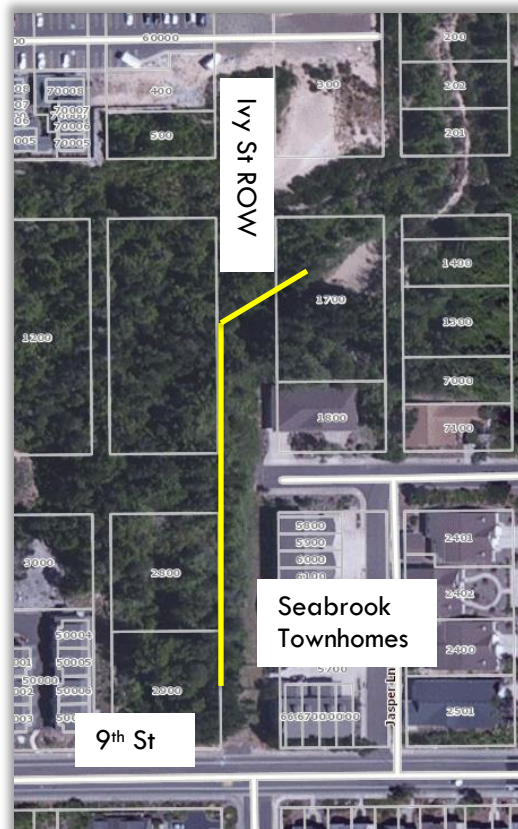
Figure 6-16 - CI Project Diagram (Ivy St. Ditch)

Drainage issues on 9<sup>th</sup> Street from Ivy to Elm are described in Section 4.8. As stated there, a majority of the drainage problems in this corridor appear to be caused by an excessive amount of sediments entering the system via the 42-inch concrete pipe on the west side of Seabrook Townhomes. Field inspections of the ditch took place after it was already hand dug by a local resident, and at the time of inspection, vegetation had not grown back to stabilize the walls of the ditch.

It is recommended that the City complete improvements to this ditch, to increase its capacity, and stabilize its banks. City Public Works crews have traditionally used a high-strength woven coir twine erosion control mat (Coir Mat 90) to preserve ditch banks until a root base can be established. This, or a similar product, is recommended for installation after excavating a new ditch with a more definitive flow path. It is recommended to complete this project in the early spring, to give grass seed ample opportunity to germinate.

Furthermore, it is recommended to install riprap or a geosynthetic cementitious composite mat along the bottom of the ditch. Doing so will reduce the erosion that may occur along the flow line, while still allowing ground water to enter the ditch through the vegetated banks. Riprap or a concrete headwall should be installed around the entrance of the 42-inch pipe.
