From: [Mike Miller](#)
To: [REDACTED]
Cc: [Roxanne Johnston](#)
Subject: RE: GSI report and request
Date: Wednesday, November 17, 2021 4:45:41 PM
Attachments: [Pumping at Fairway Estates.pdf](#)

From: Steve WILLIAMS [REDACTED]
Sent: Monday, November 8, 2021 4:46 PM
To: Roxanne Johnston <Roxanne.Johnston@ci.florence.or.us>; Mike Miller <mike.miller@ci.florence.or.us>
Subject: GSI report and request

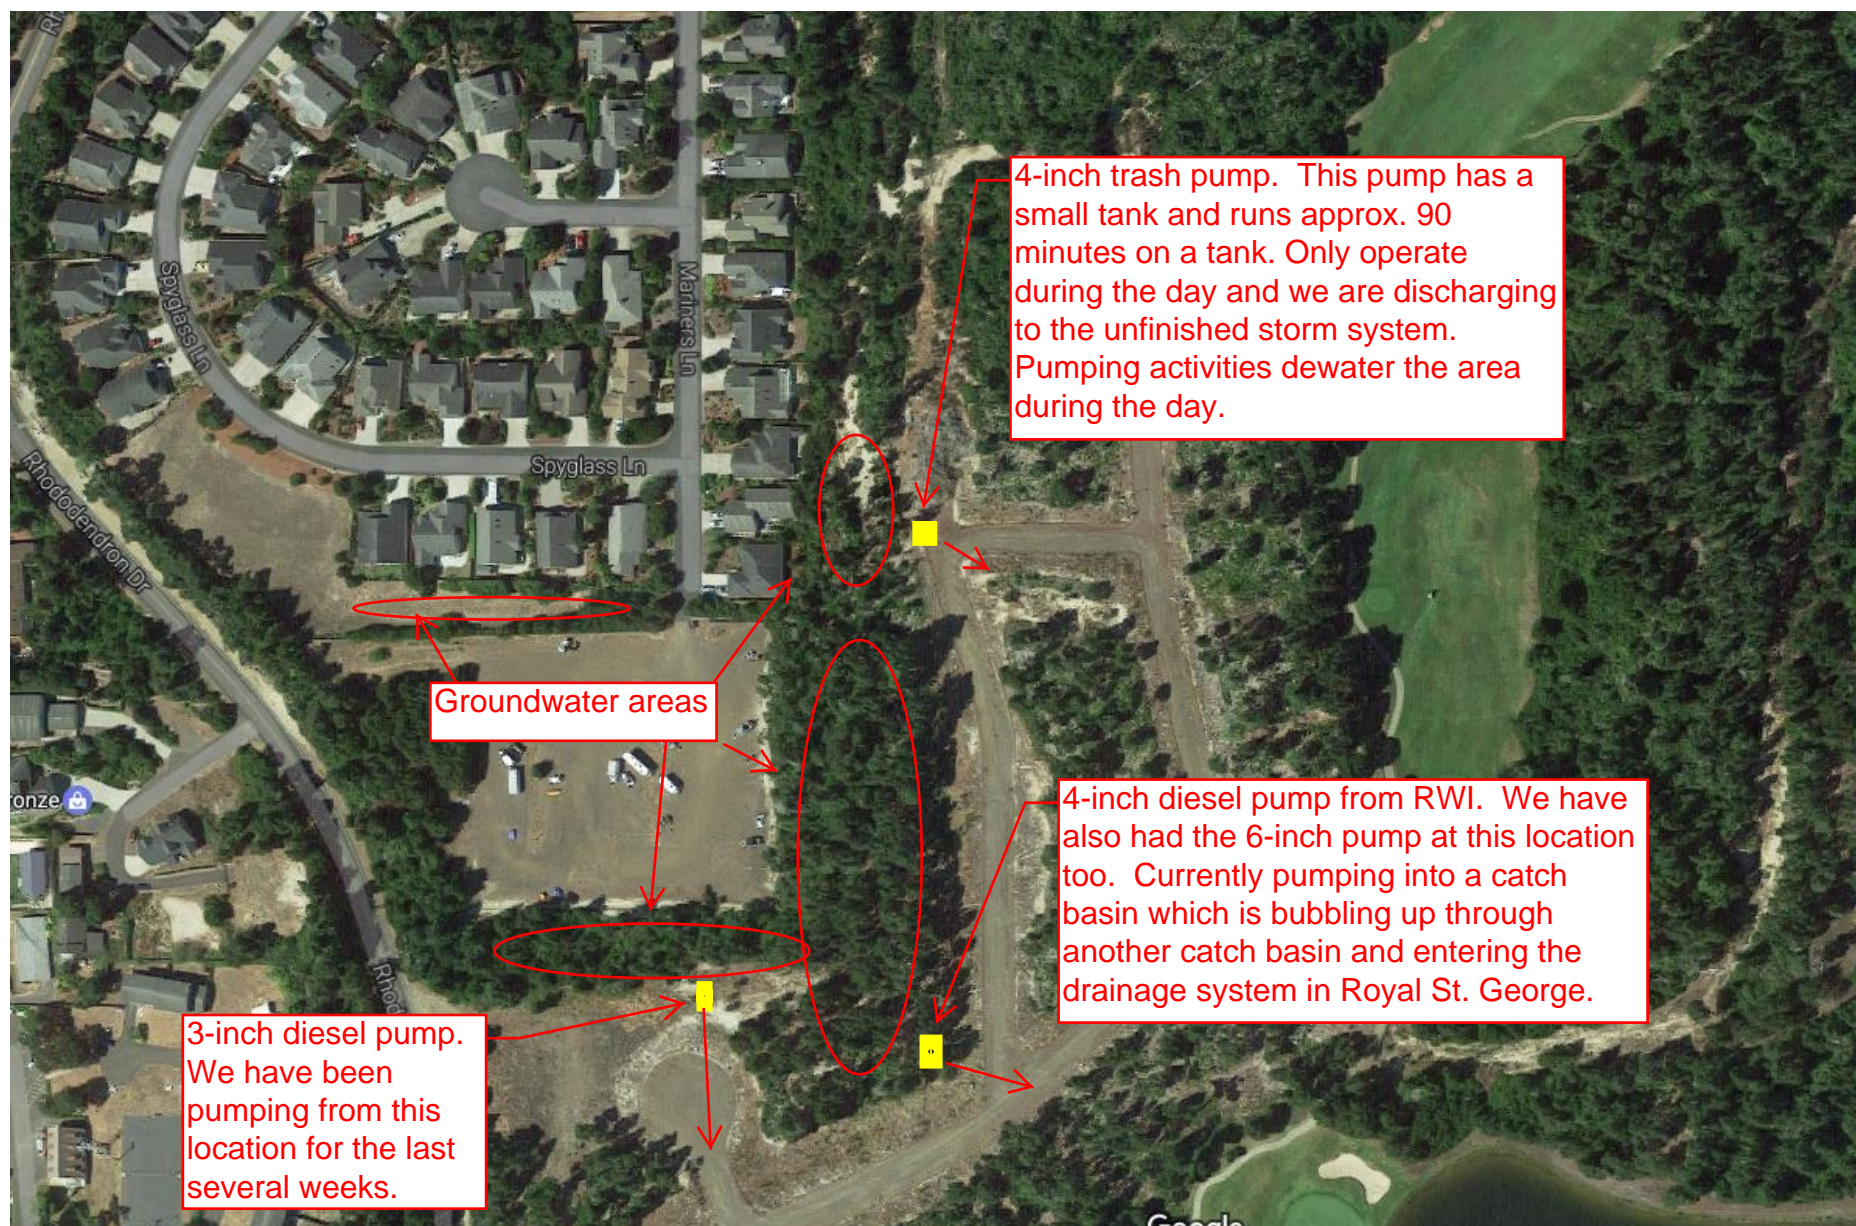
Groundwater areas

4-inch trash pump. This pump has a small tank and runs approx. 90 minutes on a tank. Only operate during the day and we are discharging to the unfinished storm system. Pumping activities dewater the area during the day.

4-inch diesel pump from RWI. We have also had the 6-inch pump at this location too. Currently pumping into a catch basin which is bubbling up through another catch basin and entering the drainage system in Royal St. George.

3-inch diesel pump. We have been pumping from this location for the last several weeks.

Steve, I would like to provide some information regarding your question above. If it is in regards to the 2017 rain events, Fairway Estates was not completed (the streets were still gravel and the stormwater system had nowhere to discharge). During the stormwater events of February-April 2017, the City rented large capacity pumps to pump water from several locations inside Fairway Estates to reduce localized flooding in Mariners Village. Please see attached PDF of the locations and direction of flow of the pumped water. The map was produced at the end of March 2017 and noted conditions at that time. The oval areas is where the groundwater had become surface water and ponding occurred. Again, Fairway Estates road network was still gravel (same basic condition it had been since 2007) and the stormwater system was a closed system with no outlet. It wasn't until later when Fairway Estates installed a 15-inch stormwater line along Rhododendron and connected to the stormwater system just north of 35th that crosses to the west side of Rhododendron Drive into 'Buds Ravine'. The 15-inch stormwater line is connected to a flow control manhole at the entrance to Fairway Estates that meters the stormwater from their system to attenuate flows.
